EXHIBIT 1

REPRESENTATIVE SITE PHOTOGRAPHS

EXHIBIT 2

USACE FUNCTIONAL RATIO METHOD CALCULATION

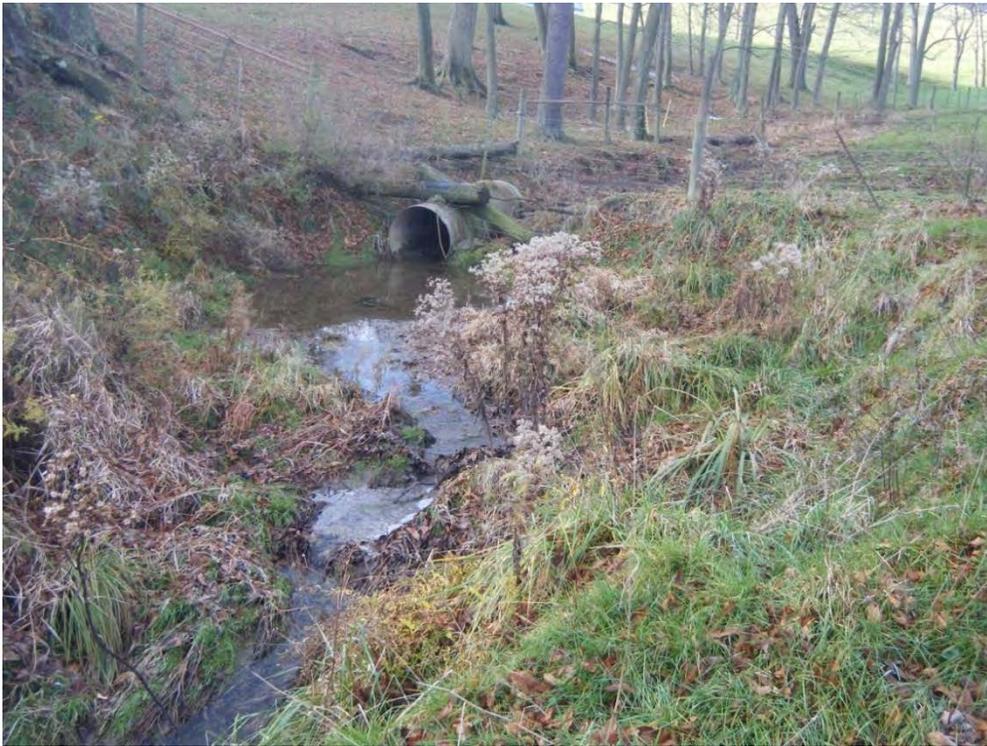
Photo 1 – Unnamed tributary as it enters the Site from neighboring western property through culvert.

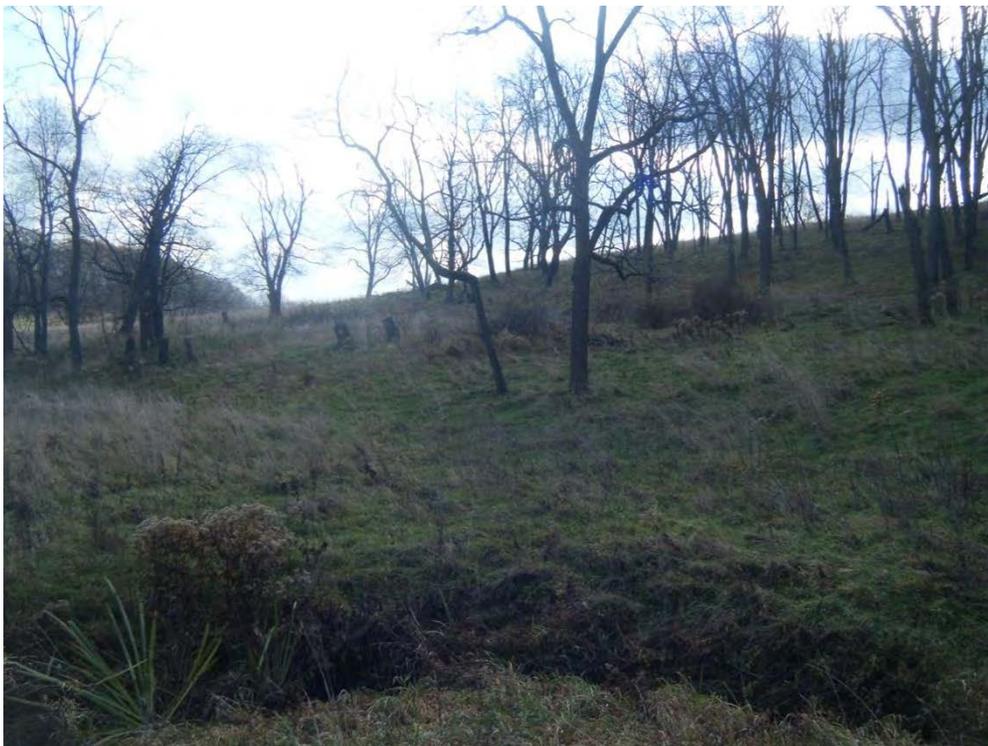
Photo 2 – Unnamed tributary riparian zone and adjacent upland.

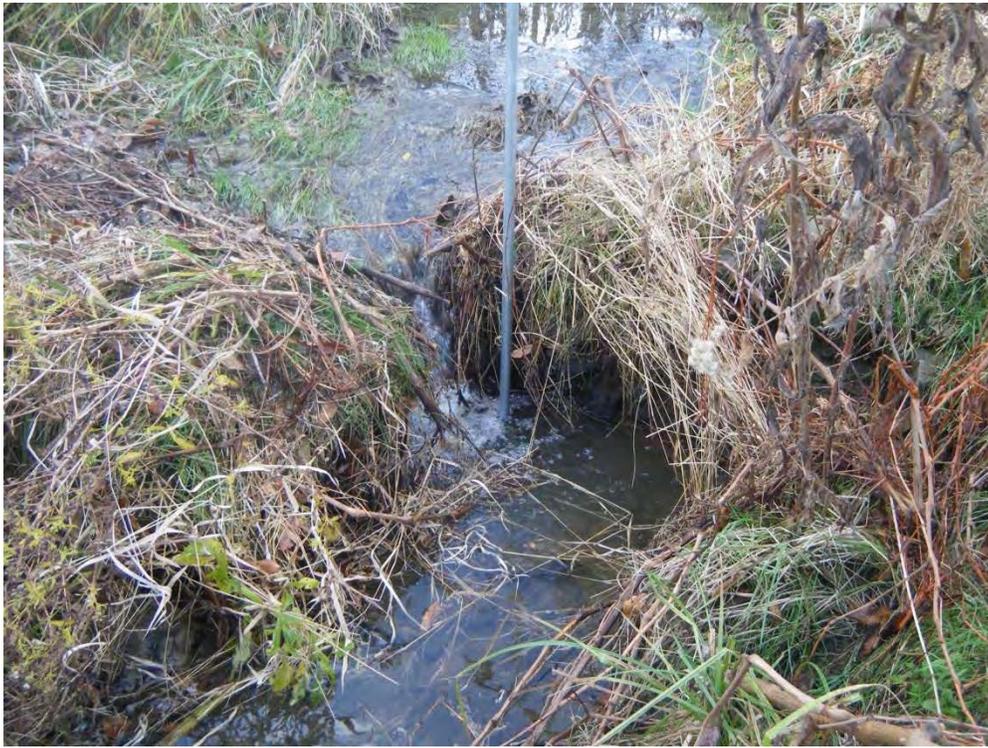
Photo 3 – A head-cut erosion indicating instability on the unnamed tributary.

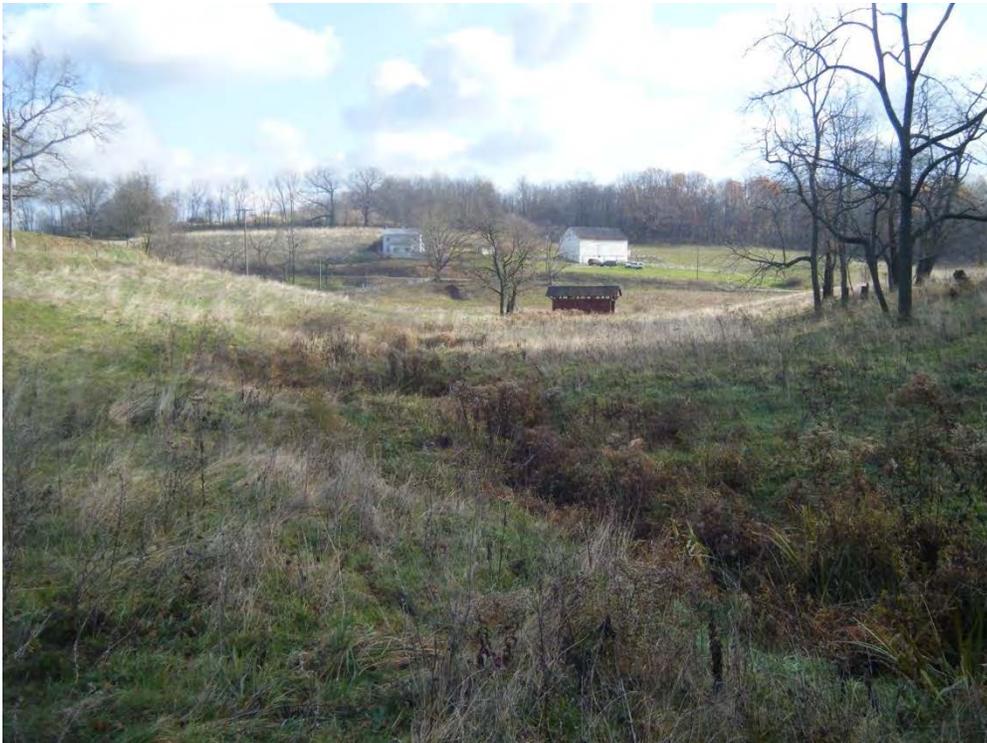
Photo 4 – Unnamed tributary lacking a forested buffer as it flows through pasture fields.

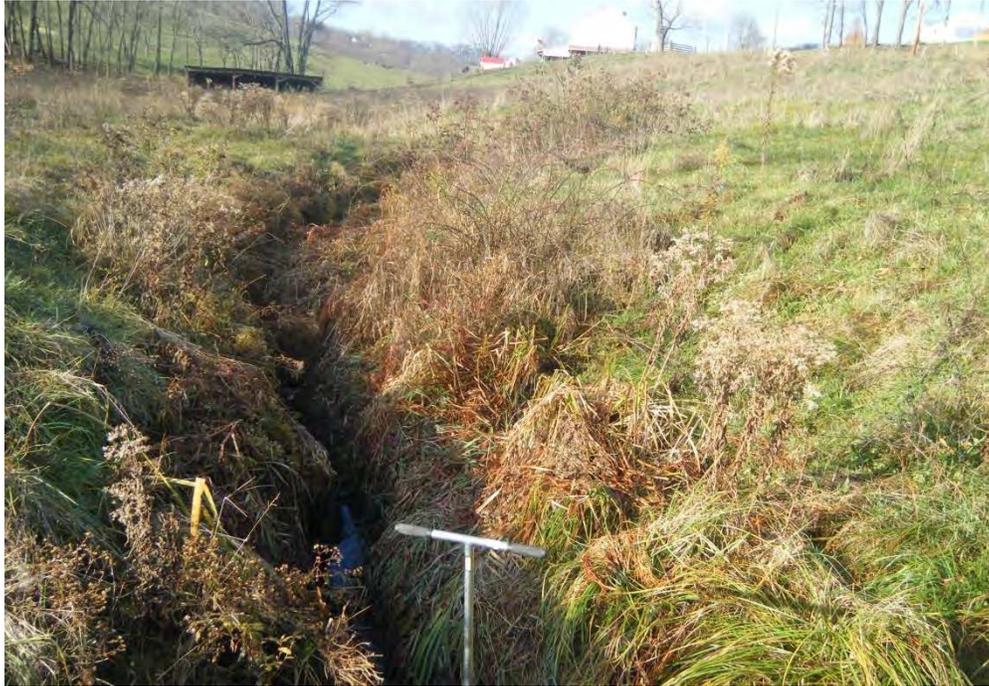
Photo 5 – Unnamed tributary is incised downstream from the head-cut.

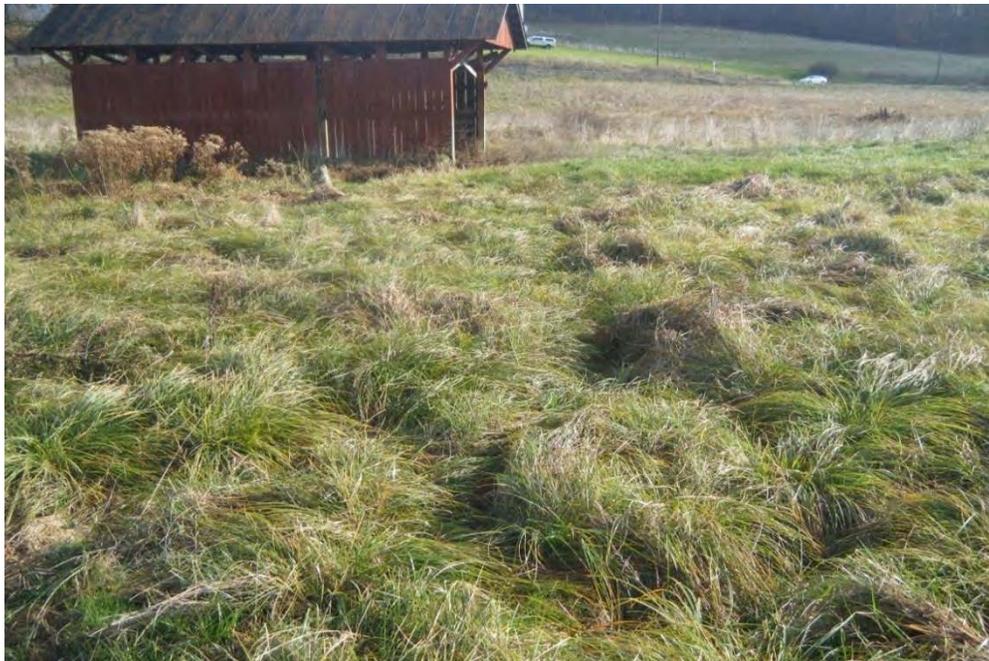
Photo 6 – Pastured and degraded PEM wetlands within floodplain.

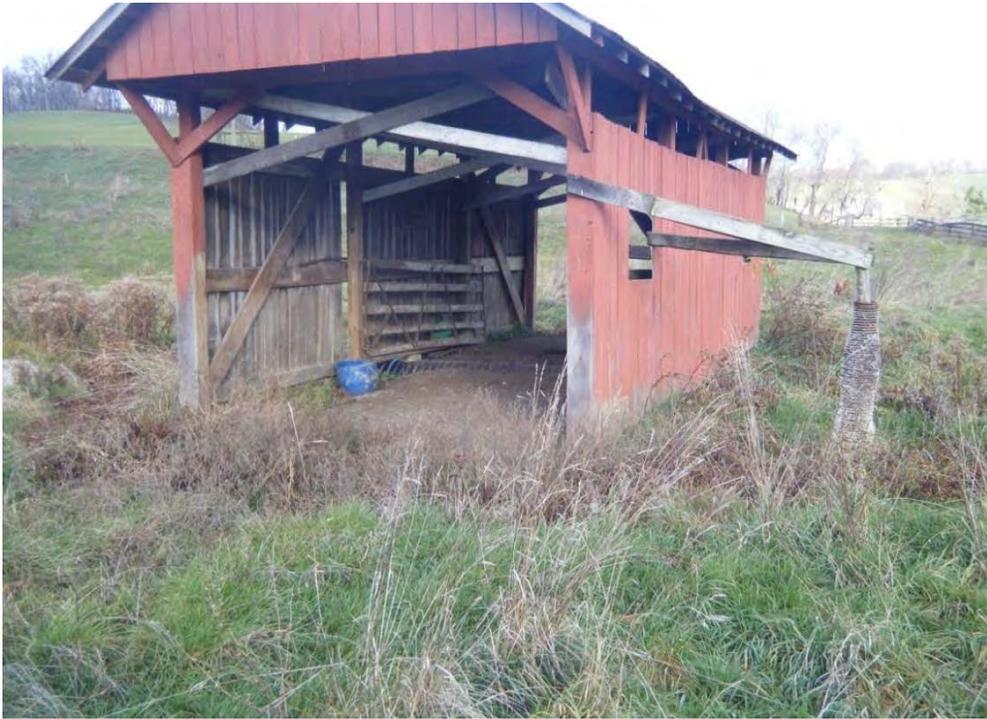
Photo 7 – Crossing structure over unnamed tributary. A culvert conveys the stream flow under the structure.

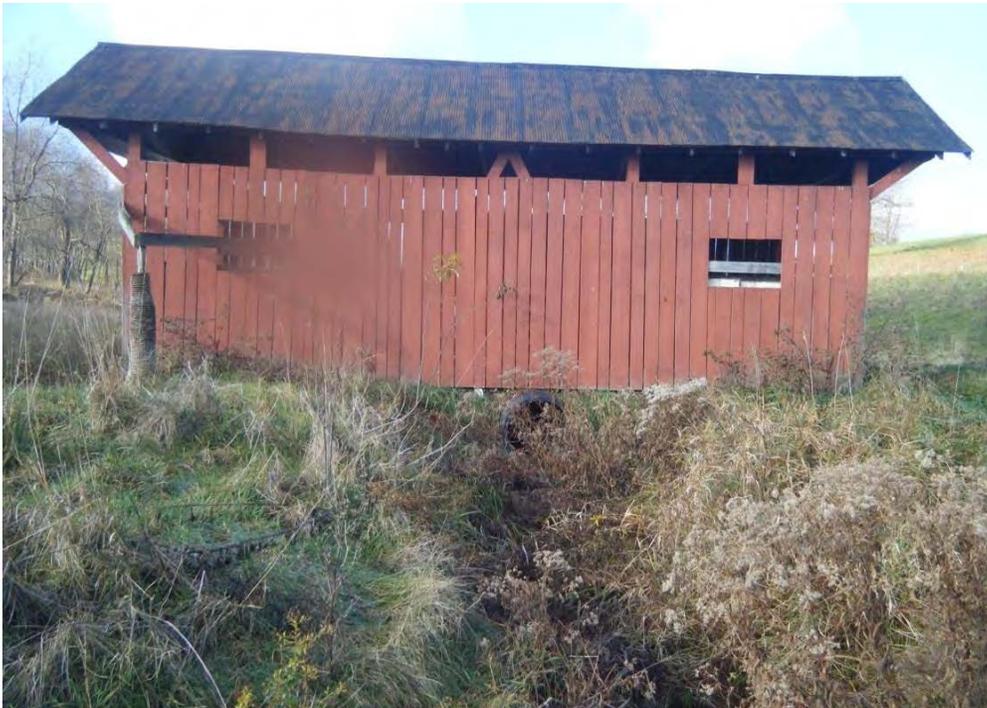
Photo 8 – Structure spanning stream to be removed.

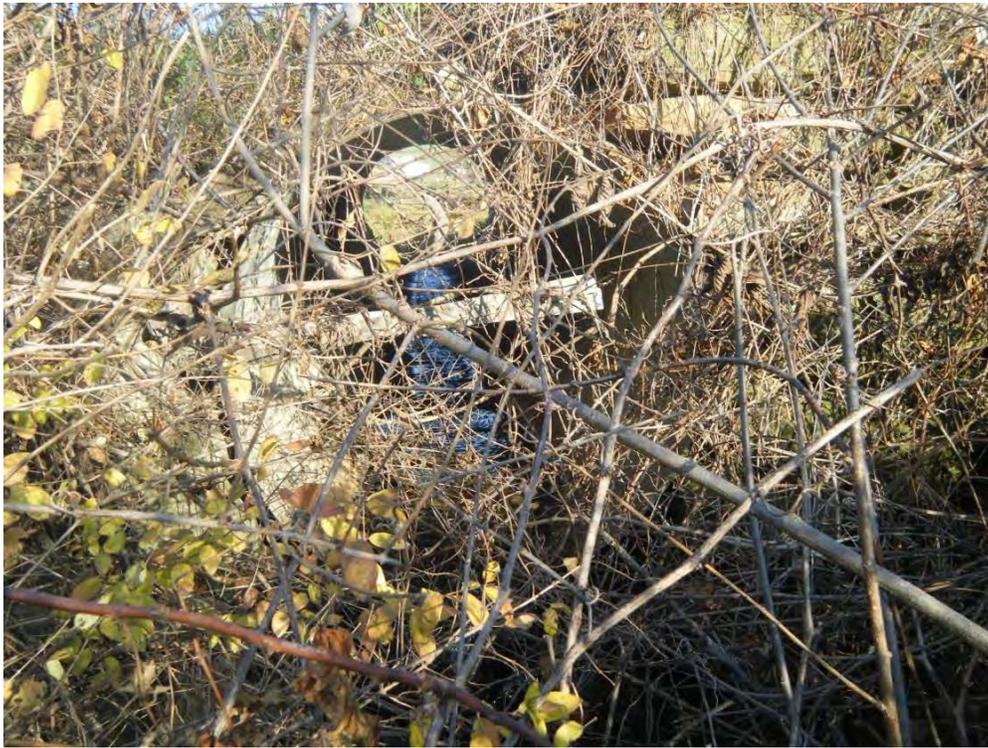
Photo 9 – The North Branch of Pigeon Creek enters the Site through this culvert under Young Road.

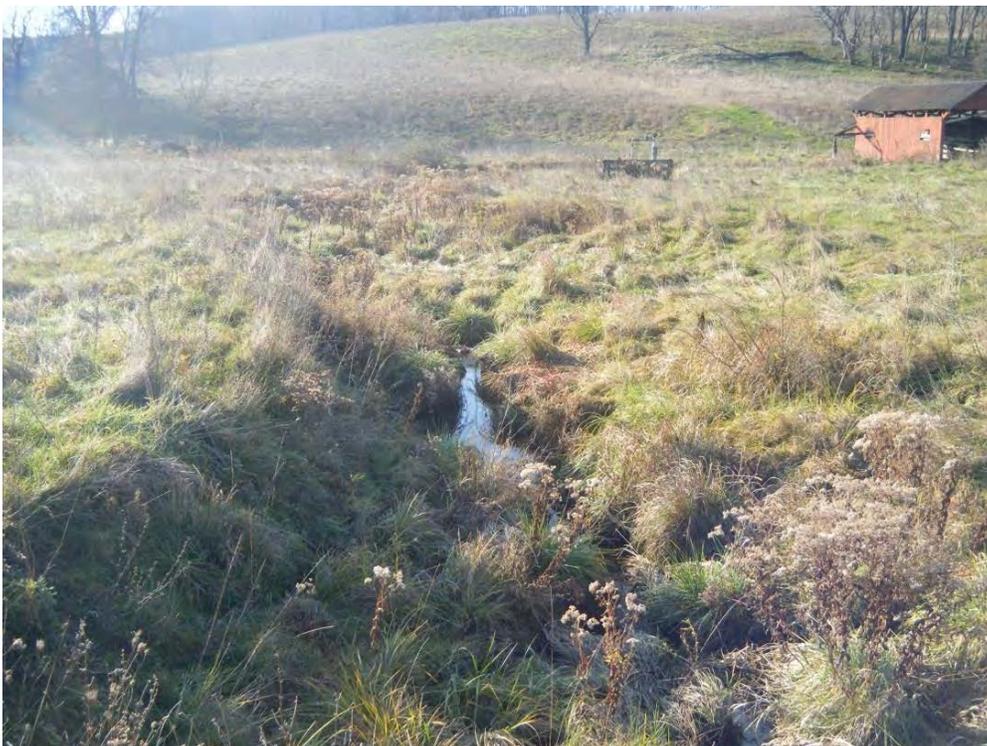
Photo 10 – Downstream of the North Branch of Pigeon Creek as it enters the Site.

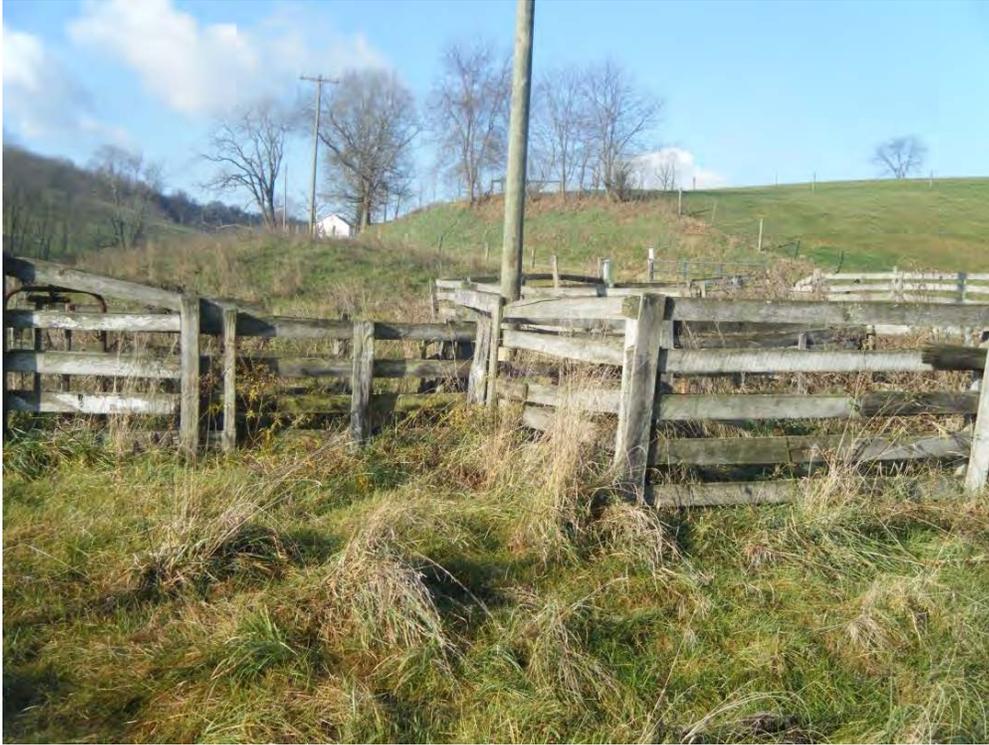
Photo 11 – Old farm corral to be removed from within the RZOI of the North Branch of Pigeon Creek.

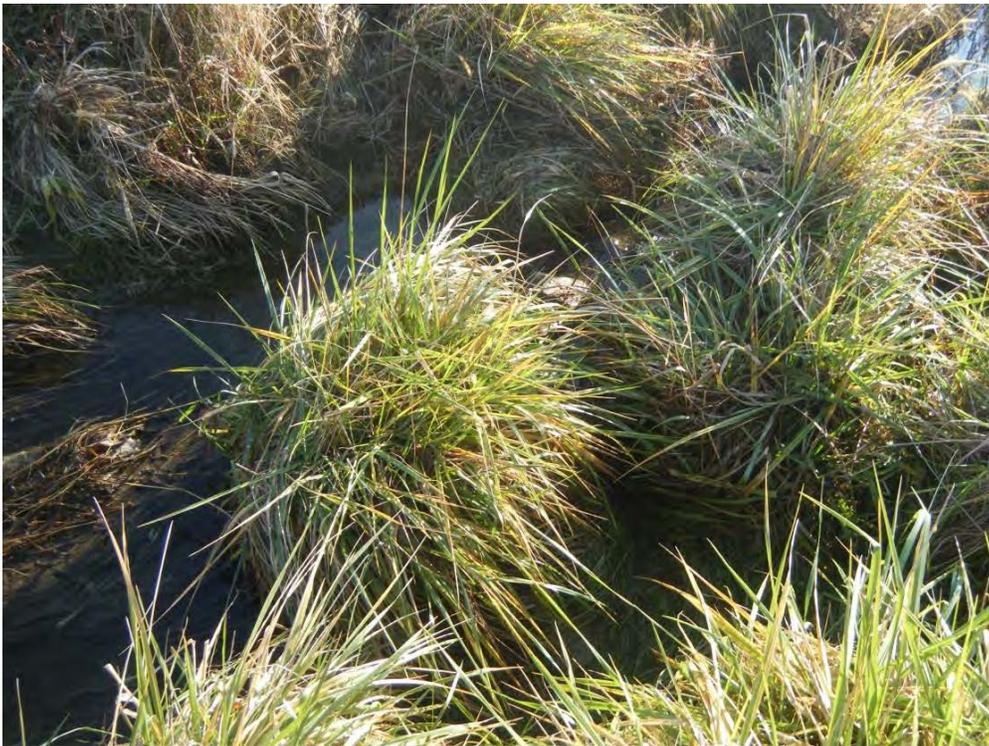
Photo 12 – Pasture grass tussocks within the North Branch of Pigeon Creek.

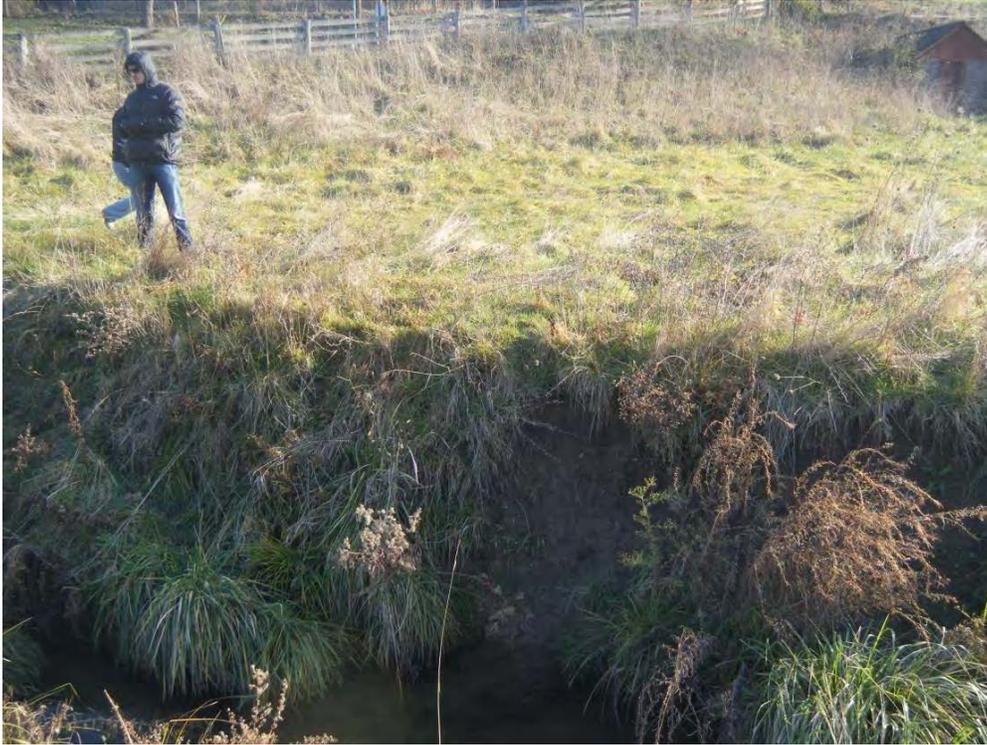
Photo 13 – Unstable left stream bank of the North Branch of Pigeon Creek which is five feet high limiting the stream to access its historical floodplain.

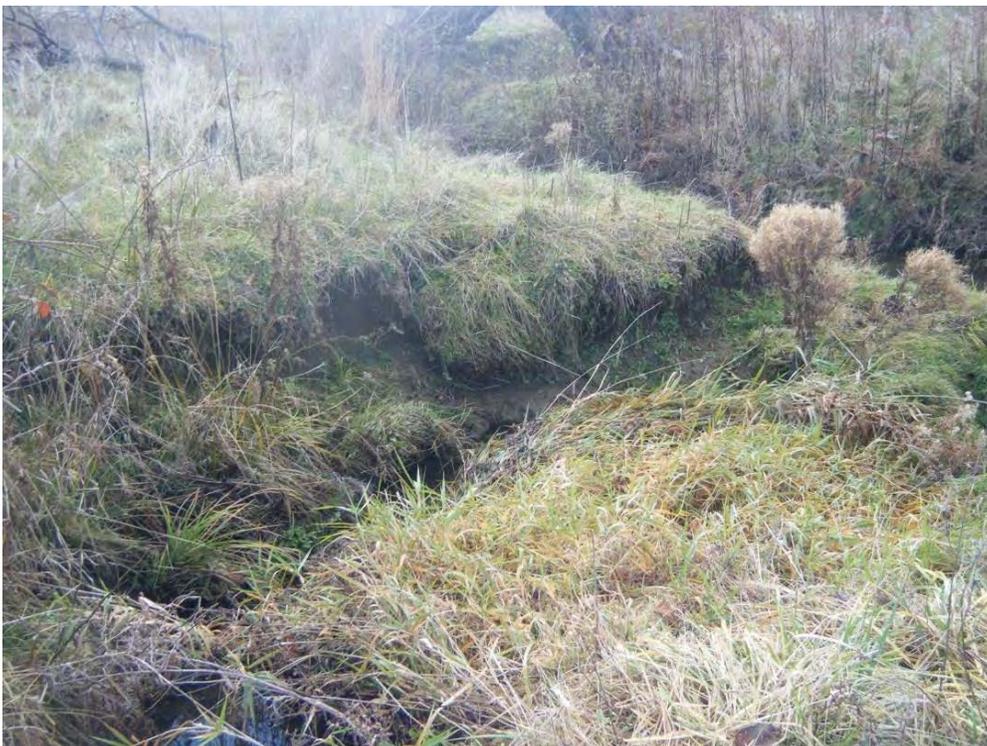
Photo 14 – Eroding banks downstream of the confluence of the North Branch of Pigeon Creek and the unnamed tributary.

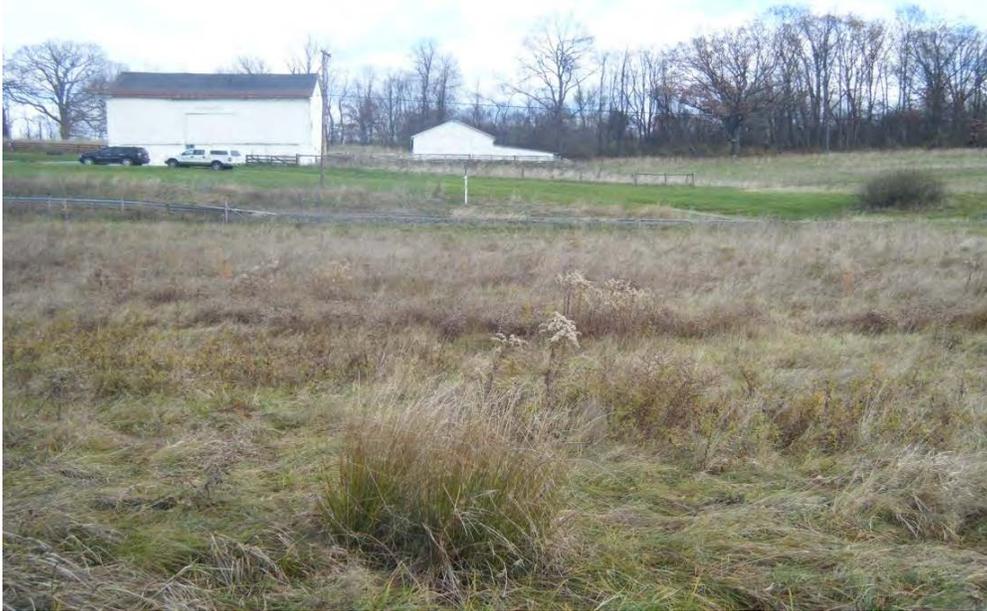
Photo 15 – Degraded wetlands within the stream floodplain.

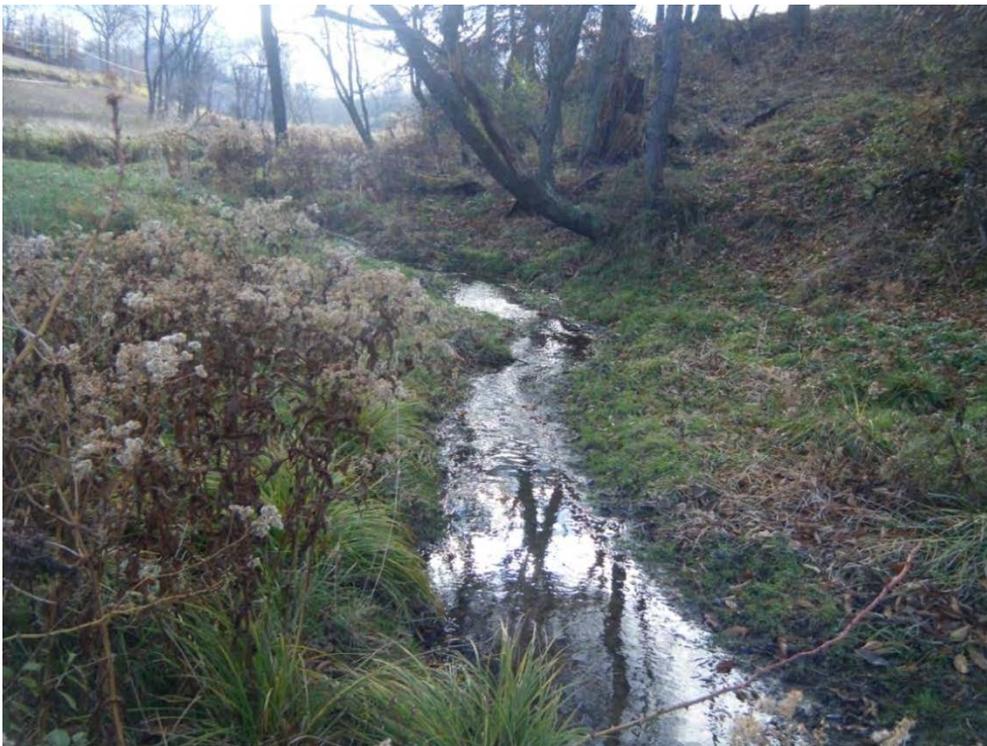
Photo 16 – Example of the North Branch of Pigeon Creek onsite showing channel migration to the far right extent of the floodplain along the steep confining slope.

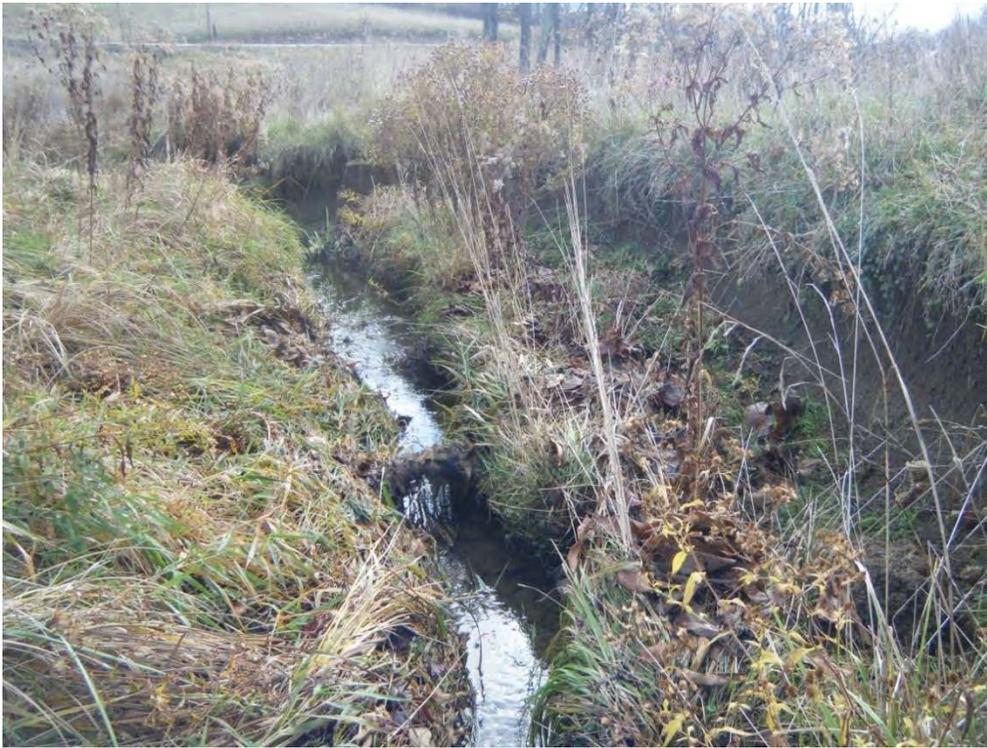
Photo 17 – Example of unstable channel characteristics including bank failure in the North Branch of Pigeon Creek onsite.

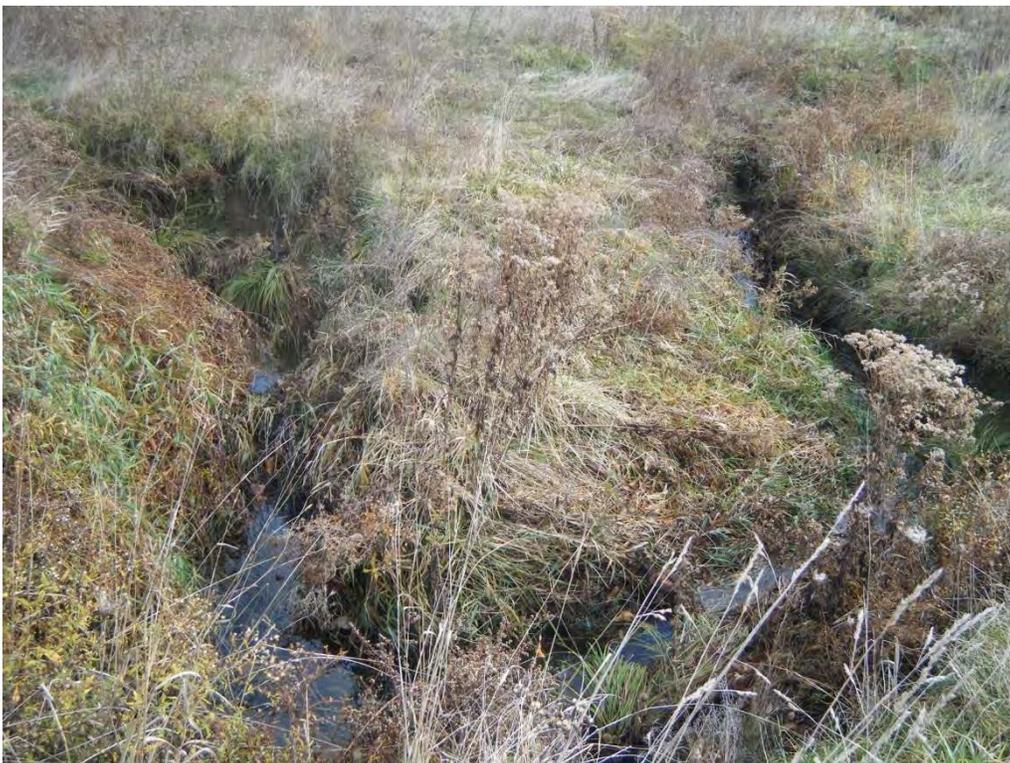
Photo 18 – Example of lateral instability of the North Branch of Pigeon Creek.

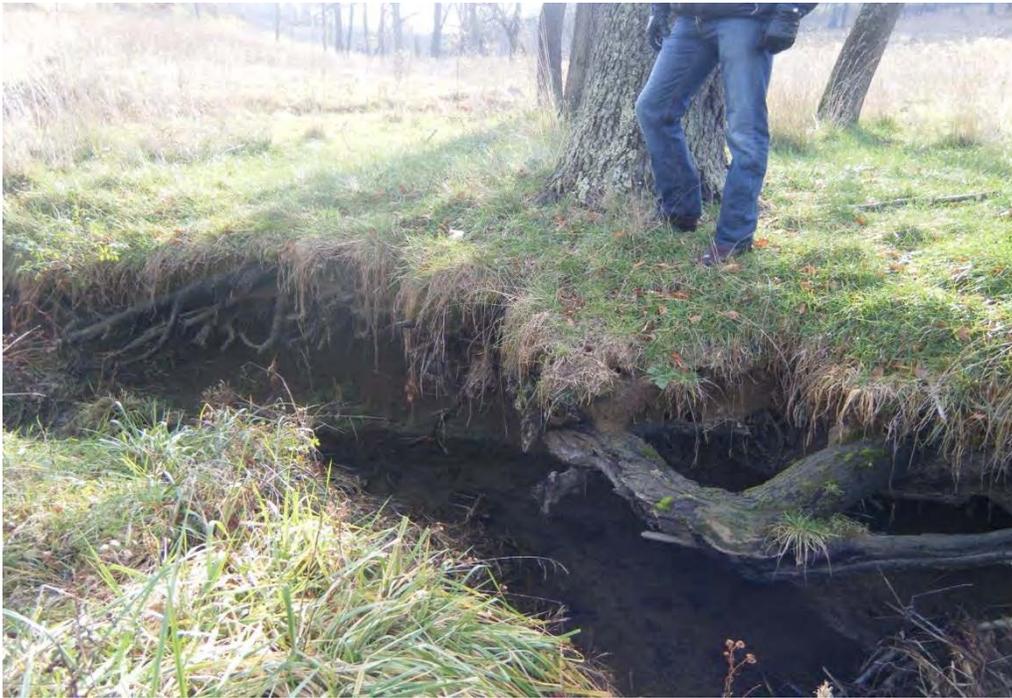
Photo 19 – Under-cut bank of the North Branch of Pigeon Creek.

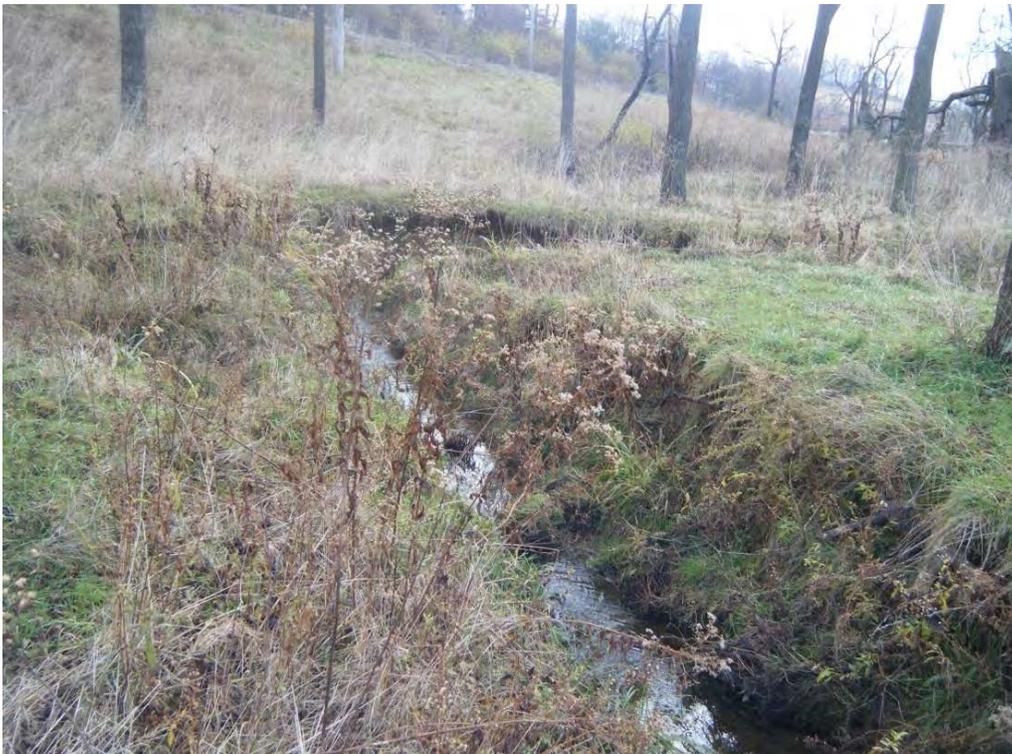
Photo 20 – Example of stream channel incision in the lower third of Site limiting access to the floodplain.

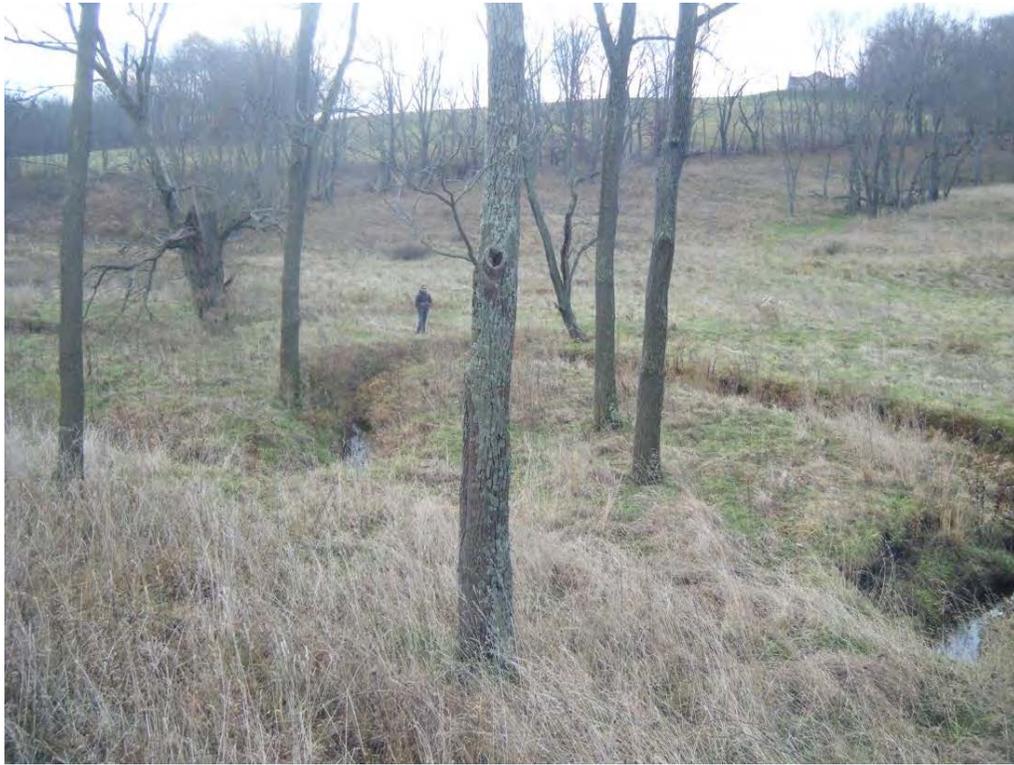
Photo 21 – Portion of the North Branch of Pigeon Creek onsite showing unstable sinuosity, channel incision below the historical floodplain, and up-valley meander migration.

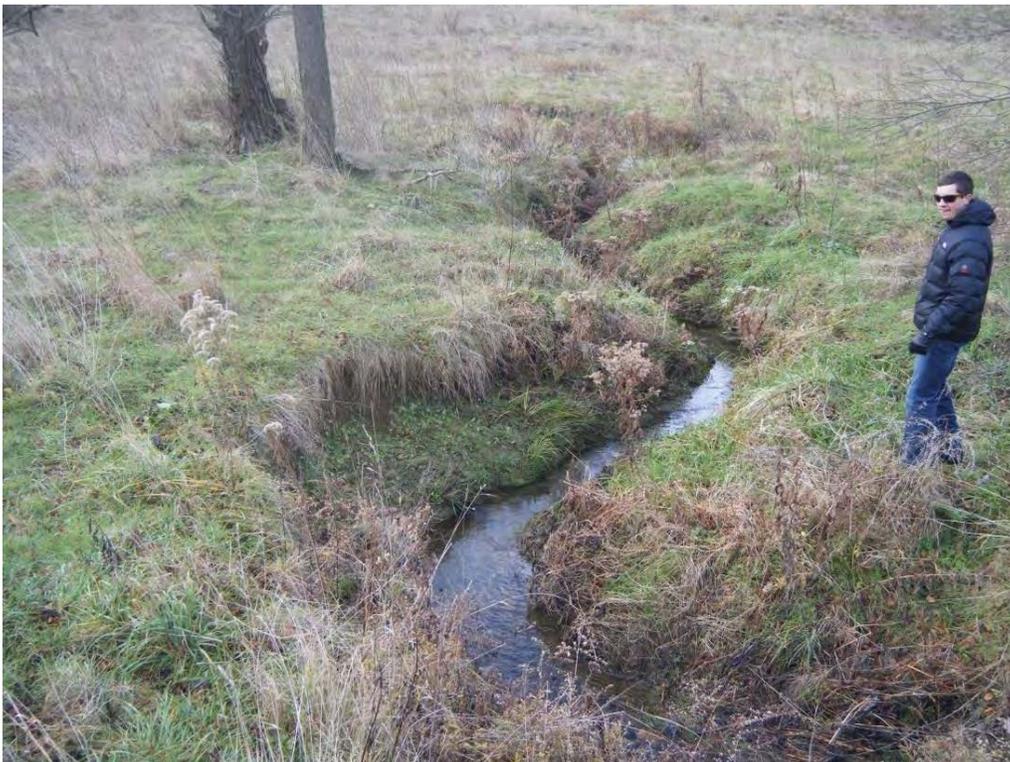
Photo 22 – The North Branch of Pigeon Creek has very few trees within the riparian buffer.

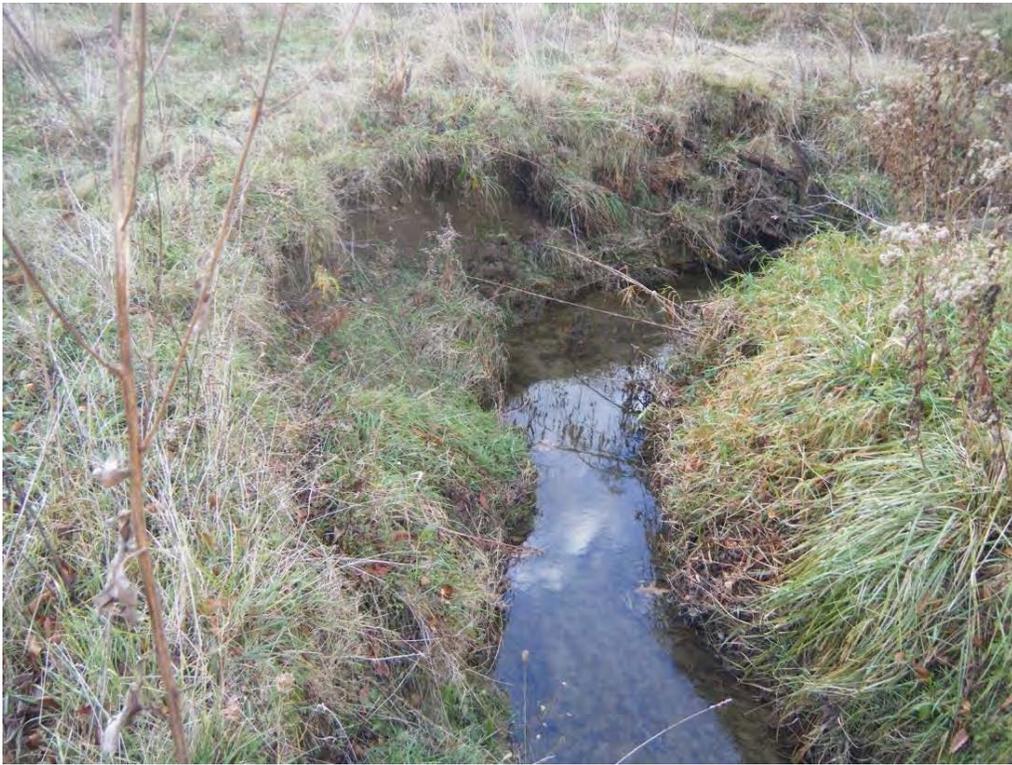
Photo 23 – Example of sloughing banks on the North Branch of Pigeon Creek.

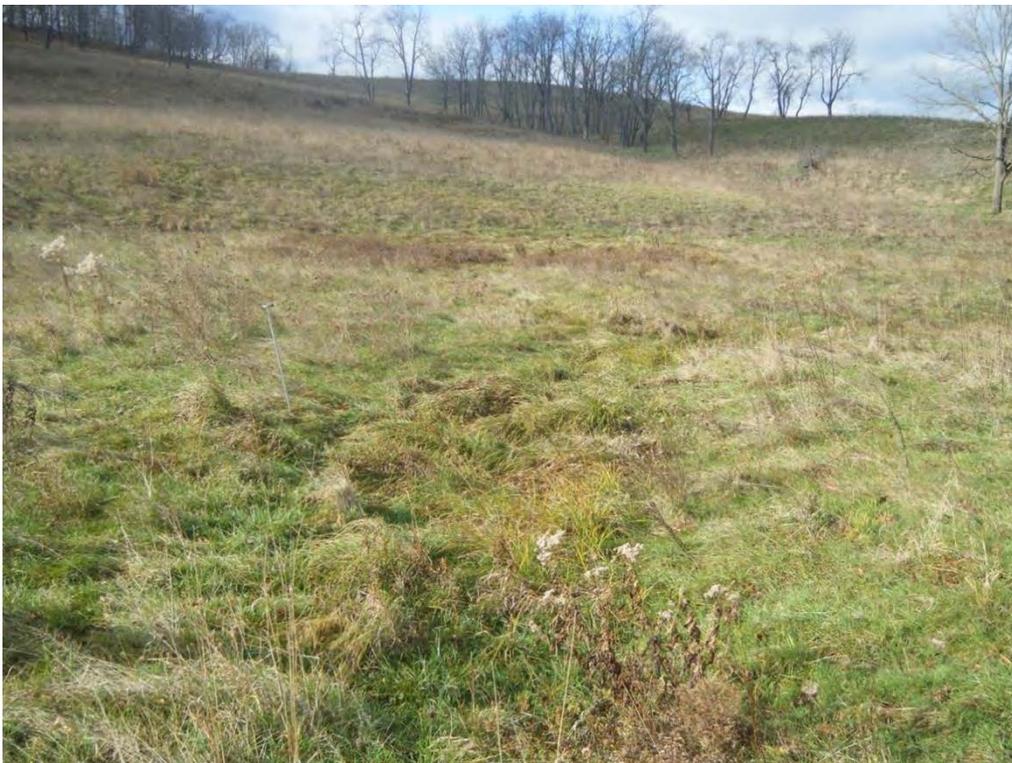
Photo 24 – Example of degraded and pastured wetland within the historical floodplain.

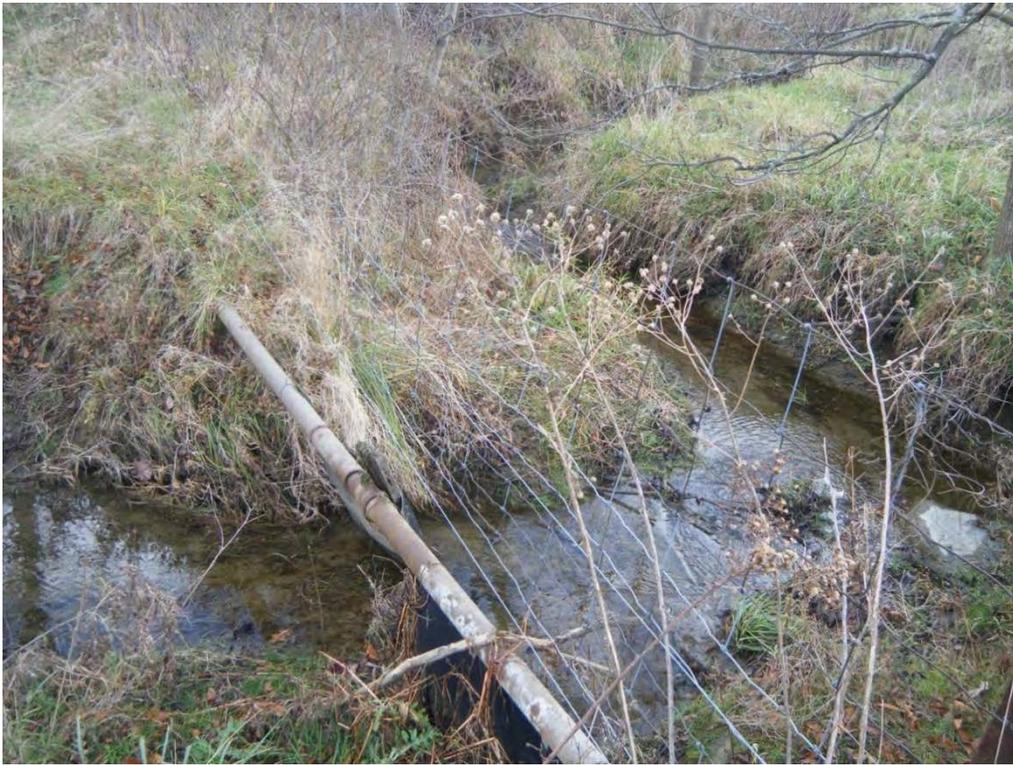
Photo 25 – North Branch of Pigeon Creek as it flows off Site.

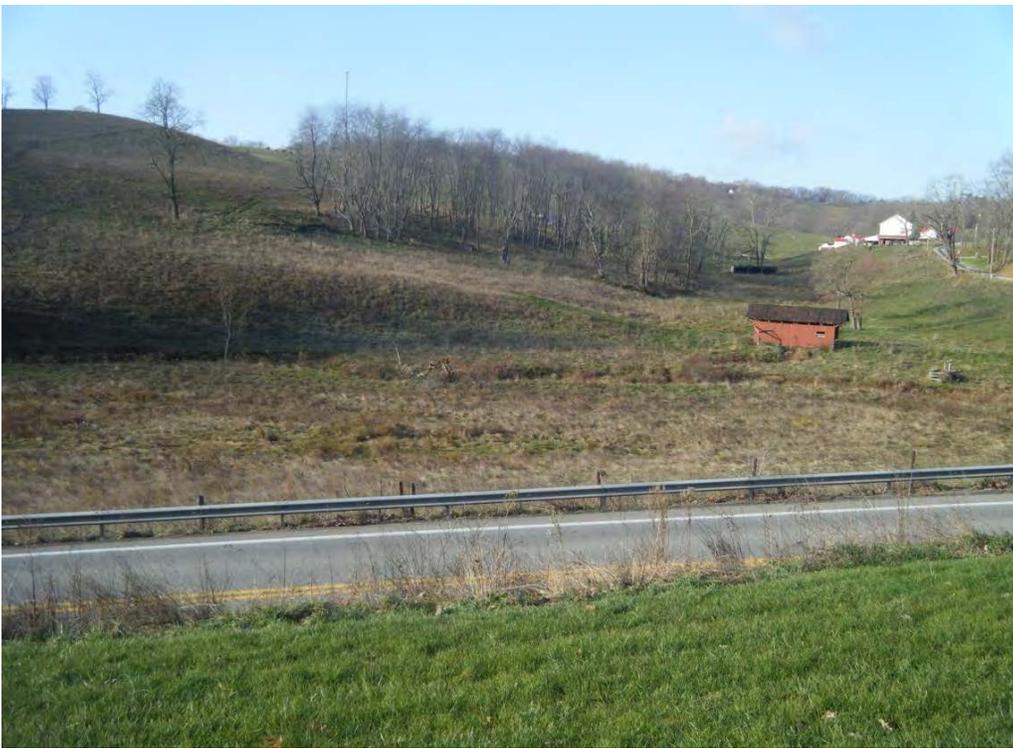
Photo 26 – Overview of upper portion of Site showing the confluence of the North Branch of Pigeon Creek and the unnamed tributary near the red stream crossing structure.
