Rapid Bioassessment Protocol
Field Data Sheets

PHYSICAL CHARACTERIZATION/WATER QUALITY FIELD DATA SHEET
(FRONT)

STREAM NAME <u>South Fork of Tenmile Creek</u>		LOCATION <u>Foundation 404 Water Intake RBP</u>	
STATION # <u>201911402931527115</u>		RIVERMILE	
LAT <u>39° 52' 30.99" N</u>		LONG <u>90° 16' 57.87" W</u>	
STORET #		AGENCY <u>WPI</u>	
INVESTIGATORS <u>GM BW</u>		FORM COMPLETED BY <u>GM</u>	
DATE <u>01-05-11</u>		REASON FOR SURVEY <u>Baseline</u>	
TIME <u>2:25 PM</u>		Has there been a heavy rain in the last 7 days? <u>YES</u>	
WEATHER CONDITIONS		Air Temperature (degrees) <u>32°F</u>	
Now storm (heavy rain) rain (steady rain) showers (intermittent) % cloud cover <u>clear/sunny</u>		Past 24 Hours storm (heavy rain) rain (steady rain) showers (intermittent) % cloud cover <u>clear/sunny</u>	
Other		Other

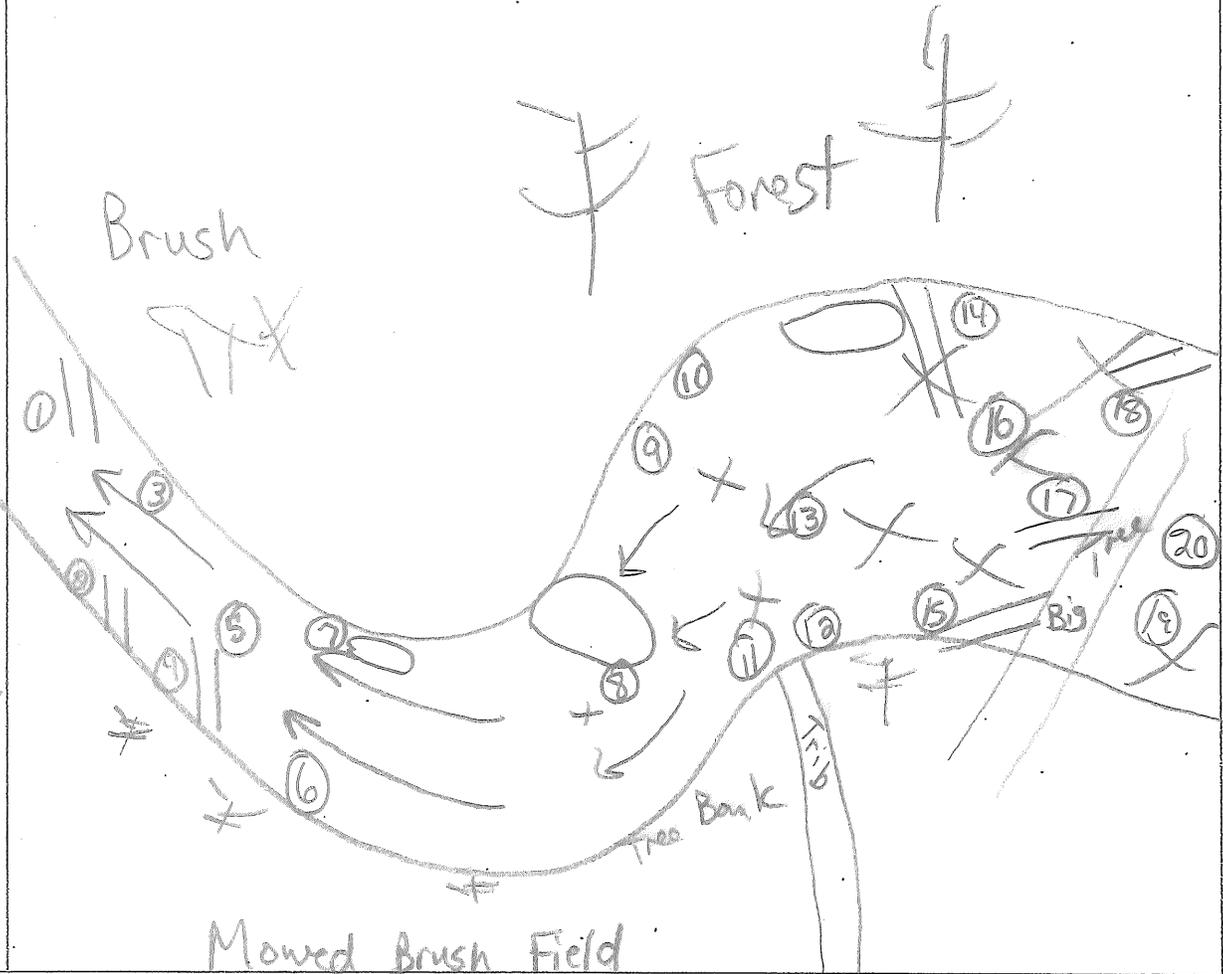
SITE LOCATION MAP

- - Pool
 - - Run
 - X - Ripple
 - // - Snag
- Kicks (20)
- ClG - III
 - Snag - IIII
 - SAV - II
 - SFS - IIII
 - CPOM - IIII

- 1 Snag
- 2 Snag
- 3 SAV
- 4 Snag
- 5 SFS
- 6 CPOM
- 7 CPOM
- 8 SFS
- 9 ClG
- 10 SAV
- 11 CPOM
- 12 SFS
- 13 CPOM
- 14 Snag
- 15 Snag
- 16 ClG
- 17 Snag
- 18 Snag
- 19 ClG
- 20 sand SFS

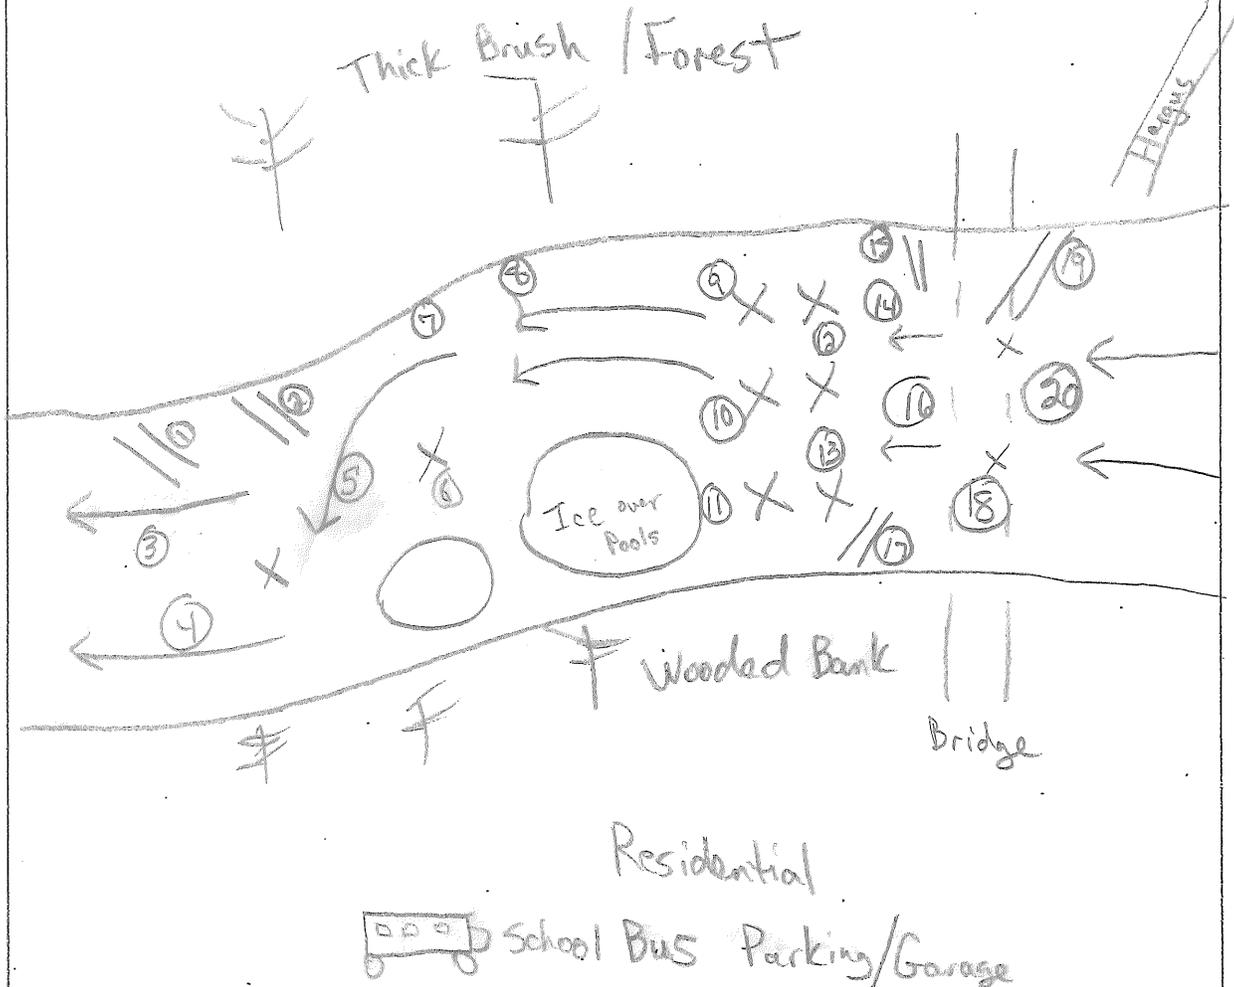
SITE LOCATION MAP

- - Run
- X - Riffle
- - Pool
- // - Snag

Kicks (20)

- C/G - IIII
- SFS - III
- CPOM - IIII
- Snag - IIII
- SAV - III

1 Snag	5 CPOM	9 C/G	13 C/G	17 Snag
2 Snag	6 C/G	10 C/G	14 CPOM	18 SFS
3 SFS	7 SAV	11 SAV	15 Snag	19 Snag
4 SFS	8 SAV	12 C/G	16 CPOM	20 CPOM

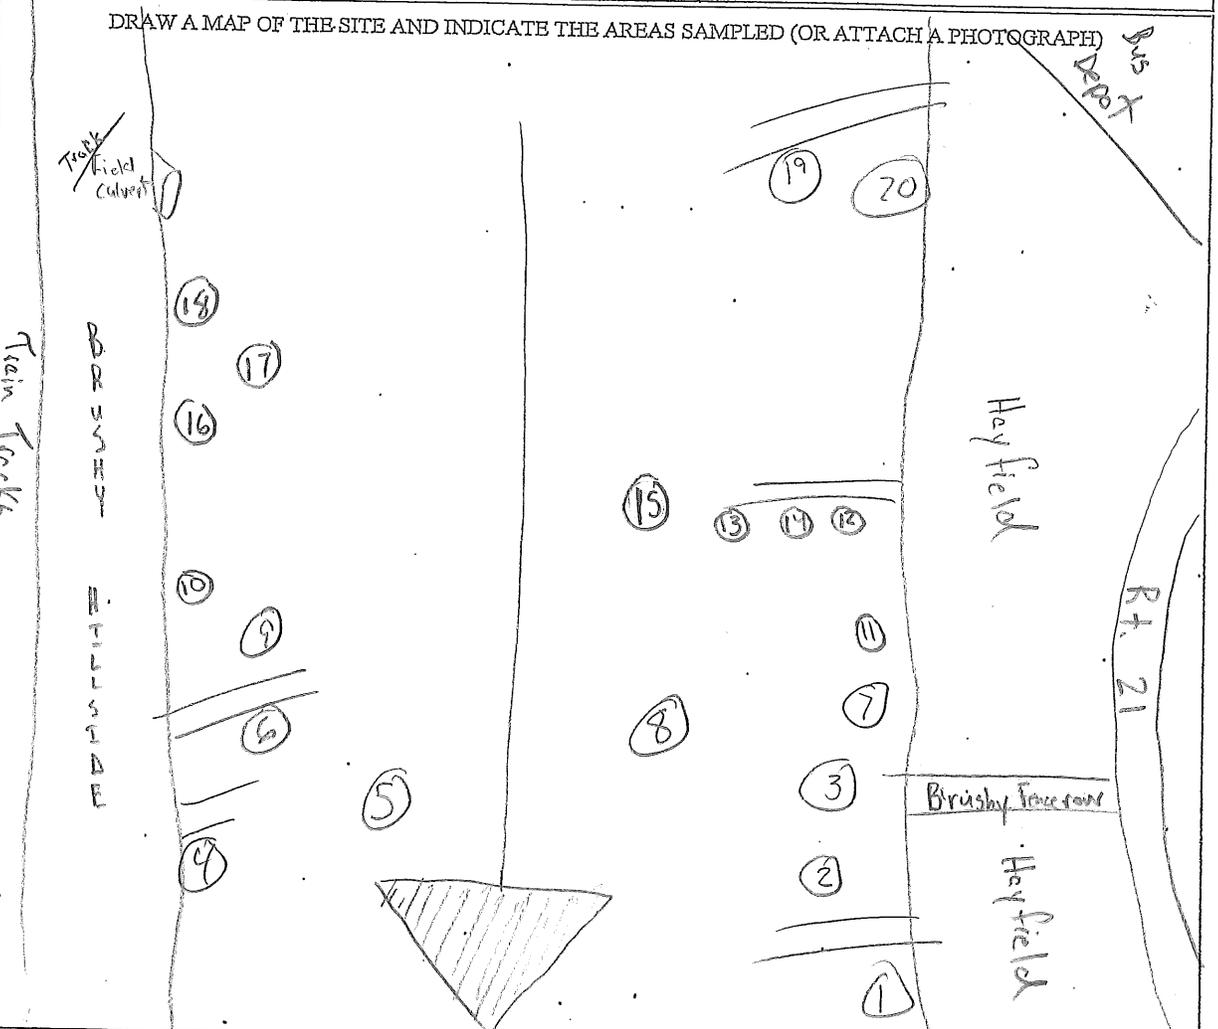
- SITE LOCATION MAP
- Flow ↓
- 1 SNAG 15. CPOM
 - 2 Sandstone 16. Cobble
 - 3 CPOM 17. Cobble
 - 4 SNAG 18. Sand
 - 5 Sand 19. SNAG
 - 6 SNAG 20. CPOM
 - 7 CPOM
 - 8 SAND
 - 9 CPOM
 - 10 Cobble
 - 11 Sand
 - 12 SNAG
 - 13 SNAG
 - 14 Sand
- ▲ = Run
// = Spring

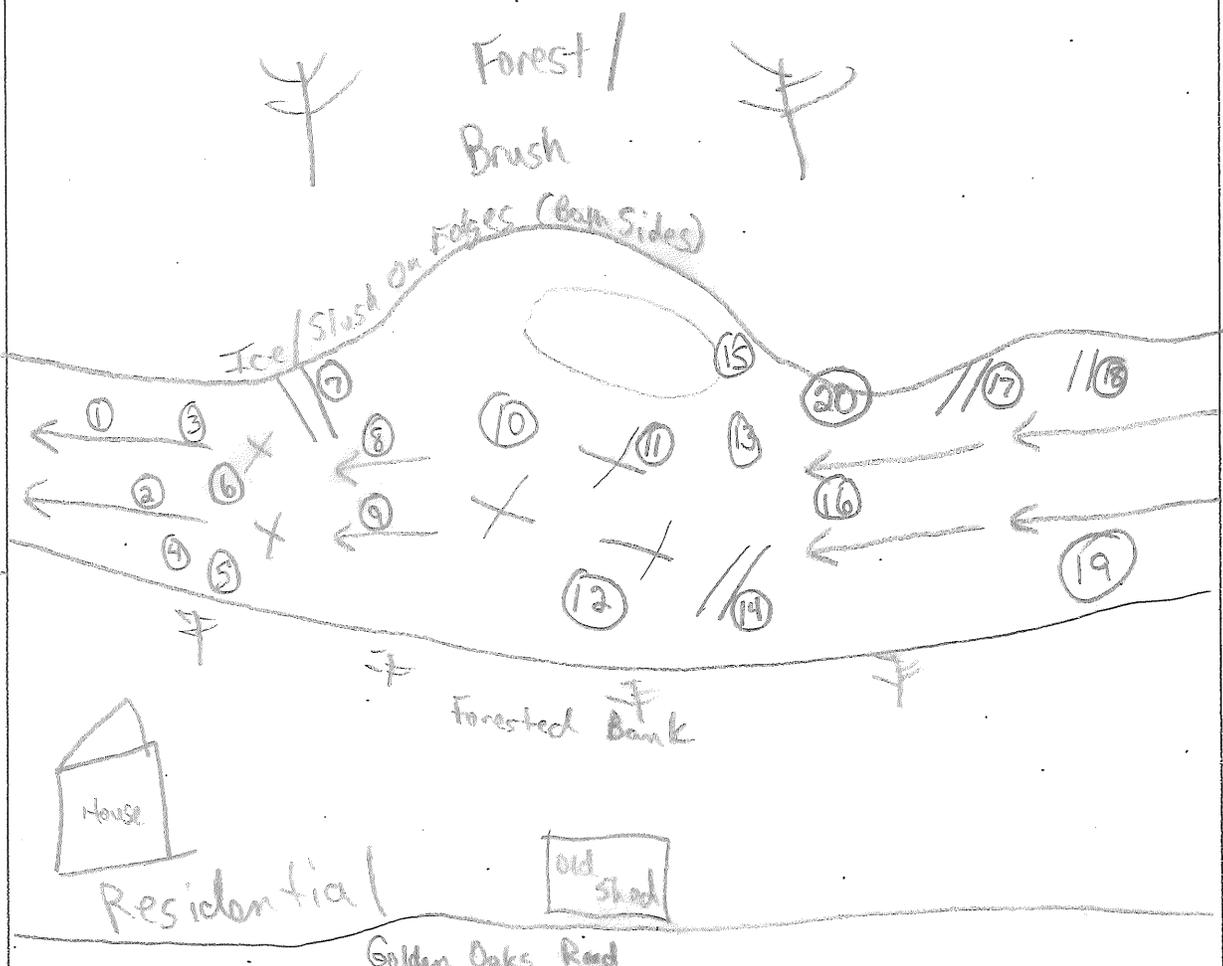
SITE LOCATION MAP

- - Run
- X - Riffle
- - Pool
- // - Snag

Kicks (20)

CIG = III
 CPOM = UH
 SAV = Ø
 SFS = UH III
 Snag = IIII
