DRY LAND APPROVED JURISDICTIONAL DETERMINATION FORM¹
U.S. Army Corps of Engineers

B. DISTRICT OFFICE, FILE NAME, AND NUMBER: CELRP-RG-S 2021-00285

B. REQUIRED ADDITIONAL COMMENTS TO SUPPORT JD. EXPLAIN RATIONALE FOR DETERMINATION THAT THE REVIEW AREA ONLY INCLUDES DRY LAND: Mr. Butts is requesting an AJD because his property may contain a stream, and he had begun filling in a portion of this area already. He wished to ensure that work he's done is compliant and to continue filling in the remaining portion of this area to expand his existing pasture land. While visiting the site, it was evident that fill had occurred at the top of a valley. The fill prism extended down sharply to the valley bottom and ended at a fence line under some powerlines which cross the area. Being a valley bottom, it is expected that some sort of water feature has the potential to exist here. Upon walking the area below the fill prism, no sign of water feature was observed: no wetland characteristics (vegetation, hydrology) nor was a stream bed or bank observed. Looking down the valley below the AJD area, the elevation dropped rapidly into a "toe" region of the slope which contained some pooled water (not

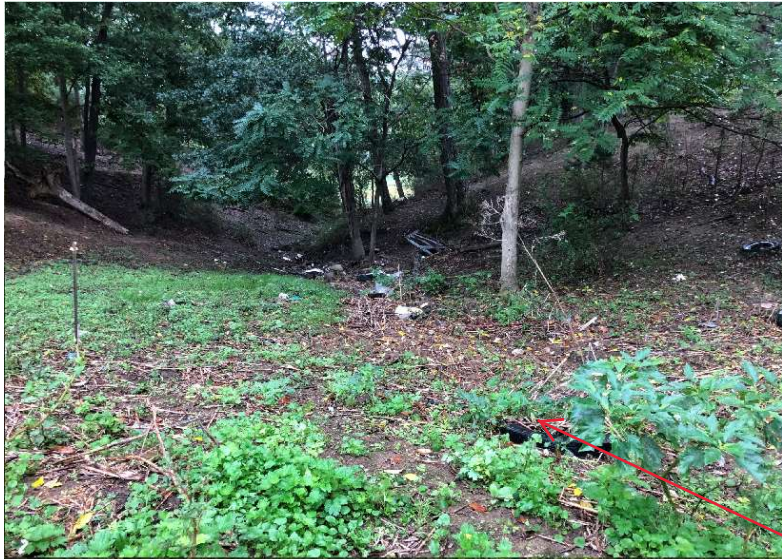
Facing Southeast looking down valley bottom. Some wracking of materials found as evidence of surface flows, though no identifiable bed & bank of a stream feature.

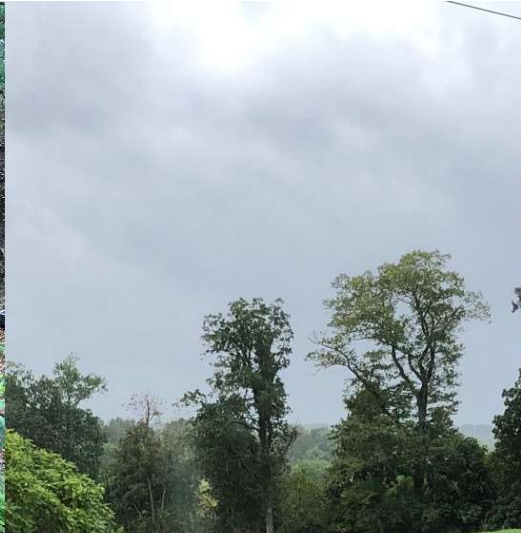
Facing Northwest looking up valley towards fill prism. Erosional feature and outwash is observed at the bottom of the valley.
