Draft Environmental Assessment ATC Group Services LLC Speedway Sanitary Force Main Installation Project – Westmoreland County

October 2016

Speedway LLC is proposing to install a 2 inch diameter sanitary sewer force main in a 4 inch conduit along S.R. 22 (William Penn Highway) in parts of New Alexandria Borough, Derry Township and Salem Township, in Westmoreland County, PA. The proposed sanitary sewer force main is necessary to provide transportation capacity for sanitary sewage for the proposed Speedway Store located at 107 Operators Way, New Alexandria, in Westmoreland County, PA. The length of the installation is approximately 3,161 linear feet crossing federal lands administered by the United States Army Corps of Engineers (USACE) (the Loyahanna Lake and its Tributary No. 6) in two separate areas.

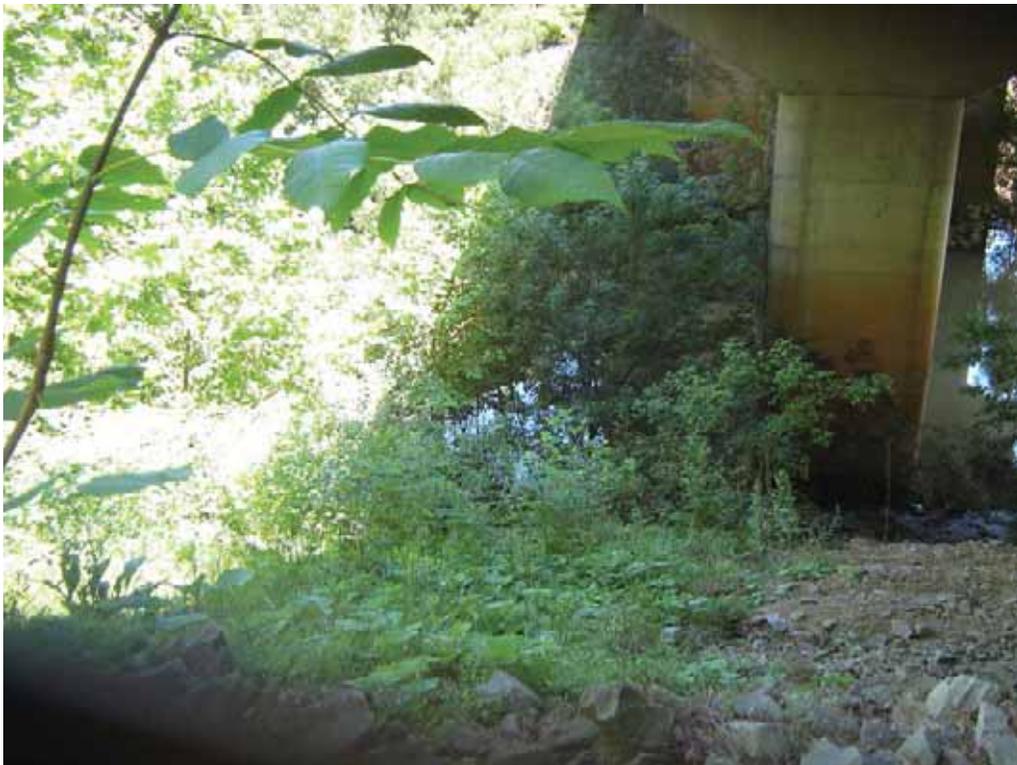
Photograph 25: View of Loyalhanna Creek looking east-southeast from underneath west side of bridge. Rip-rap and loose rock down to the bank of the creek. Creek was too deep to safely cross.

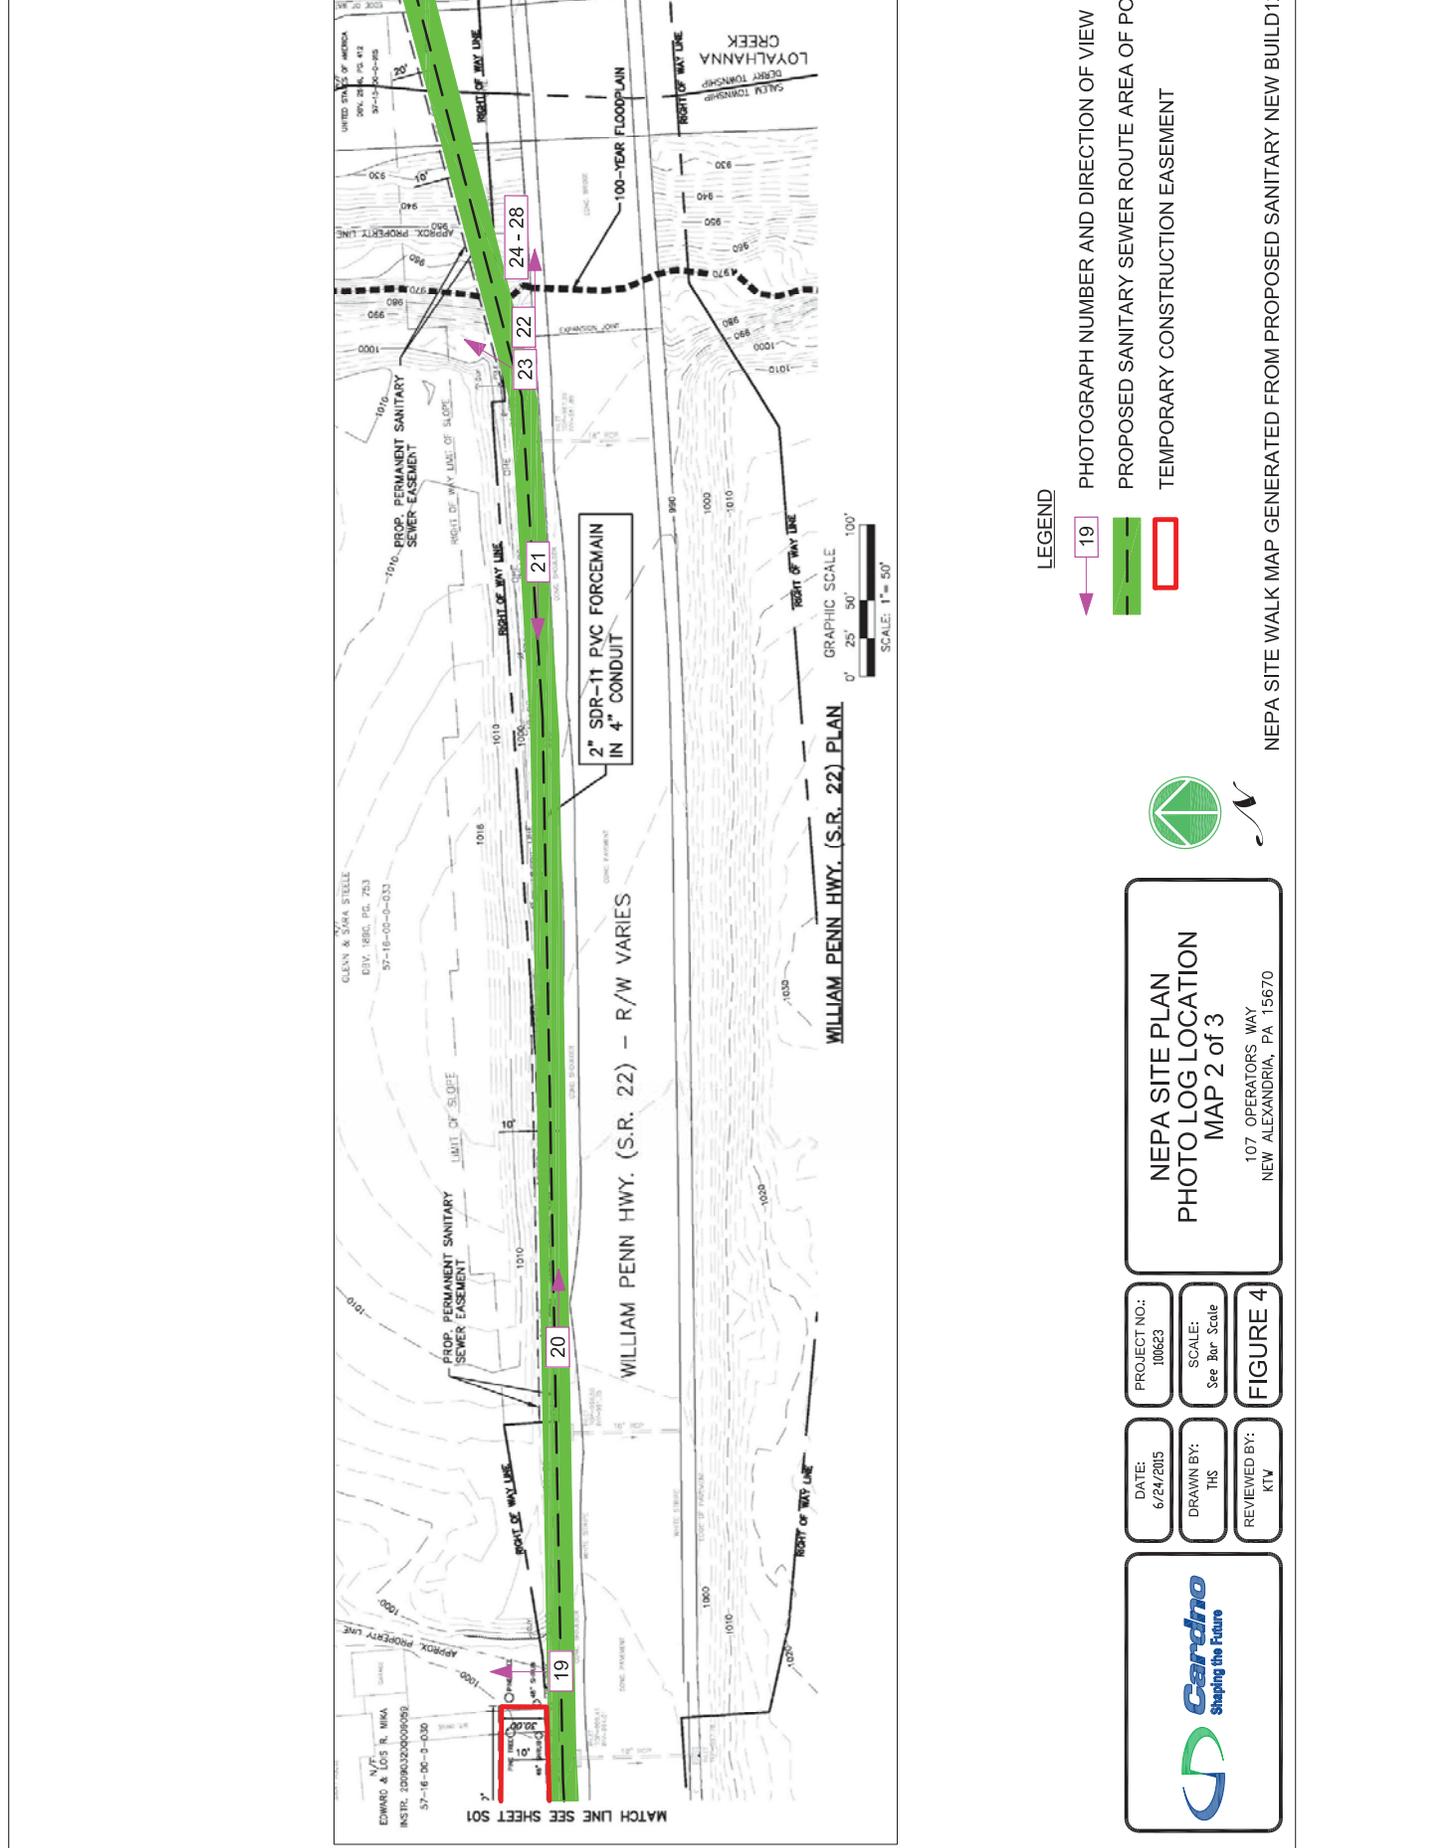
NEPA SITE WALK MAP GENERATED FROM PROPOSED SANITARY NEW BUILD12/29/14 DRAWING.

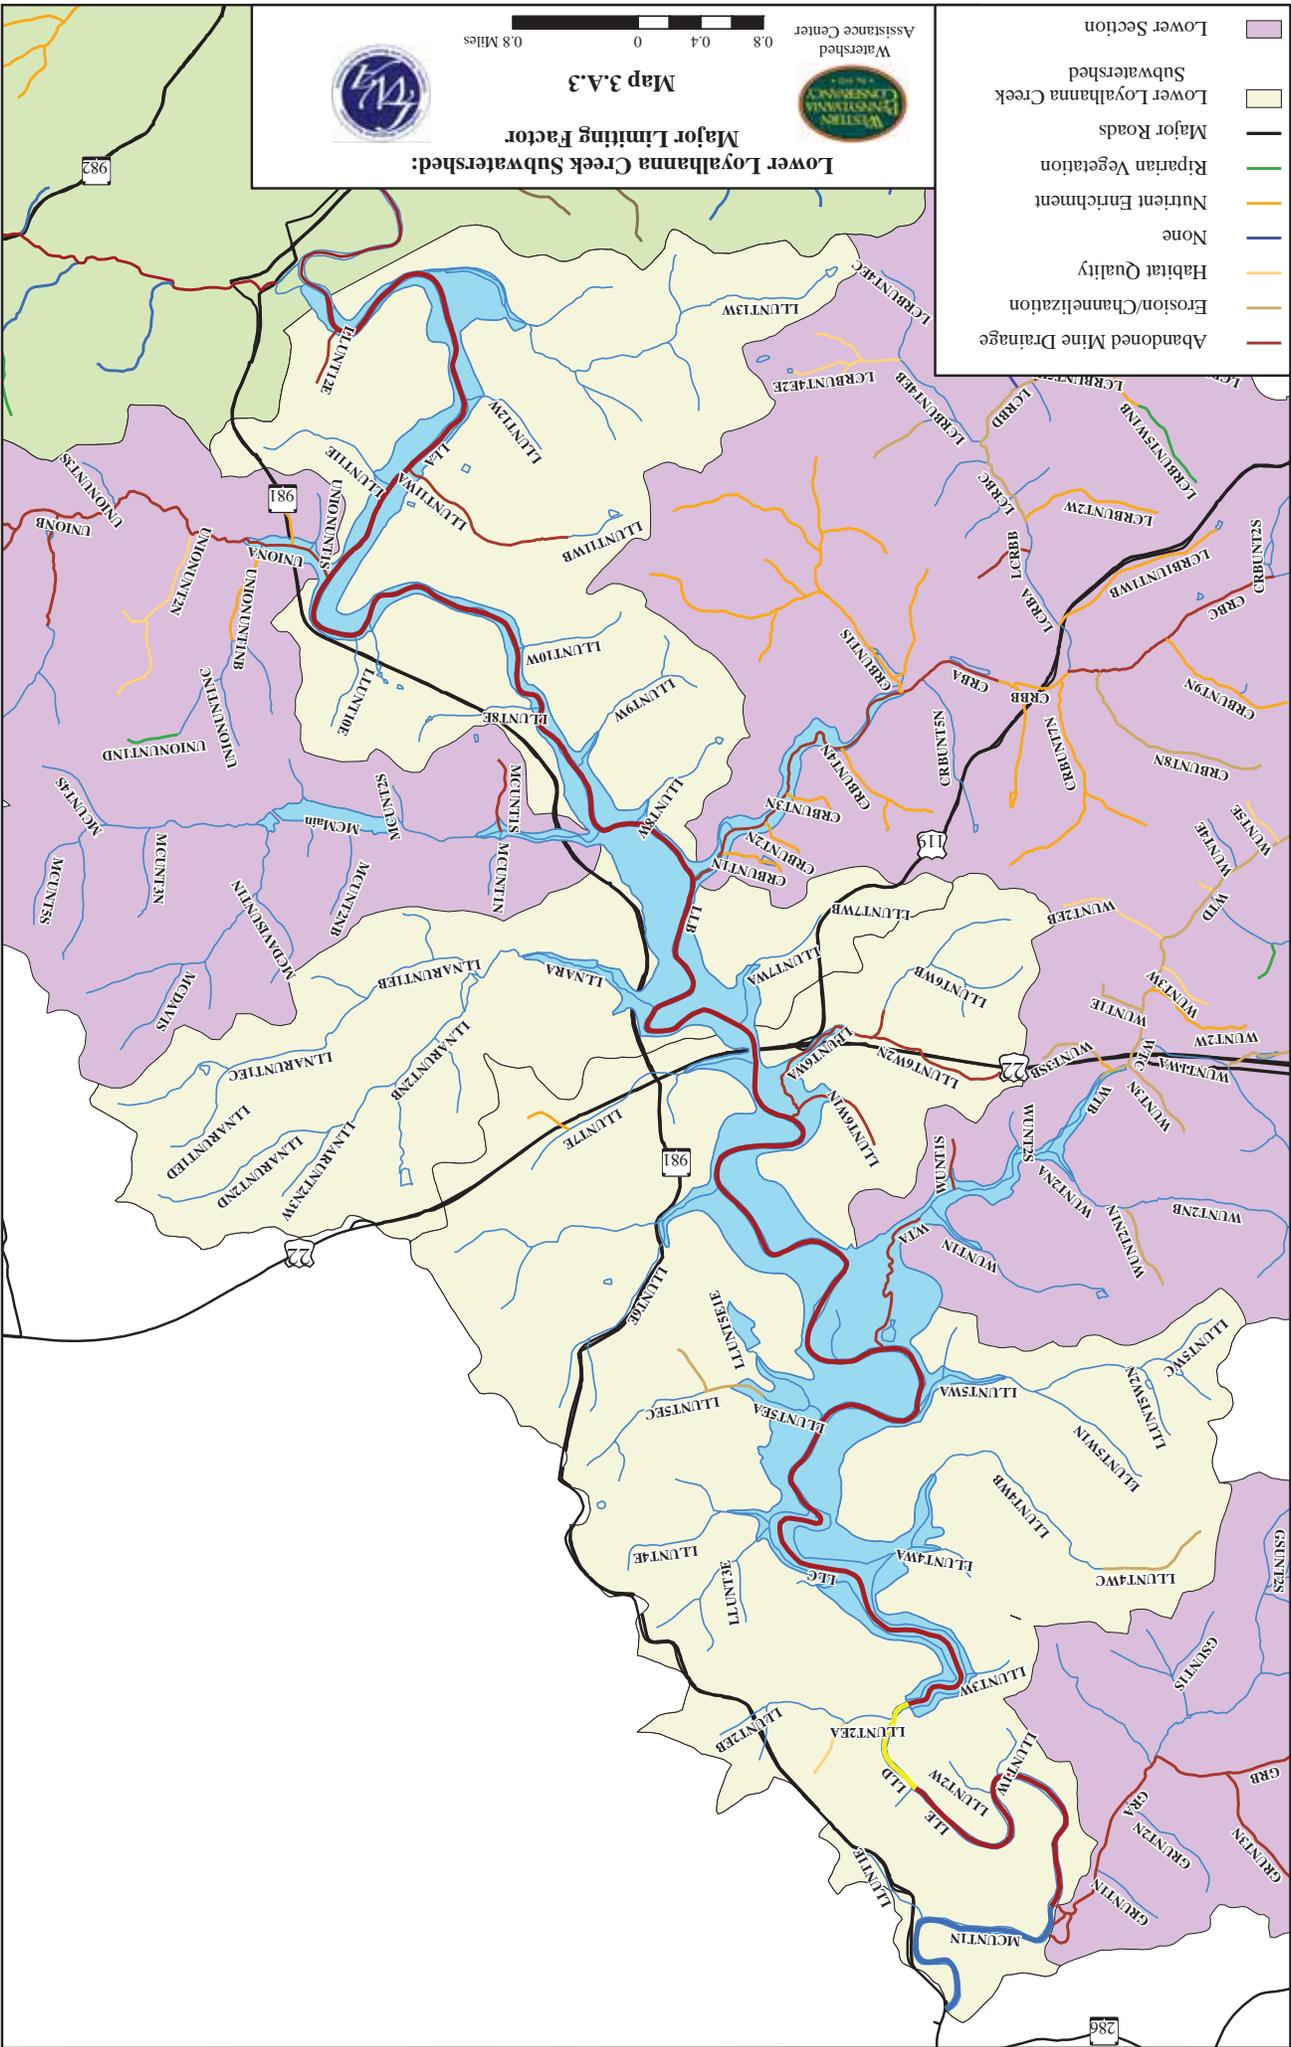
Map 3.A.3
Lower Loyahanna Creek Subwatershed:
Major Limiting Factor

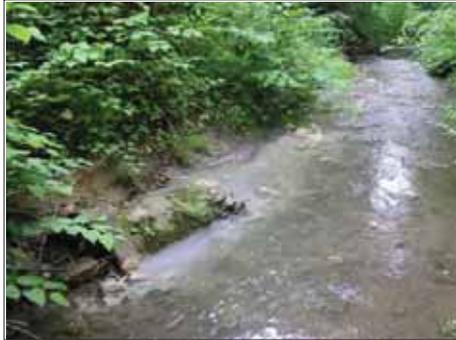
Aluminum seep entering Crabtree Creek from the Forbes Road coal refuse pile

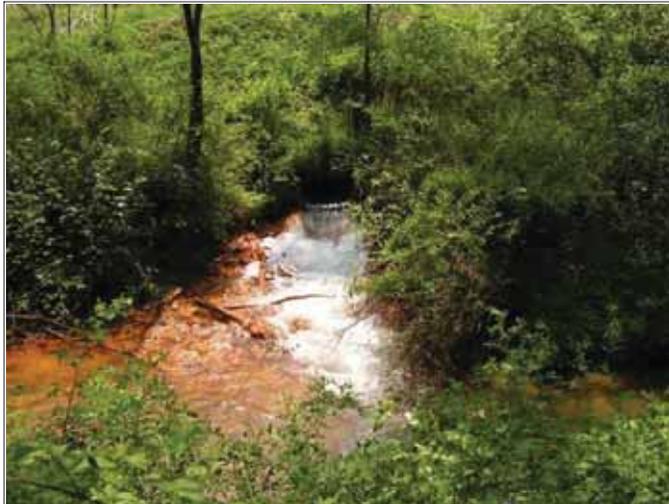
The Crabtree Creek Discharge, located behind the Crabtree Fire Hall
