# Public Notice

Notice No. 13-49

# MITIGATION PLAN

## Nathaniel Mountain Wildlife Management Area In-Lieu Fee Mitigation Project

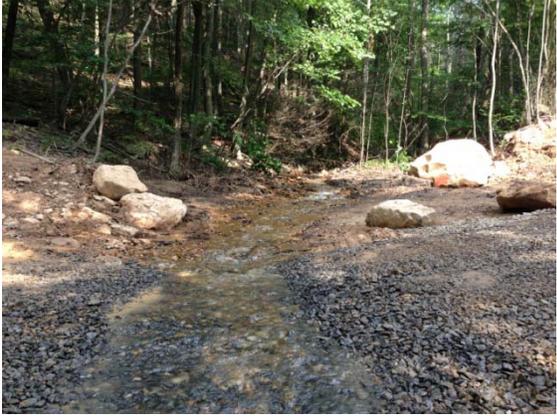
*Upstream, from center of road*

An undersized and poorly designed culvert was placed in the stream some time ago. It induced deposition of fine sediment upstream, was frequently clogged and overtopped, and projected from its fill to the extent that it was a fish migration barrier. While in the area performing other, unrelated duties, Columbia Natural Resources removed the culvert as part of this project per an earlier agreement. The crossing they left was not designed for long-term stability, nor was the approach enhanced in any way that would promote fish passage. The gravel road materials left in place at the crossing provide a smooth vehicular surface for the short term, but no long-term stability. There is a serious risk of headcut as the channel cuts through the small materials to re-establish its natural gradient and step pool sequence. This plan seeks a stable, fish passable reach that also permits limited vehicular crossing of the stream.

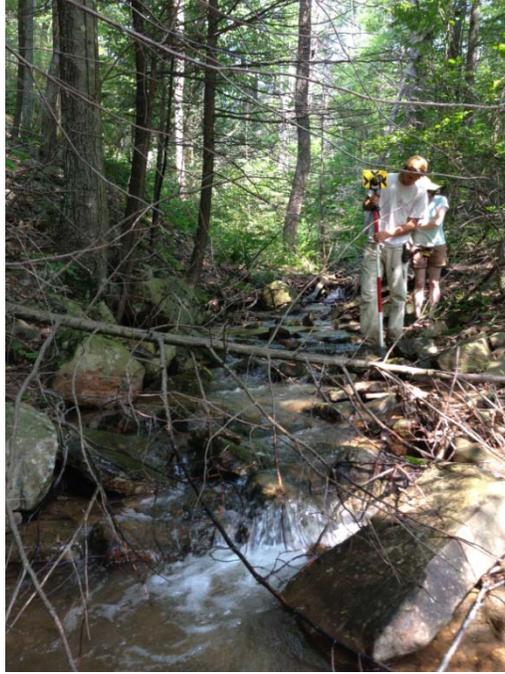
*Upstream of impacted reach*

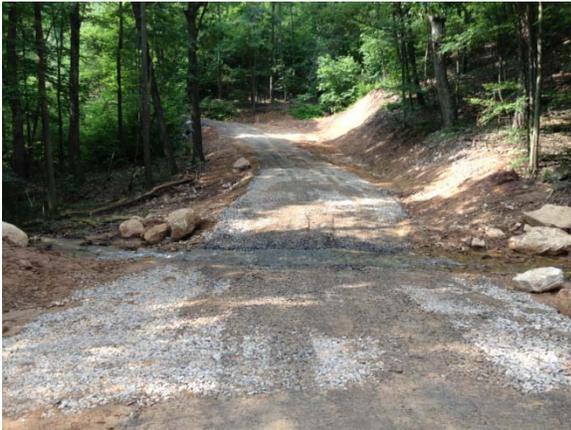
*Crossing as viewed from left*

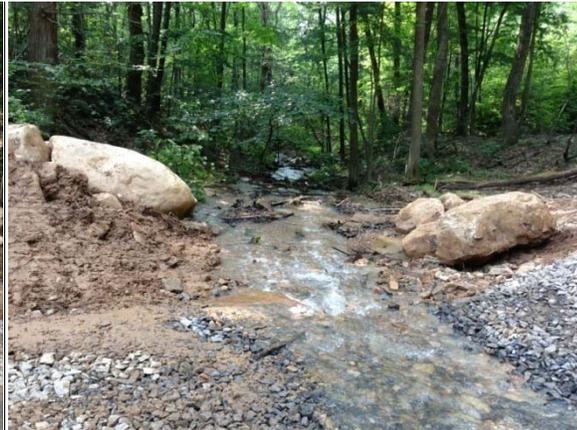
*Downstream, from center of road*

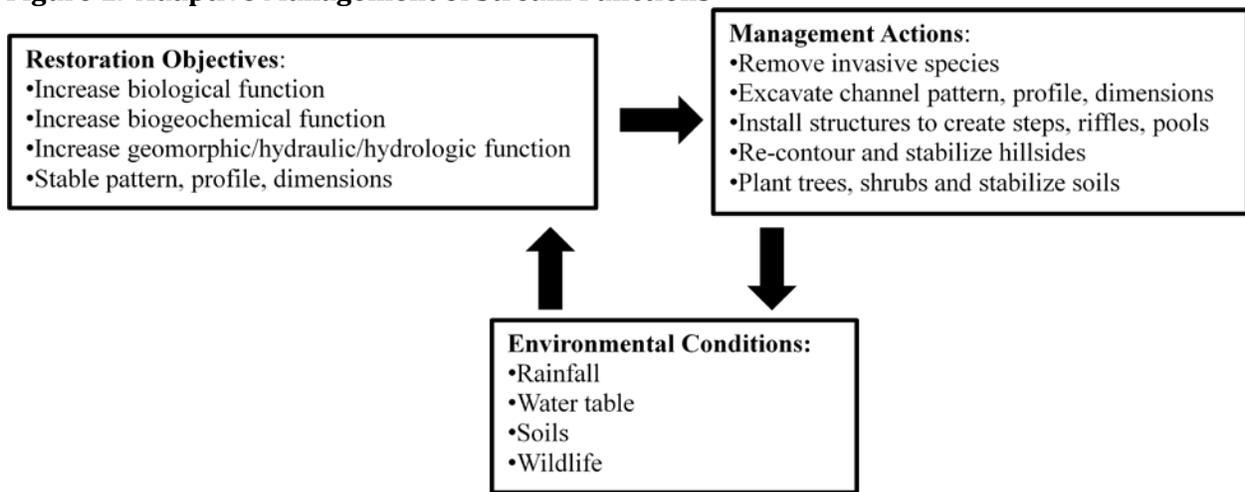
**Figure 1. Adaptive Management of Stream Functions**

CVI will be responsible for implementing this mitigation plan, and ensuring that all as-built and performance success criteria are met. If monitoring indicates that certain features of the project are not meeting their mitigation goals or success criteria, and routine maintenance is not sufficient to correct the problem, DNR will work with the District Engineer and IRT to determine appropriate adaptive management actions including site modifications and repairs. As illustrated in the flowcharts below, adaptive management actions should be designed to address environmental conditions and meet restoration objectives. Adaptive management actions may require revisions to monitoring and maintenance requirements, and performance standards, as approved by the District Engineer and IRT.

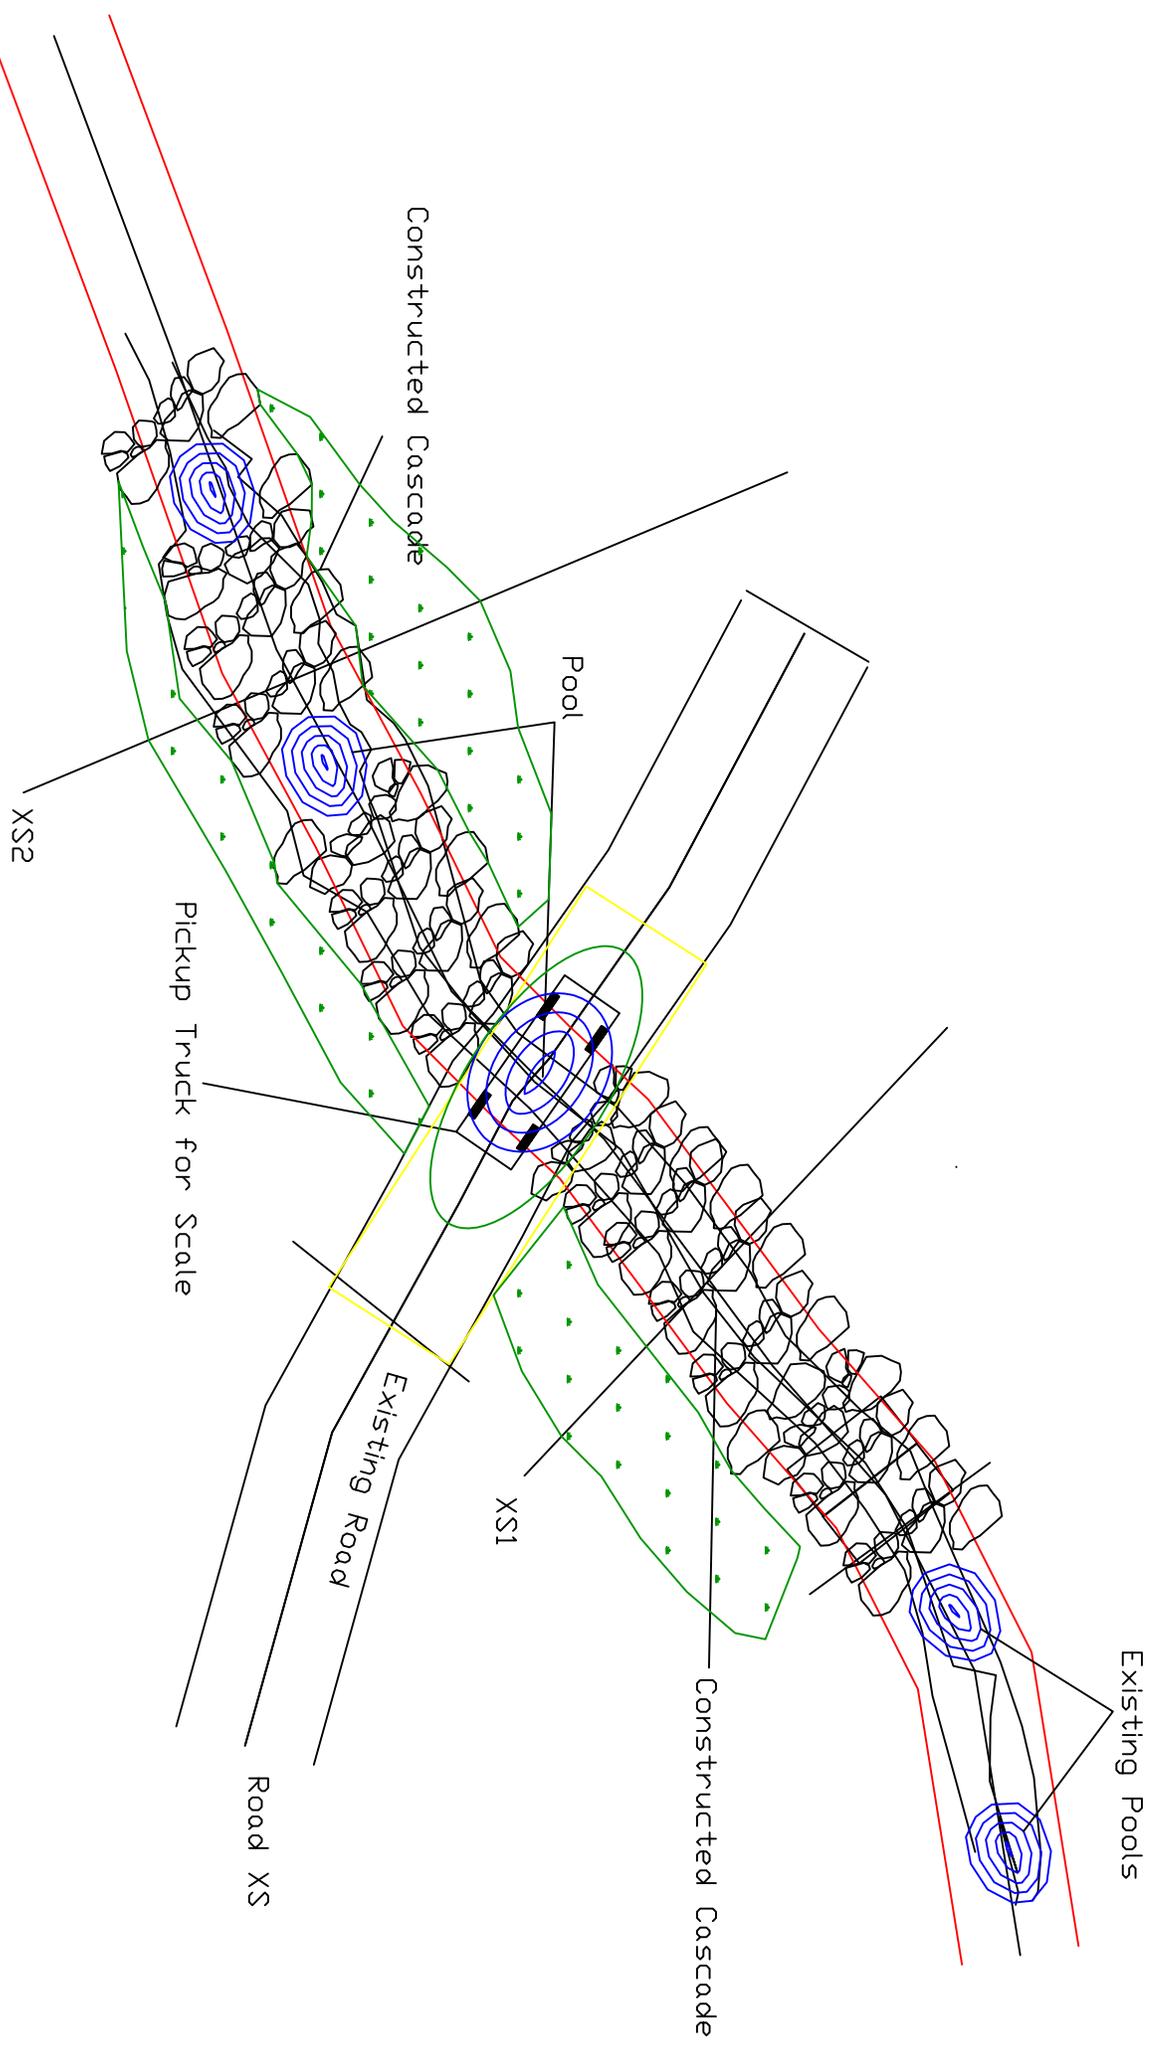
# Proposed Nathaniel Mt. WMA Crossing/Fish Passage

The objectives for restoring the site are to enable fish passage, sediment transport and storm flows through the step-pool channel, and for the restored reach to remain stable and functional over time. High clearance vehicles (pickup trucks) will also be able to cross the stream, at least during reasonable flows. Design drawings are included in Appendix A.

1. Transport equipment and materials to the site.
2. In stream construction shall begin at the lower end of the reach. The pools and cascades shall be installed from downstream to upstream.
3. Once all construction activities are completed and the designer has verified that the plan has been followed, the ford will be completed with imported materials as necessary to facilitate vehicular traffic; any remaining disturbed areas shall be graded, seeded, and mulched.
4. While this site is already under forest canopy, a small number of trees, shrubs and live stakes will be planted for additional stream stability as soon as heavy equipment is unlikely to disturb them and their work.

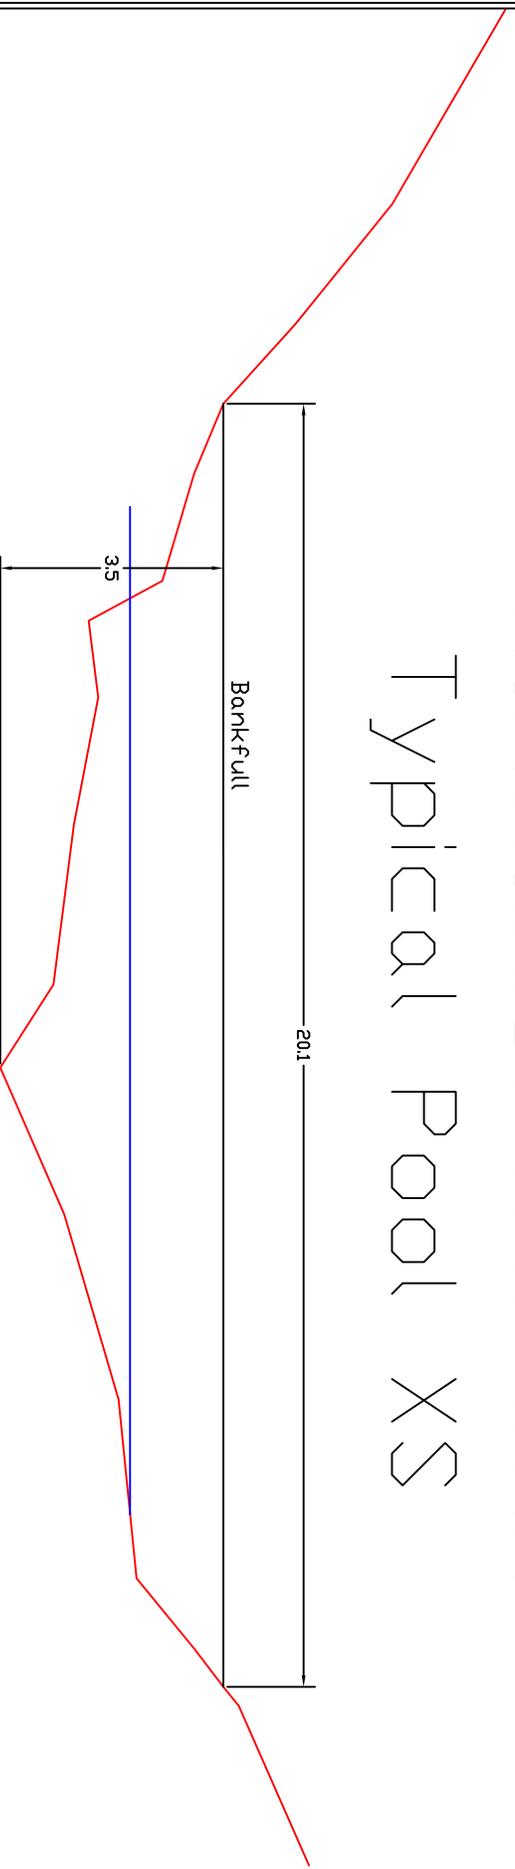
# Nathaniel Mt. WMA Typical Pool XS

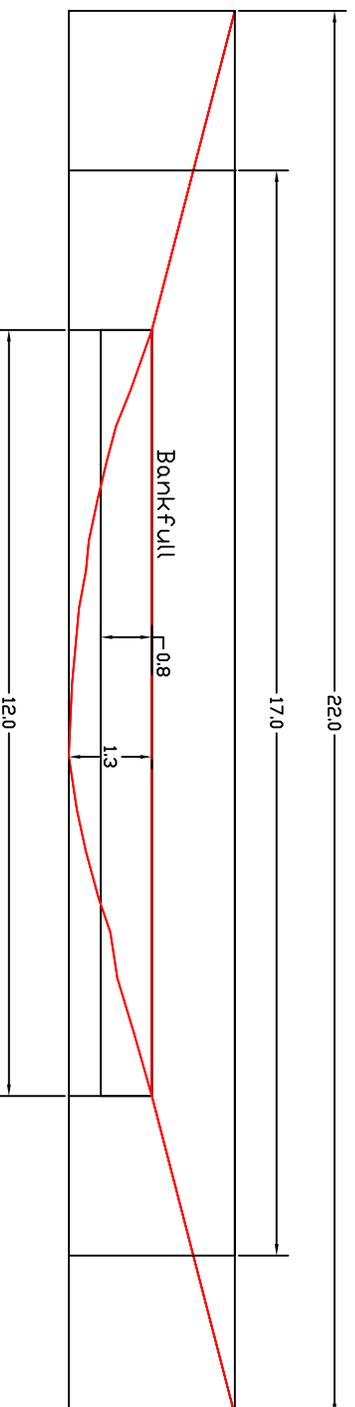
# Nathaniel Mt. WMA Typical Cascade XS

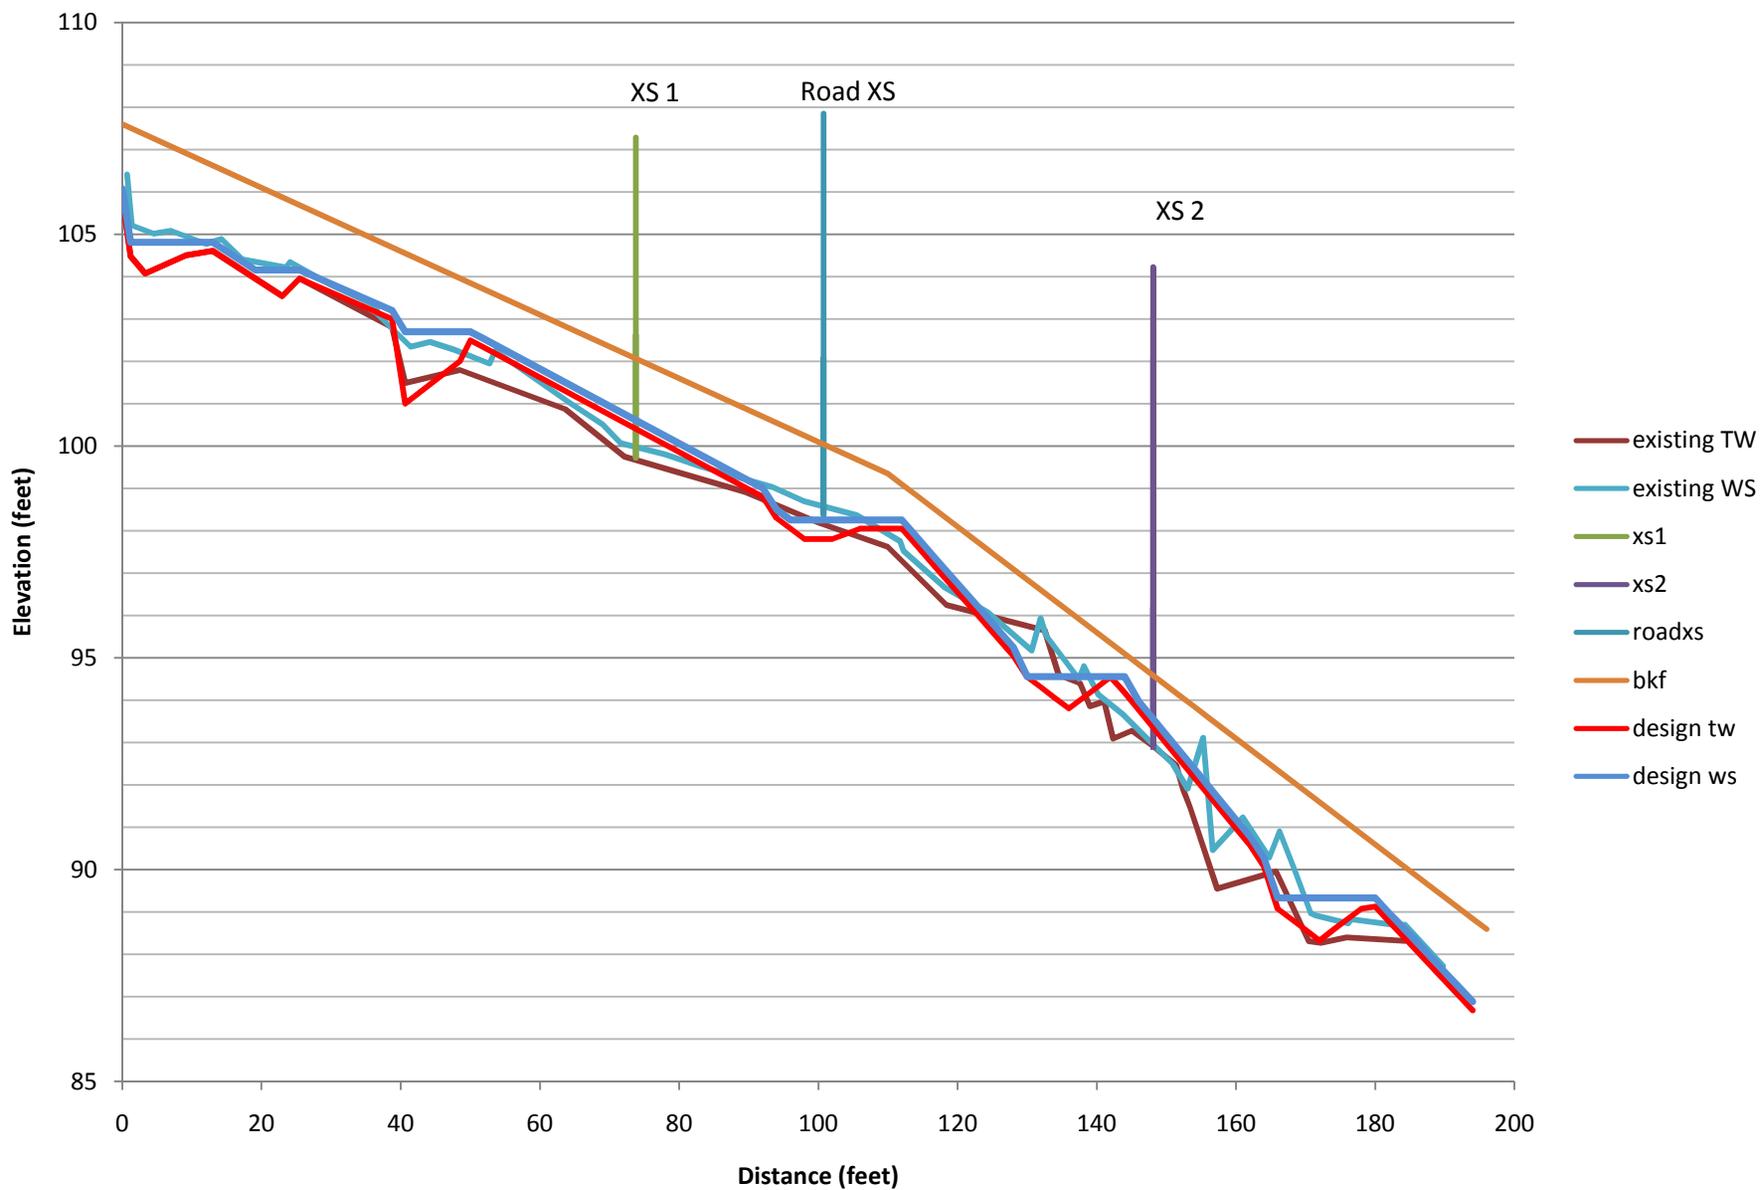
# Nat. Mt. WMA Design Longitudinal Profile

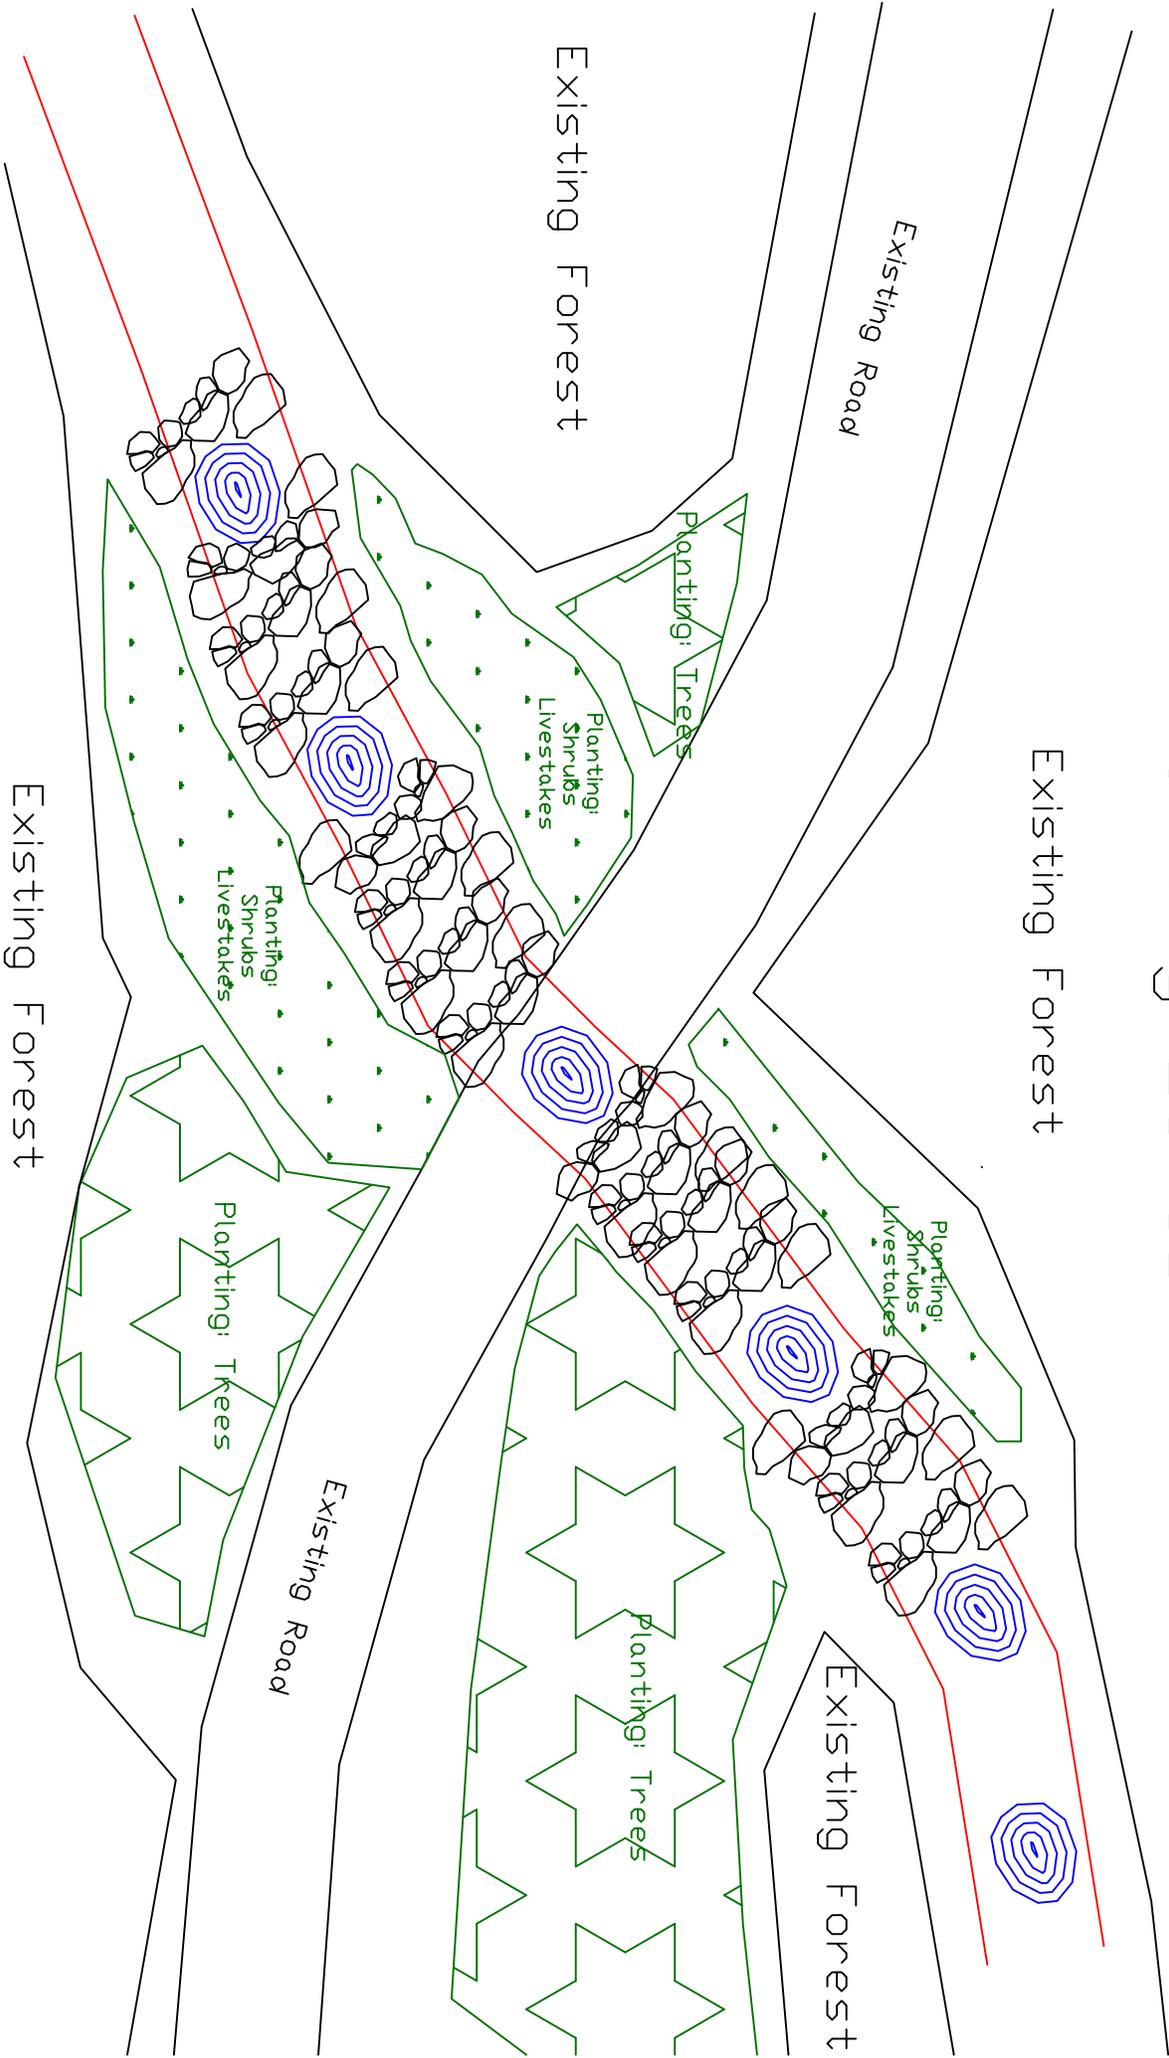
# Proposed Nathaniel Mt. WMA Crossing/Fish Passage Planting Zones
