Project Name: **North Branch Pigeon Creek Mitigation Bank - Other**

**RE: Request to Initiate Consultation  
North Branch Pigeon Creek Mitigation Bank  
Somerset Township, Washington County**

## **NORTH BRANCH PIGEON CREEK MITIGATION BANK REQUEST TO INITIATE SECTION 106 CONSULTATION**

**Management Summary**  
**North Branch Pigeon Creek Mitigation Bank**  
**Washington County, Pennsylvania**  
**April 2013**

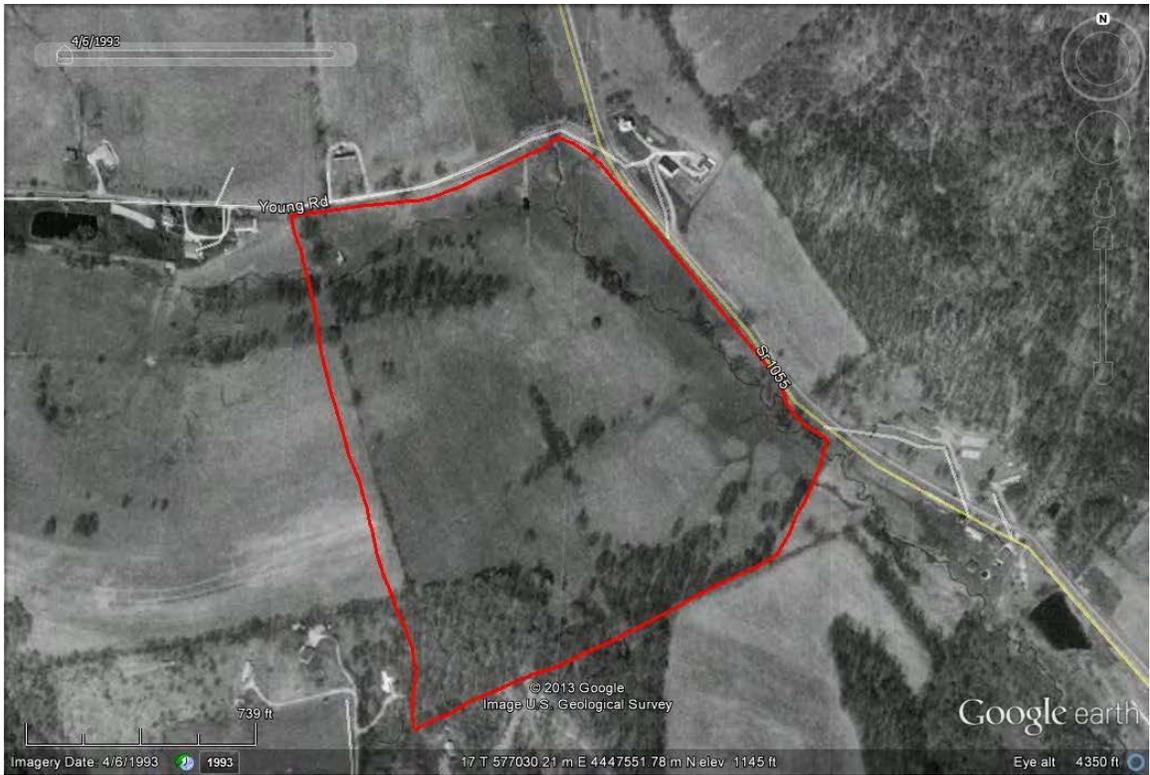
Figure 1. 1993 aerial view of Site from Google Earth.

Aerial photos from 1993 to the present show no change within the Site during the last 20. The aerial photos are shown as Figures 1 through 7.

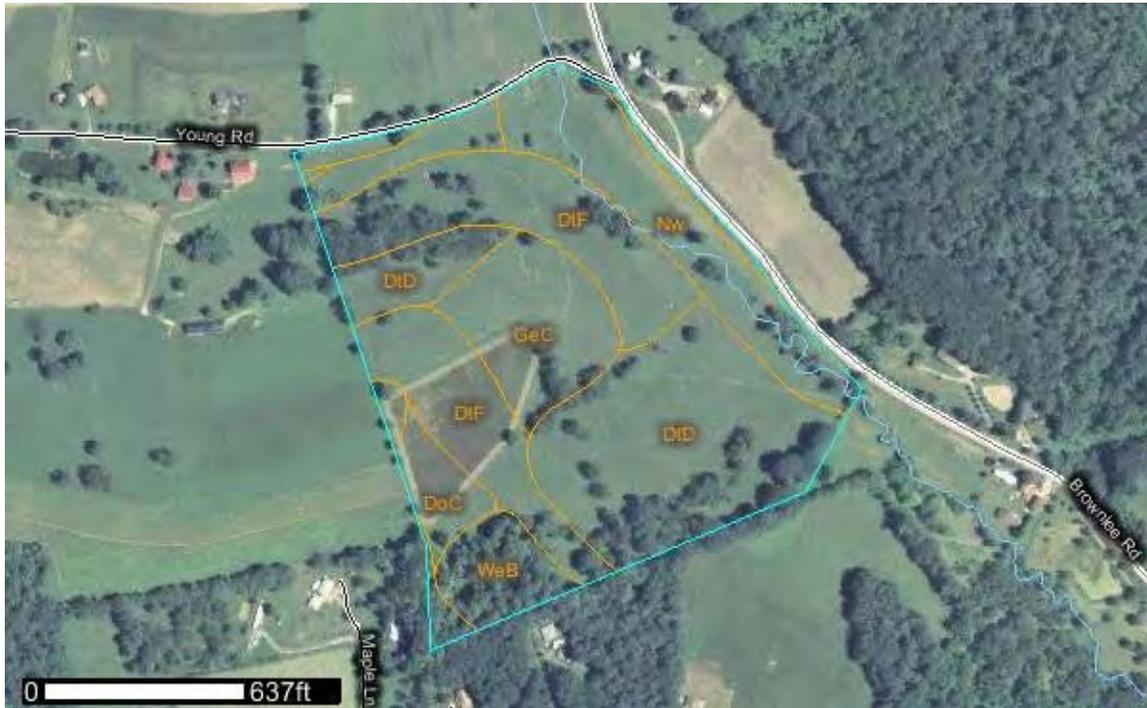
Figure 8. Site soil map from NRCS website.

According to the Natural Resources Conservation Service (NRCS), at least nine different soil types and soil type variants exist within the Site. These soil types and variants include Dormont-Culleoka silt loam, 15% to 25% slopes; Dormont-Culleoka silt loam, 25% to 50% slopes; Newark silt loam; Guernsey silt loam, 8% to 15% slopes; Weikert-Culleoka complex, 3% to 8% slopes; Dormont silt loam, 8% to 15% slopes; Fluvaquents, loamy; Culleoka silt loam, 3% to 8% slopes; and Weikert-Culleoka complex, 15% to 25% slopes. Each of these types and variants are described below including references to drainage, hunting and gathering potential, and horticultural and agricultural productivity potential. Further, conclusions regarding the suitability of each for historic and Native American occupation and archaeological site probability are also explained.

Dormont-Culleoka silt loam, 15% to 25% slopes (DtD) is the primary soil identified within the Site covering approximately 31% of the northwestern, southeastern, and extreme southwestern portions of the Site (Figure 8). Dormont-Culleoka silt loam, 25% to 50% slopes (DtF) is identified within the northeastern, western, and northwestern portions of the Site covering approximately 27% of the Site. Newark silt loam (Nw) is identified within the eastern and northern portions of the Site covering approximately 15% of the Site. Guernsey silt loam, 8% to 15% slopes (GeC) is identified within the central and extreme northwestern portions of the Site covering approximately 12% of the Site. Weikert-Culleoka complex, 3% to 8% slopes (WeB) is identified within the southwestern portion of the Site covering approximately 5% of the Site. Dormont silt loam, 8% to 15% slopes (DoC) is identified within the western portion of the Site

covering approximately 4% of the Site. Fluvaquents, loamy (Fa) is identified within the northern portion of the Site covering approximately 4% of the Site. Culleoka silt loam, 3% to 8% slopes (CaB) is identified within the western portion of the Site covering approximately 1% of the Site. Weikert-Culleoka complex, 15% to 25% slopes (WeD) is identified within the eastern portion of the Site covering approximately 1% of the Site.

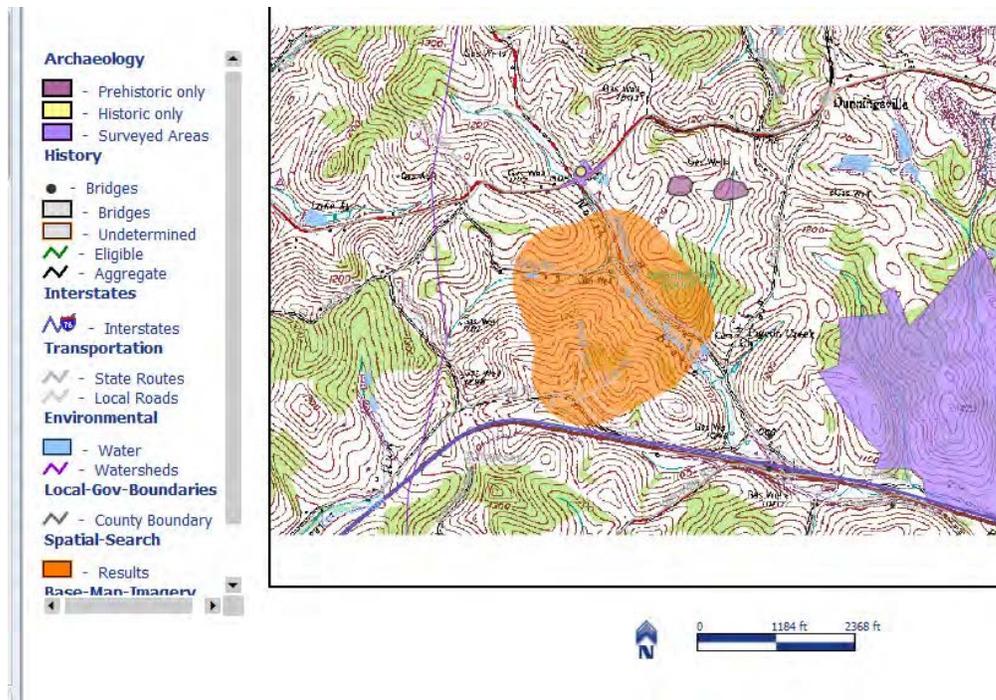
Figure 10. Map of archaeological surveys completed within a 1,000 foot area around the Site.

Circa~ performed an archival search for the Site using the CRGIS on the Pennsylvania Historical and Museum Commission (PHMC) website on February 28, 2013. This research was completed to determine if historic resources exist within the Site. No archaeological resources were recorded on or within 1,000 feet of the Site. Figures 9 and 10 show the approximate Site and surveys completed within a 1,000 foot buffer area (orange shaded area). The two archaeological surveys recorded to the north are located at the headwaters of the North Branch of Pigeon Creek. One of these headwater areas contributes drainage to the portion of the North Branch of Pigeon Creek which runs through the eastern part of the Site.

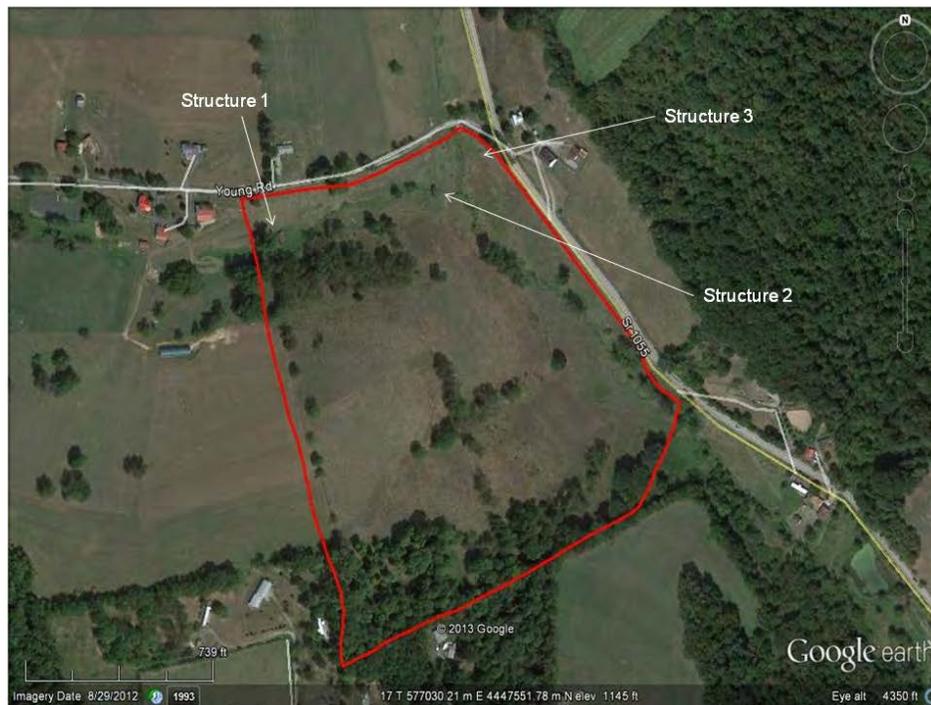
Figure 11. Map showing location of structures within the Site.

Within the Site there are three ca. early to mid 20<sup>th</sup> century structures located along the northern portion (Figure 11).

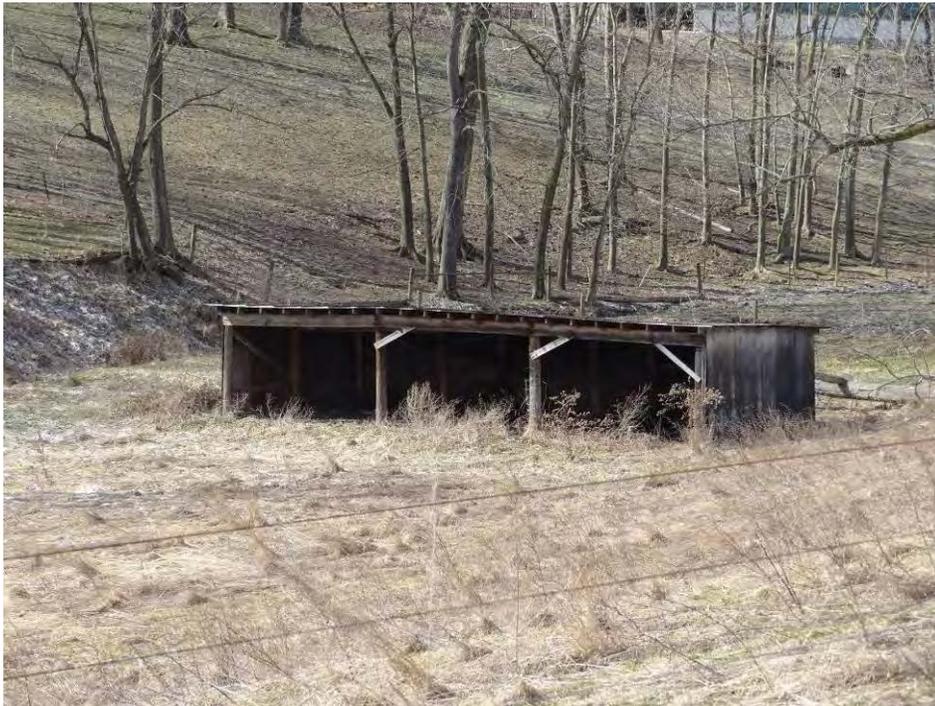
Plate 1. View of Structure 1 facade looking southwest.

This structure is located in the northwestern portion of the Site close to Young Road and is surrounded by an open field. Facing east, the structure is set on the edge of the floodplain north of the stream channel.

This ca. early 20<sup>th</sup> century, one story, three bay, shed roof, wood frame shed is clad in vertical wood planks and rests on the ground (Plate 1). The roof is covered in standing seam metal with exposed rafter tails. No windows are visible on the shed. The façade is open and supported by round rough cut logs with wood bracing on the two northernmost bays.

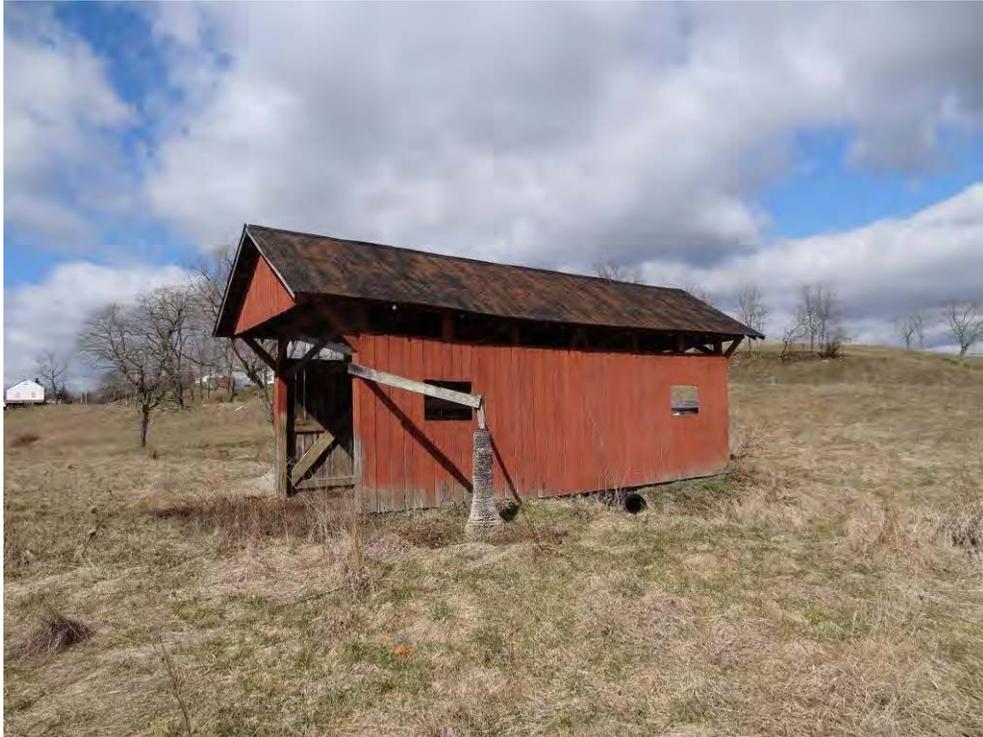
Plate 2. View of Structure 2 façade and side elevation looking west.

This structure is located in the northeastern portion of the Site close to the intersection of Young Road and Brownlee Road and is surrounded by an open field. Facing east, the structure is set over the stream channel.

This ca. early 20<sup>th</sup> century, one story, one bay, front gable, wood frame covered bridge is clad in vertical wood planks painted red and rests on a wood pier foundation (Plate 2). The raised roof is covered in standing seam metal and supported by wood bracing, leaving an opening between the roofline and the walls. The gable ends project over the entrances. Rectangular openings are visible on the sides (east and west) elevations, although the windows have been removed. The façade and rear (north) elevations are open. On the side (east) elevation, the remains of a cattle brush are visible. The interior

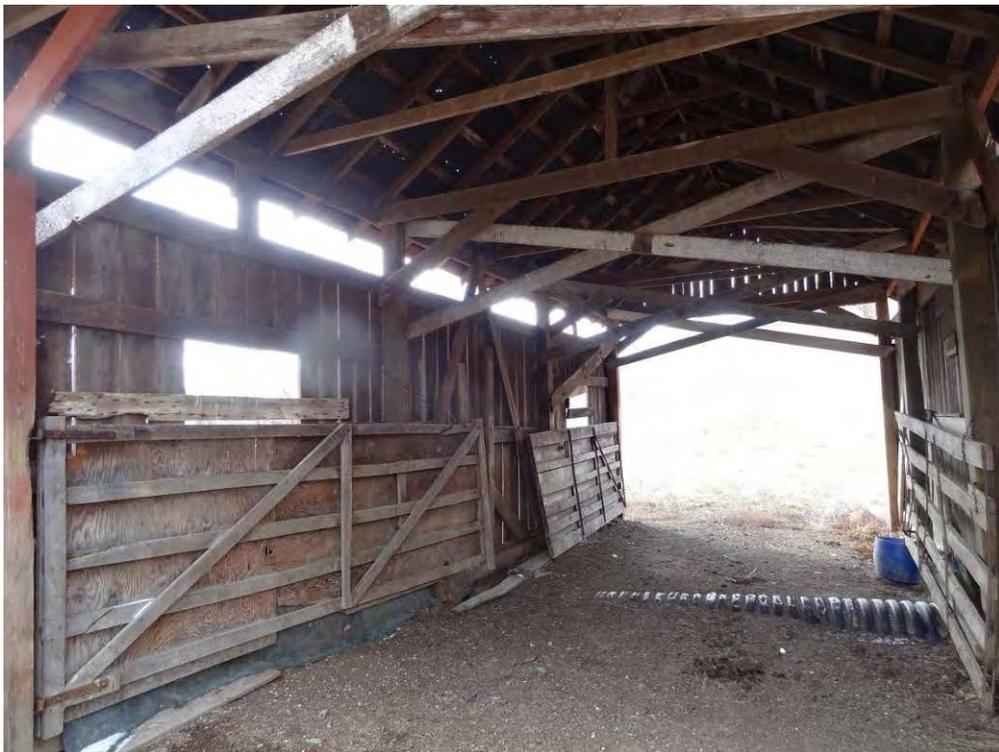
Plate 3. View of Structure 2 interior looking south.

of the bridge consists of one open room with exposed wooden roof trusses and exposed wood framing with a dirt floor over a corrugated metal pipe (Plate 3).

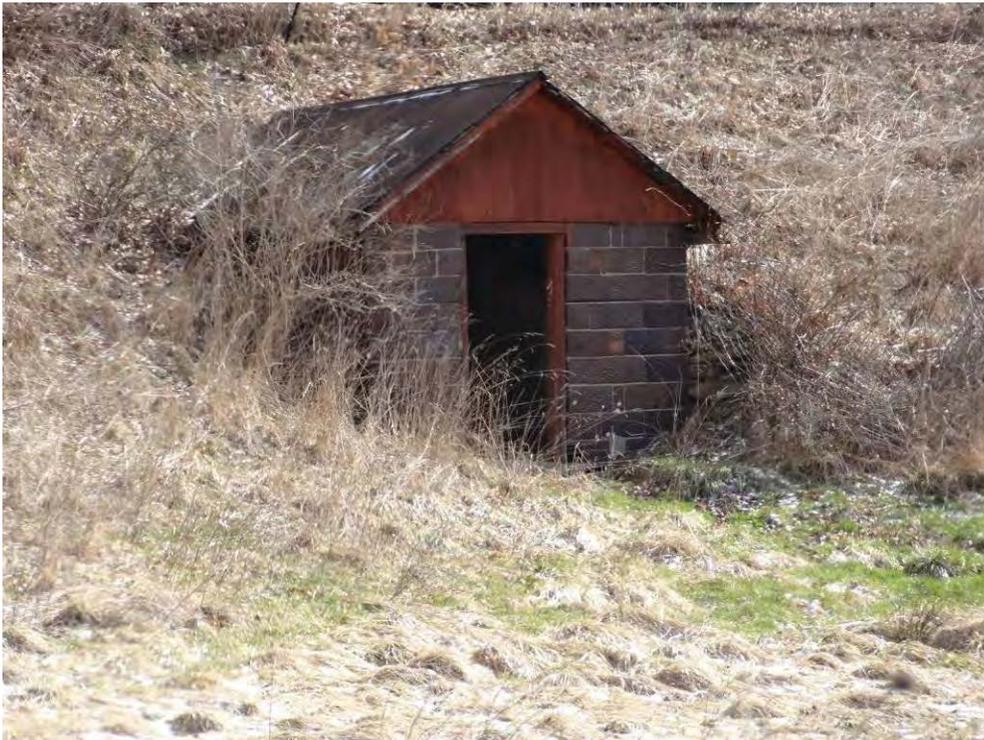
Plate 4. View of Structure 3 façade looking east.

This structure is located in the northeastern portion of the Site close to the intersection of Young Road and Brownlee Road and is surrounded by an open field. Facing west, the structure is set into a small rolling hill and vegetation is beginning to envelope the side (north and south) elevations.

This ca. early 20<sup>th</sup> century, one story, one bay, front gable, concrete block structure rests on a poured concrete slab on grade foundation (Plate 4). The roof is covered in standing seam metal with vertical wood planks painted red in the gable end on the facade. No windows are visible on the structure. The entrance on the façade consists of a single leaf, wood frame opening; the door has been removed.

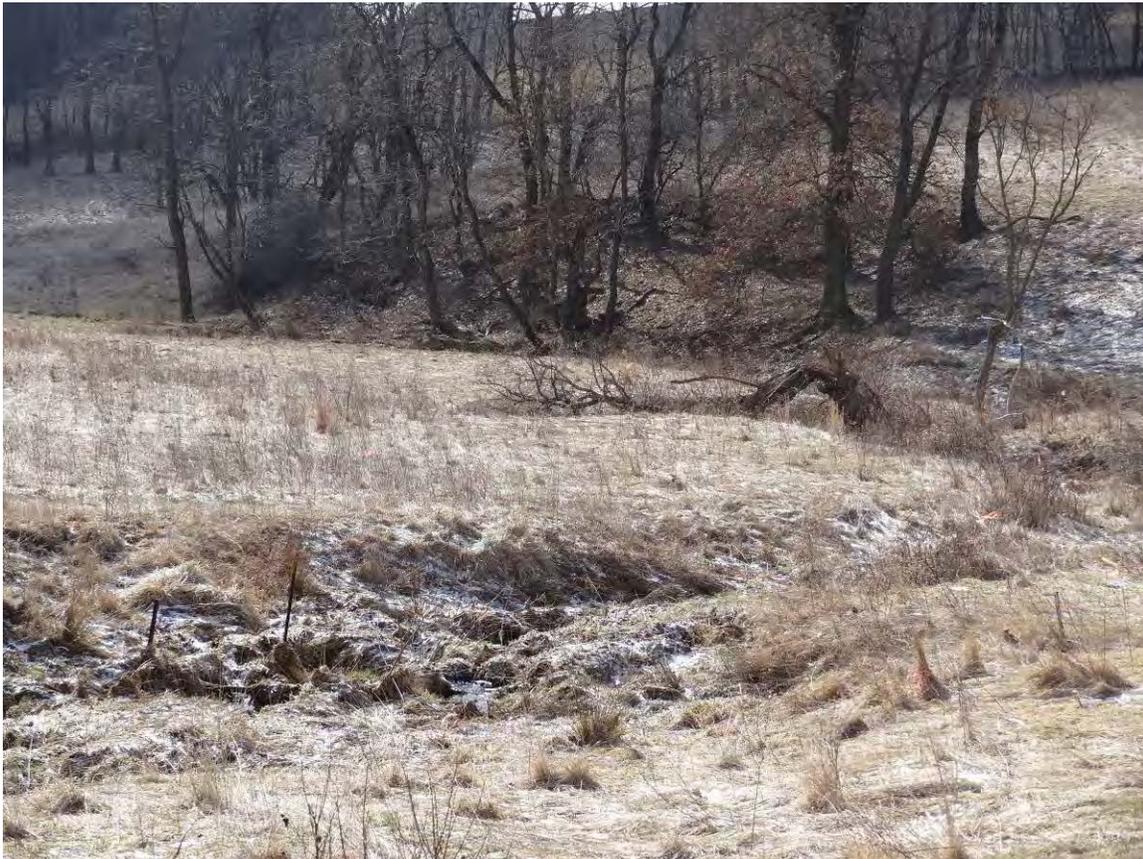
Plate 5. View of Site looking south.

The pedestrian walkover did not locate any archaeological resources or surface deposits of artifacts within the Site. The unnamed tributary in the northwestern section of the Site is roughly 75 feet wide and spreads out as it flows to the northeastern section where it joins the North Branch of Pigeon Creek. Flowing southeast, the North Branch of Pigeon Creek is fairly consistent at roughly 200 feet wide (Plates 5 - 9). The locations of the photos in plates 1 through 9 are indicated in the attached Archaeological Photograph Location Map. Brownlee Road, Young Road, and the houses on the opposite side of the road were constructed on the semi-level margins along the edge of the eastern and northern slopes. These areas appear to have been historically flatter, larger, and further removed from the actual stream channel. The steep slopes encompass the unnamed tributary until it joins the North Branch of Pigeon Creek where the slopes become more gradual.

In sum, the Site consists of a narrow stream valley with steep side slopes. The construction related activities are restricted to 8.3 acres within the narrow stream valley as indicated in Exhibit 4: Site Maps - Figure 6. In addition, the stream meanders and appears to have changed course during flooding episodes. There should also be no effect to any viewsheds as the project is limited to restoration. Circa~ recommends that the proposed project will not have any impacts to any cultural resources listed on or potentially eligible for listing on the National Register of Historic Places. Therefore, no further work is recommended.
