## **NORTH BRANCH PIGEON CREEK MITIGATION BANK**

### **PRELIMINARY JURISDICTIONAL WATERS OF THE U.S. DELINEATION PACKAGE**

**JULY 2013**

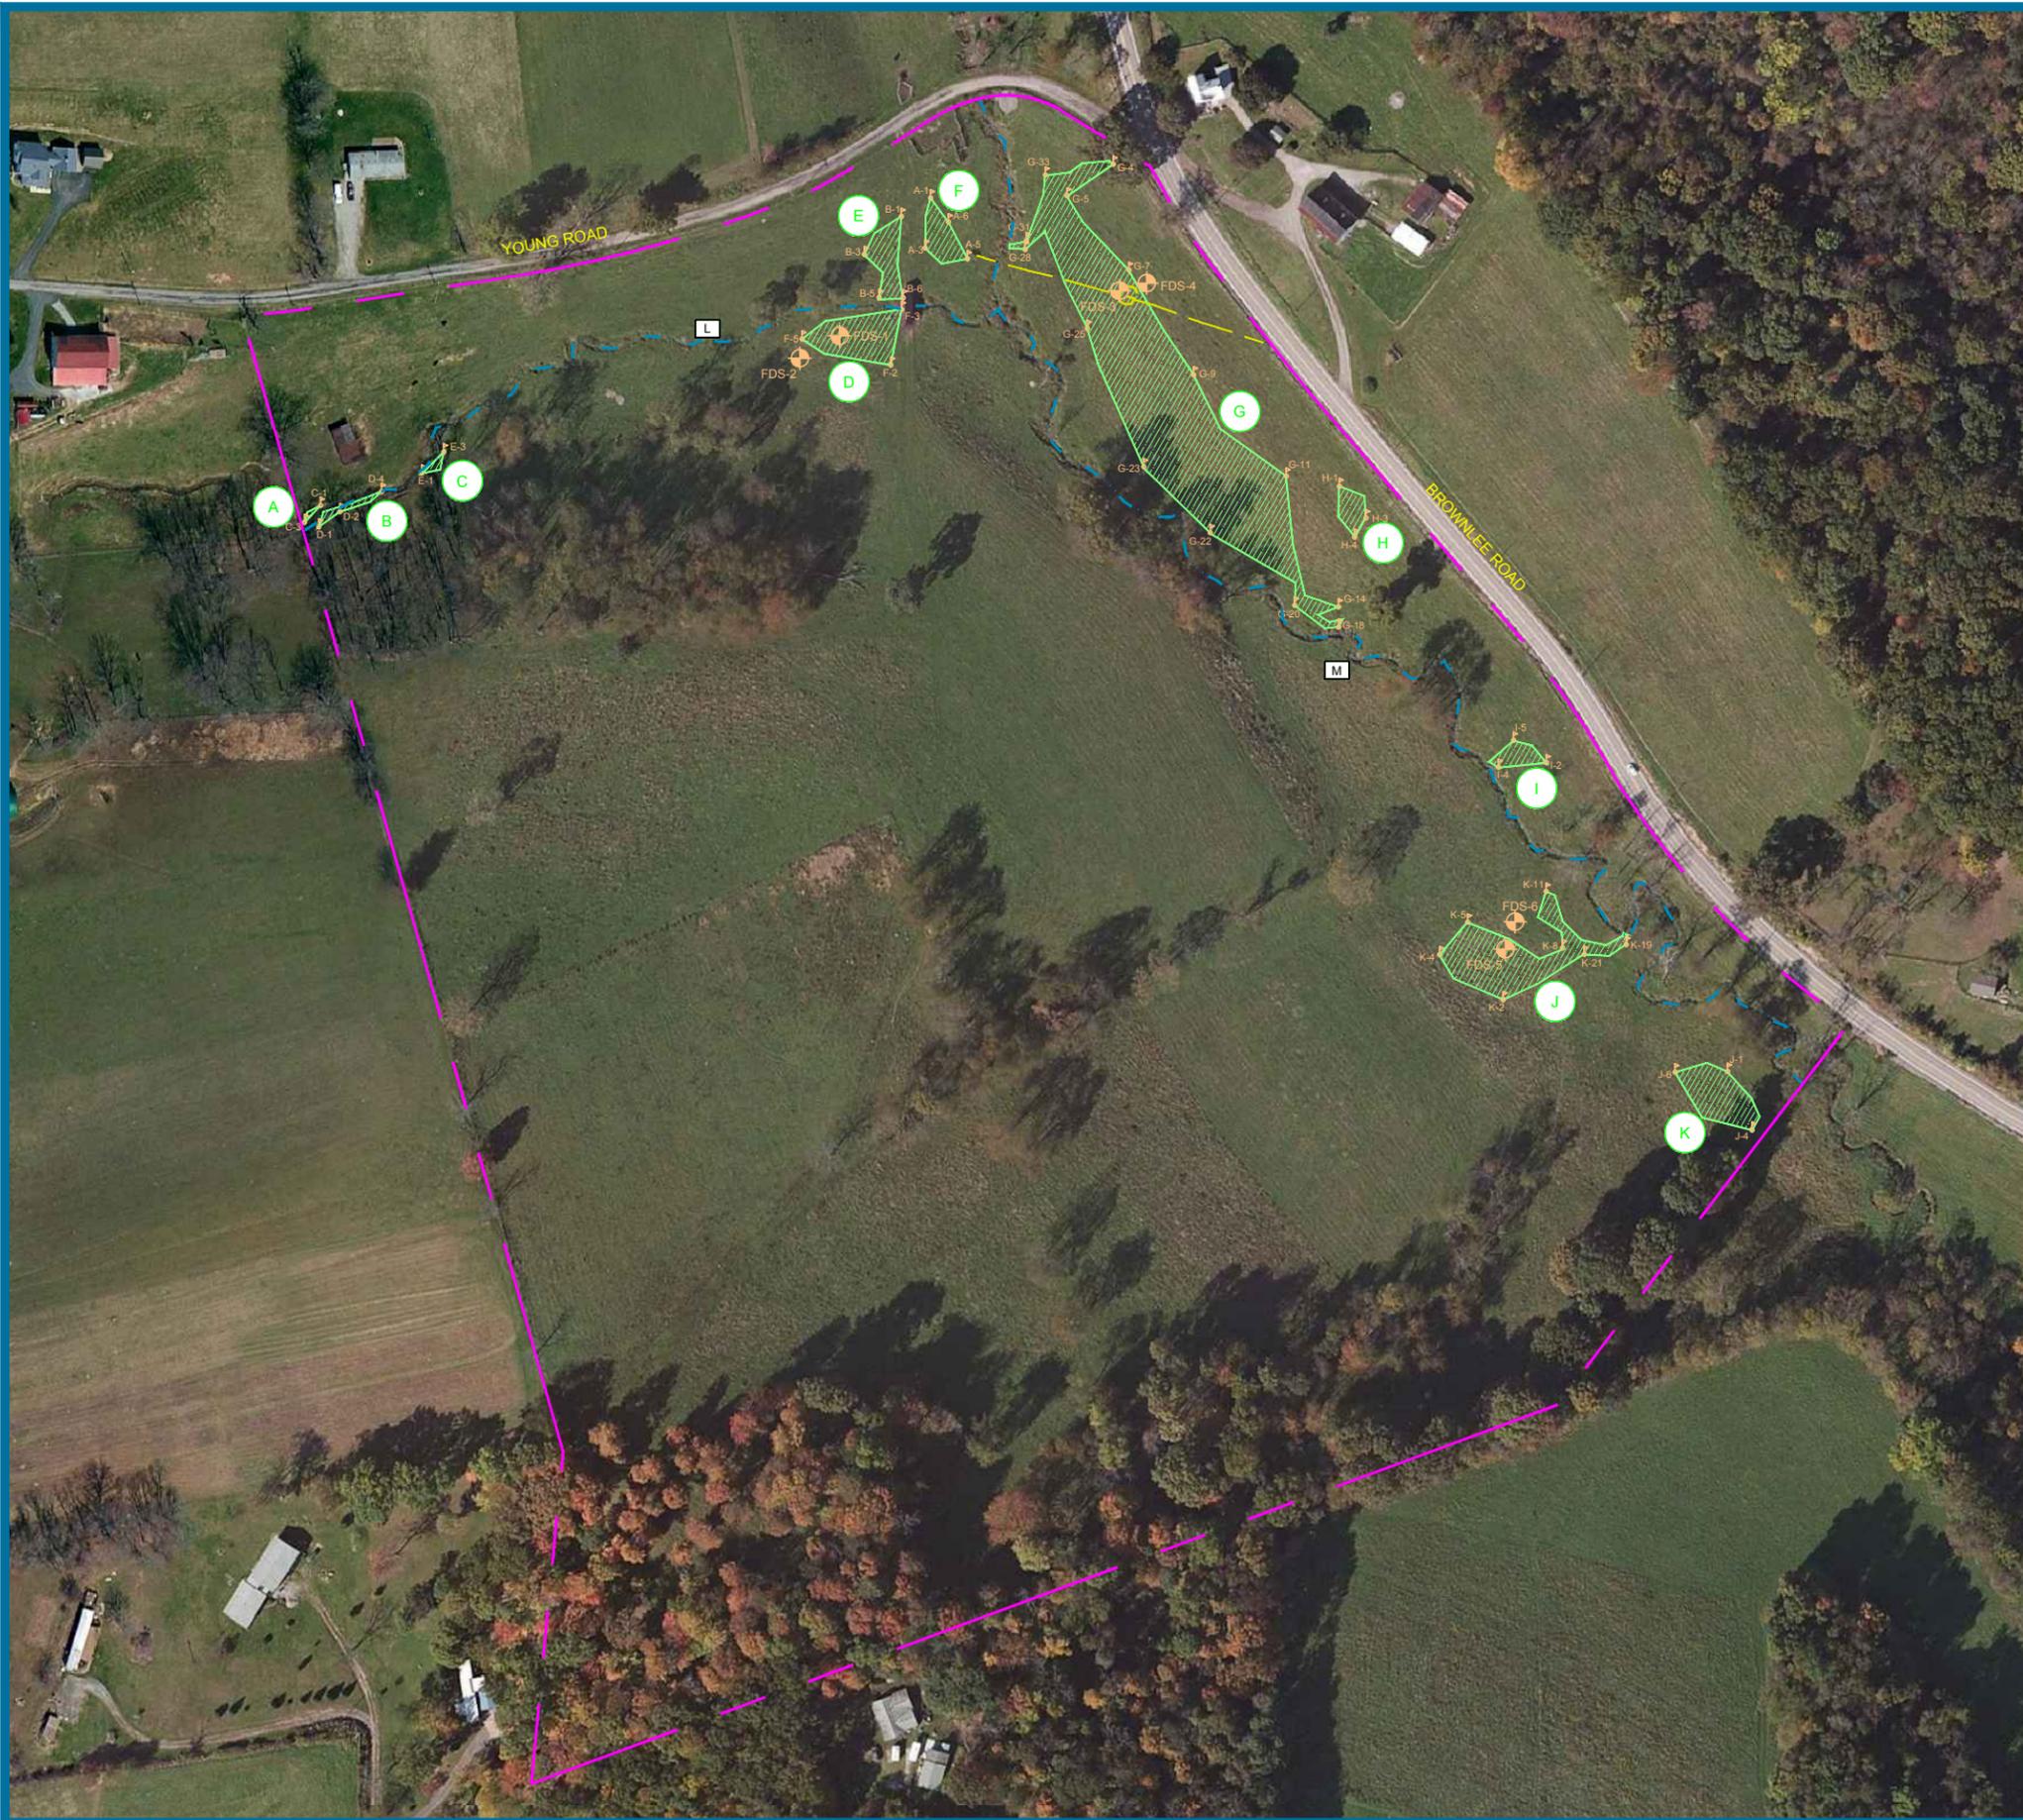
**FIGURE 4**  
 NORTH BRANCH PIGEON  
 CREEK MITIGATION BANK  
 PRELIMINARY WATERS OF  
 THE U.S. DELINEATION MAP  
 WASHINGTON COUNTY,  
 PENNSYLVANIA

1. WATERS OF THE U.S. WITHIN THE PROJECT STUDY LIMITS HAVE BEEN GPS AND SURVEY LOCATED BY TIMMONS GROUP.
2. WATERS OF THE U.S. HAVE NOT BEEN CONFIRMED BY THE U.S. ARMY CORPS OF ENGINEERS.
3. PROJECT STUDY LIMITS ARE BASED ON A BOUNDARY SURVEY BY MCTISH, KUNKEL & ASSOCIATES, DATED 02/05/2013.
4. AERIAL IMAGERY FROM ESRI ONLINE-2012.

Resource ID	Classification						Resource Description Notes*	
	PFO (ft <sup>2</sup> )	PEM (ft <sup>2</sup> )	PSS (ft <sup>2</sup> )	POW (ft <sup>2</sup> )	PERENNIAL & INTERMITTENT STREAMS (l.f.)	EPHEMERAL STREAMS (l.f.)		DITCH (l.f.)
A		71.14						NT/V
B		439.18						NT/V
C		188.63						NT/V
D		4,275.39						NT/V
E		2,203.87						NT/V
F		1,835.09						NT/V
G		39,989.35						NT/V
H		1,167.12						NT/V
I		1,103.20						NT/V
J		8,563.06						NT/V
K		3,938.55						NT/V
L					860			NT/NV
M					2,013			NT/NV
<b>Total</b>	<b>0</b>	<b>63,775</b>	<b>0</b>	<b>0</b>	<b>2,893</b>		<b>0</b>	
<b>Total Wetland Area =</b>		<b>63,774.58 ft<sup>2</sup></b>		<b>1.46</b>		<b>Acres</b>

The wetland delineation identified the presence of approximately 1.46 acres of “palustrine emergent” (“PEM”) wetlands and 2,893 linear feet of stream channel. PEM wetlands onsite were found within the floodplain of the main tributary and along hillside slopes throughout the Site. The majority of these wetlands were historically used as cattle pasture. The streams identified onsite consist of both headwater intermittent and perennial systems. The boundaries of the jurisdictional areas delineated onsite have been GPS located and are shown on [Figure 4: Preliminary Jurisdictional Waters of the U.S. Delineation Map](#). A summary of the jurisdictional areas identified onsite is provided in Table 1.
