CONCEPTUAL MITIGATION PLAN

AMERICAN ELECTRIC POWER CO., INC.
PROPOSED MITCHELL LANDFILL PROJECT
CRESAP, MARSHALL COUNTY, WEST VIRGINIA

CIVIL & ENVIRONMENTAL CONSULTANTS, INC.
CINCINNATI, OHIO

April 26, 2012

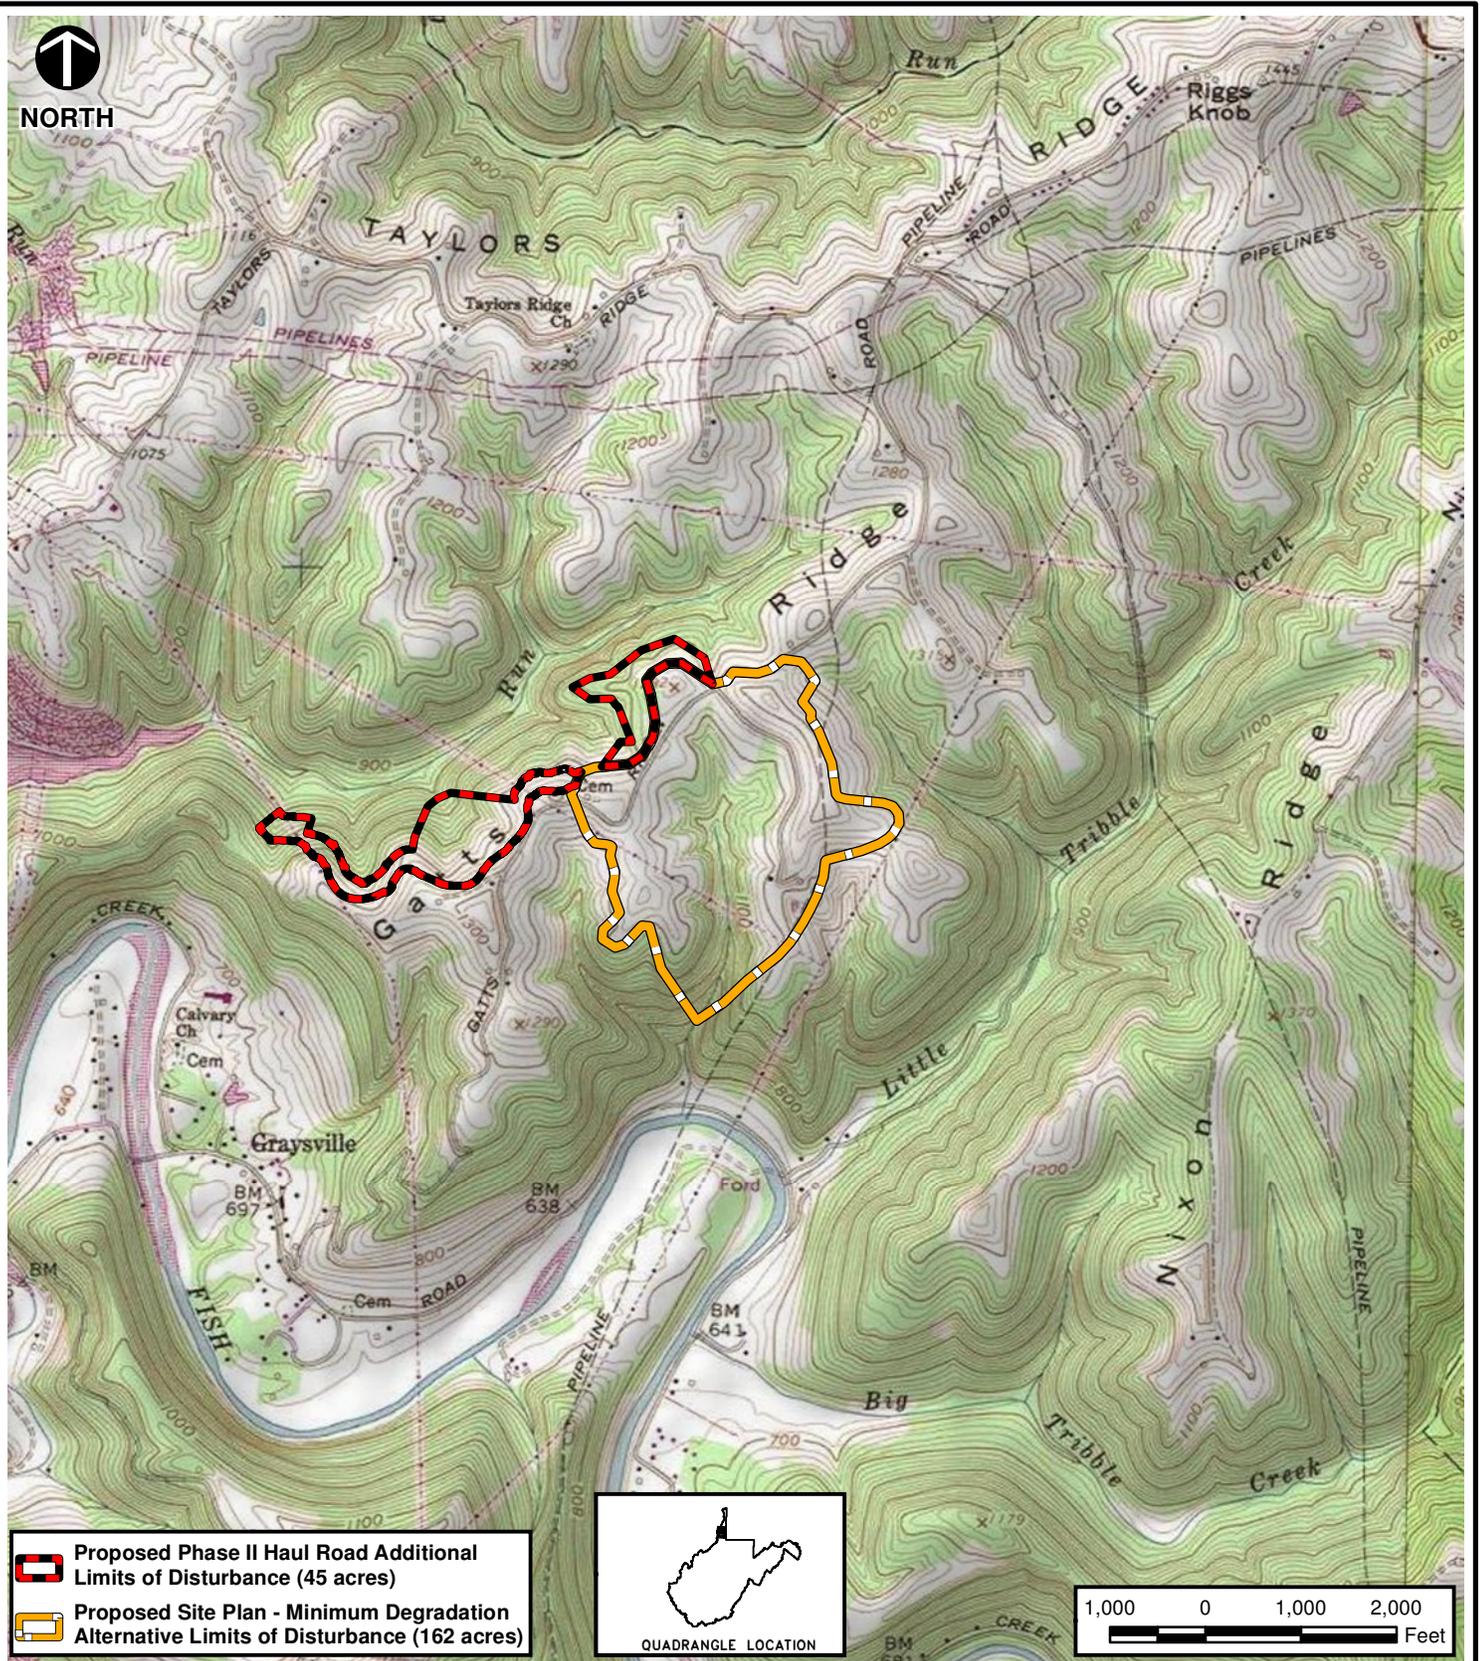
- Proposed Phase II Haul Road Additional Limits of Disturbance (45 acres)
- Proposed Site Plan - Minimum Degradation Alternative Limits of Disturbance (162 acres)

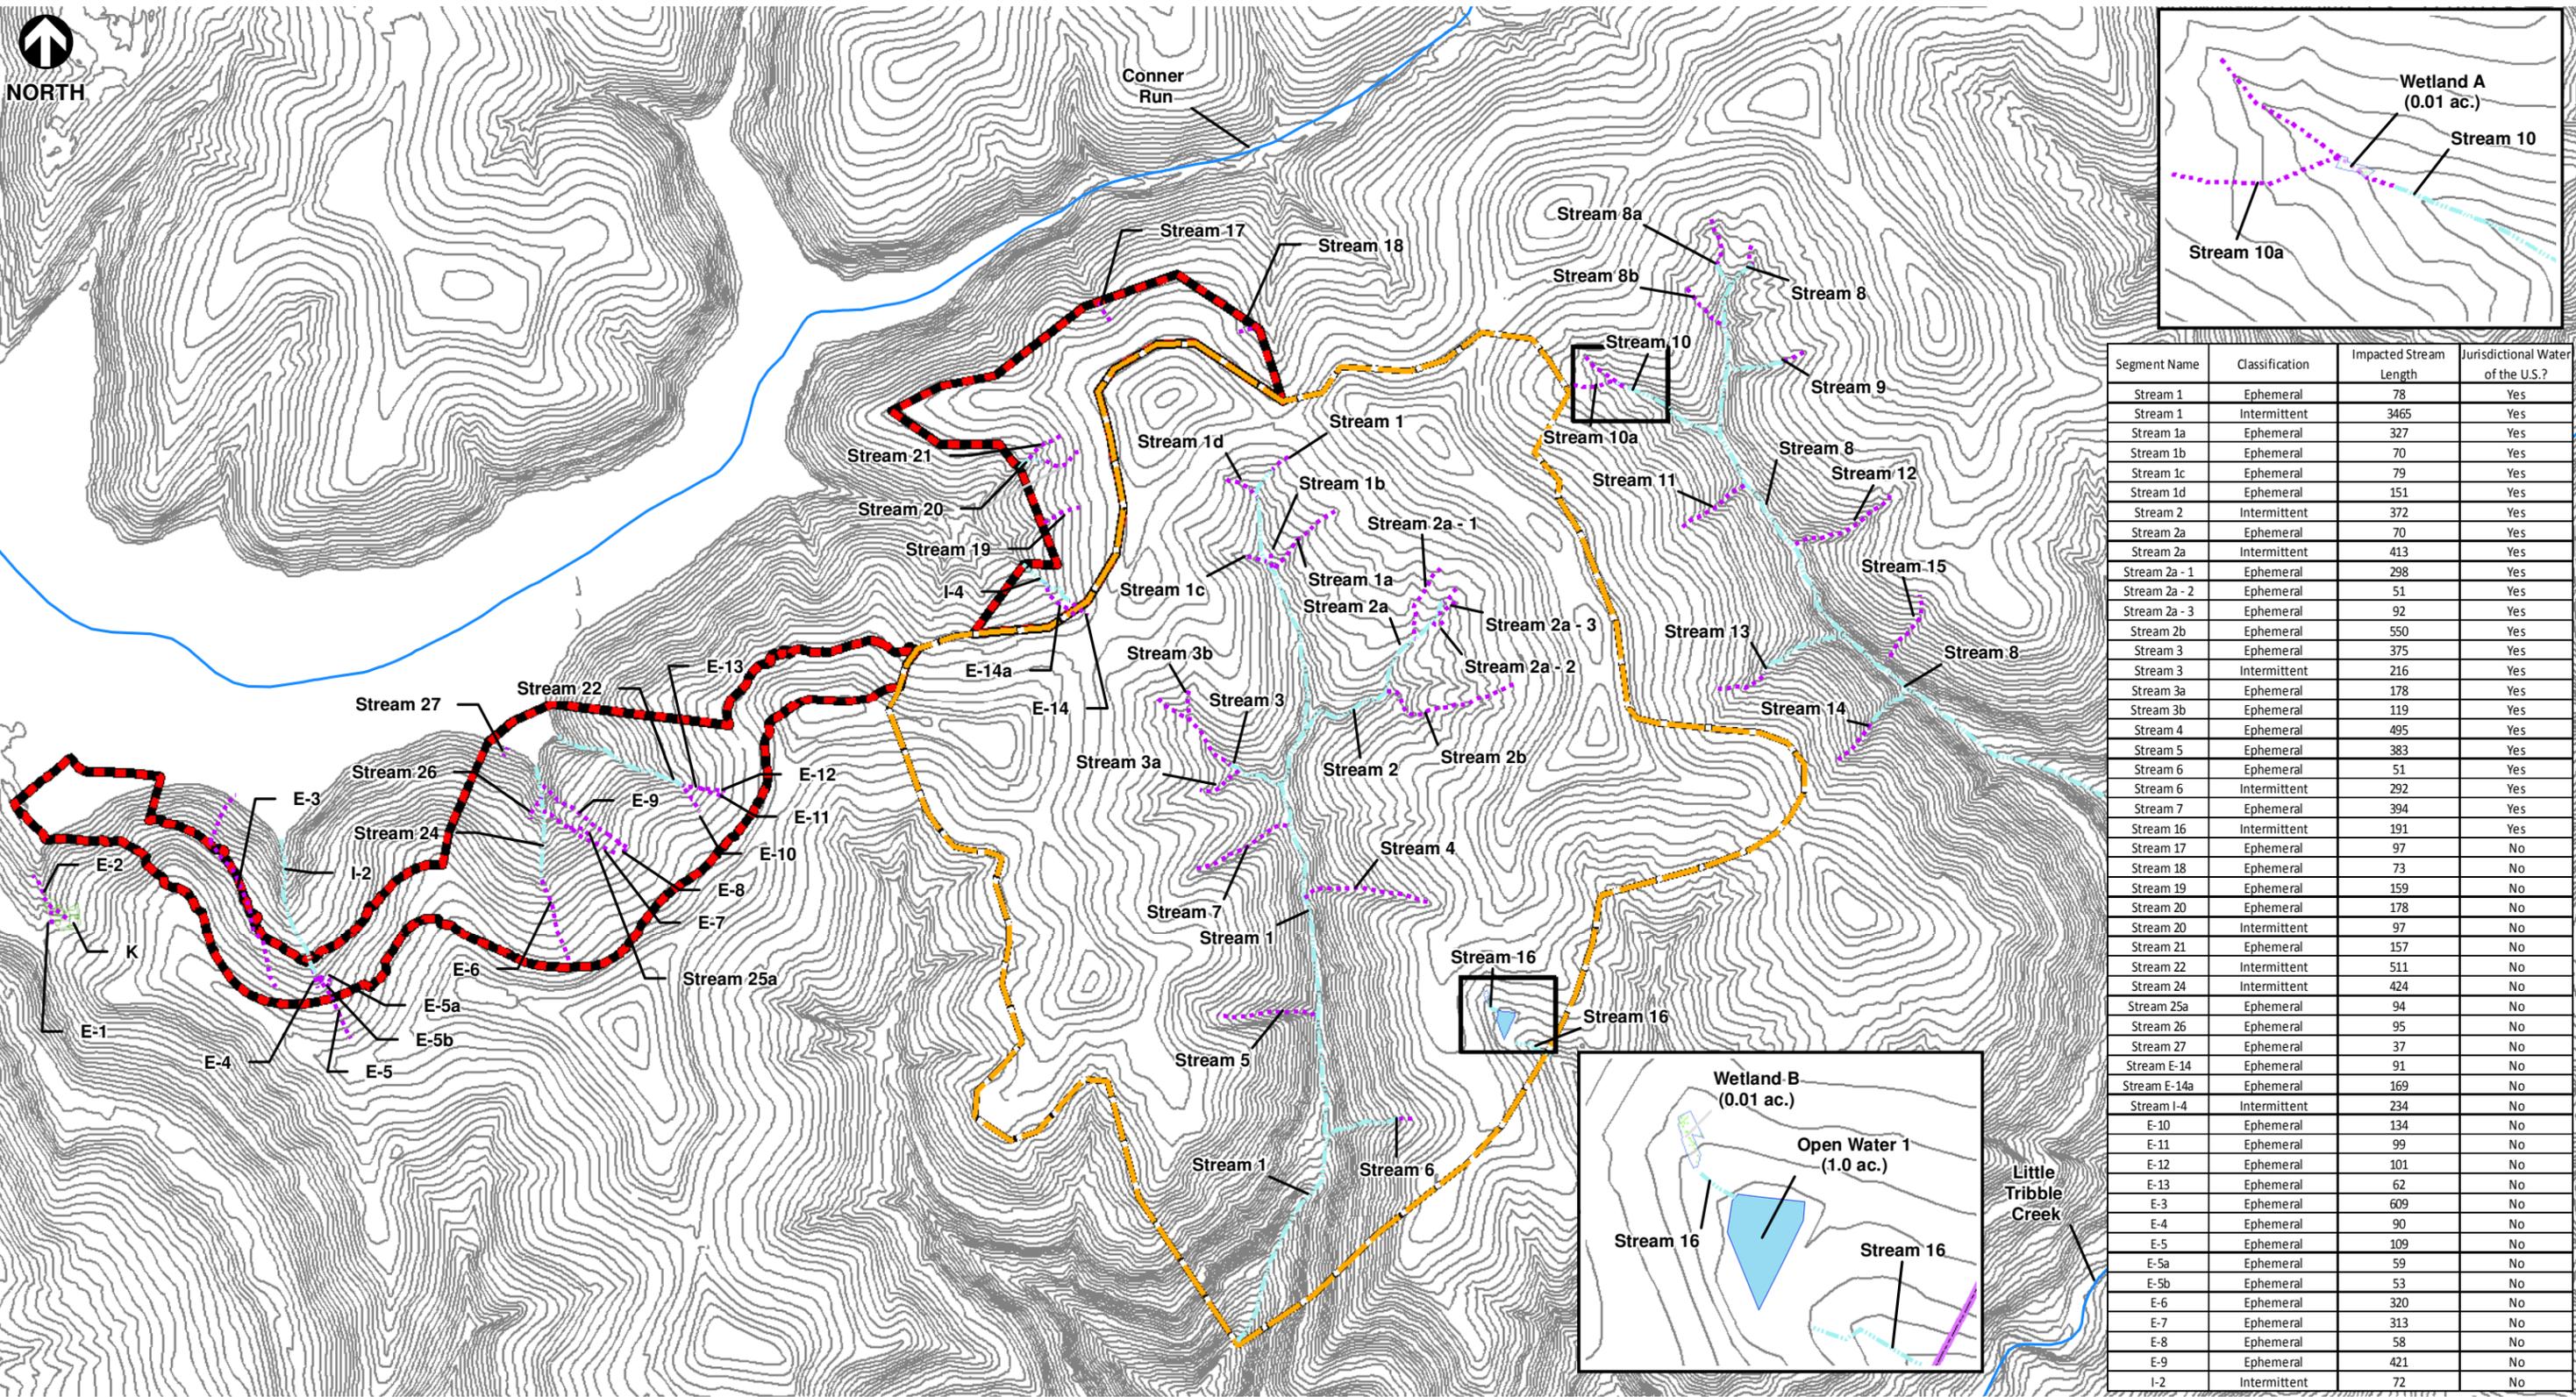
Segment Name	Classification	Impacted Stream Length	Jurisdictional Water of the U.S.?
Stream 1	Ephemeral	78	Yes
Stream 1	Intermittent	3465	Yes
Stream 1a	Ephemeral	327	Yes
Stream 1b	Ephemeral	70	Yes
Stream 1c	Ephemeral	79	Yes
Stream 1d	Ephemeral	151	Yes
Stream 2	Intermittent	372	Yes
Stream 2a	Ephemeral	70	Yes
Stream 2a	Intermittent	413	Yes
Stream 2a - 1	Ephemeral	298	Yes
Stream 2a - 2	Ephemeral	51	Yes
Stream 2a - 3	Ephemeral	92	Yes
Stream 2b	Ephemeral	550	Yes
Stream 3	Ephemeral	375	Yes
Stream 3	Intermittent	216	Yes
Stream 3a	Ephemeral	178	Yes
Stream 3b	Ephemeral	119	Yes
Stream 4	Ephemeral	495	Yes
Stream 5	Ephemeral	383	Yes
Stream 6	Ephemeral	51	Yes
Stream 6	Intermittent	292	Yes
Stream 7	Ephemeral	394	Yes
Stream 16	Intermittent	191	Yes
Stream 17	Ephemeral	97	No
Stream 18	Ephemeral	73	No
Stream 19	Ephemeral	159	No
Stream 20	Ephemeral	178	No
Stream 20	Intermittent	97	No
Stream 21	Ephemeral	157	No
Stream 22	Intermittent	511	No

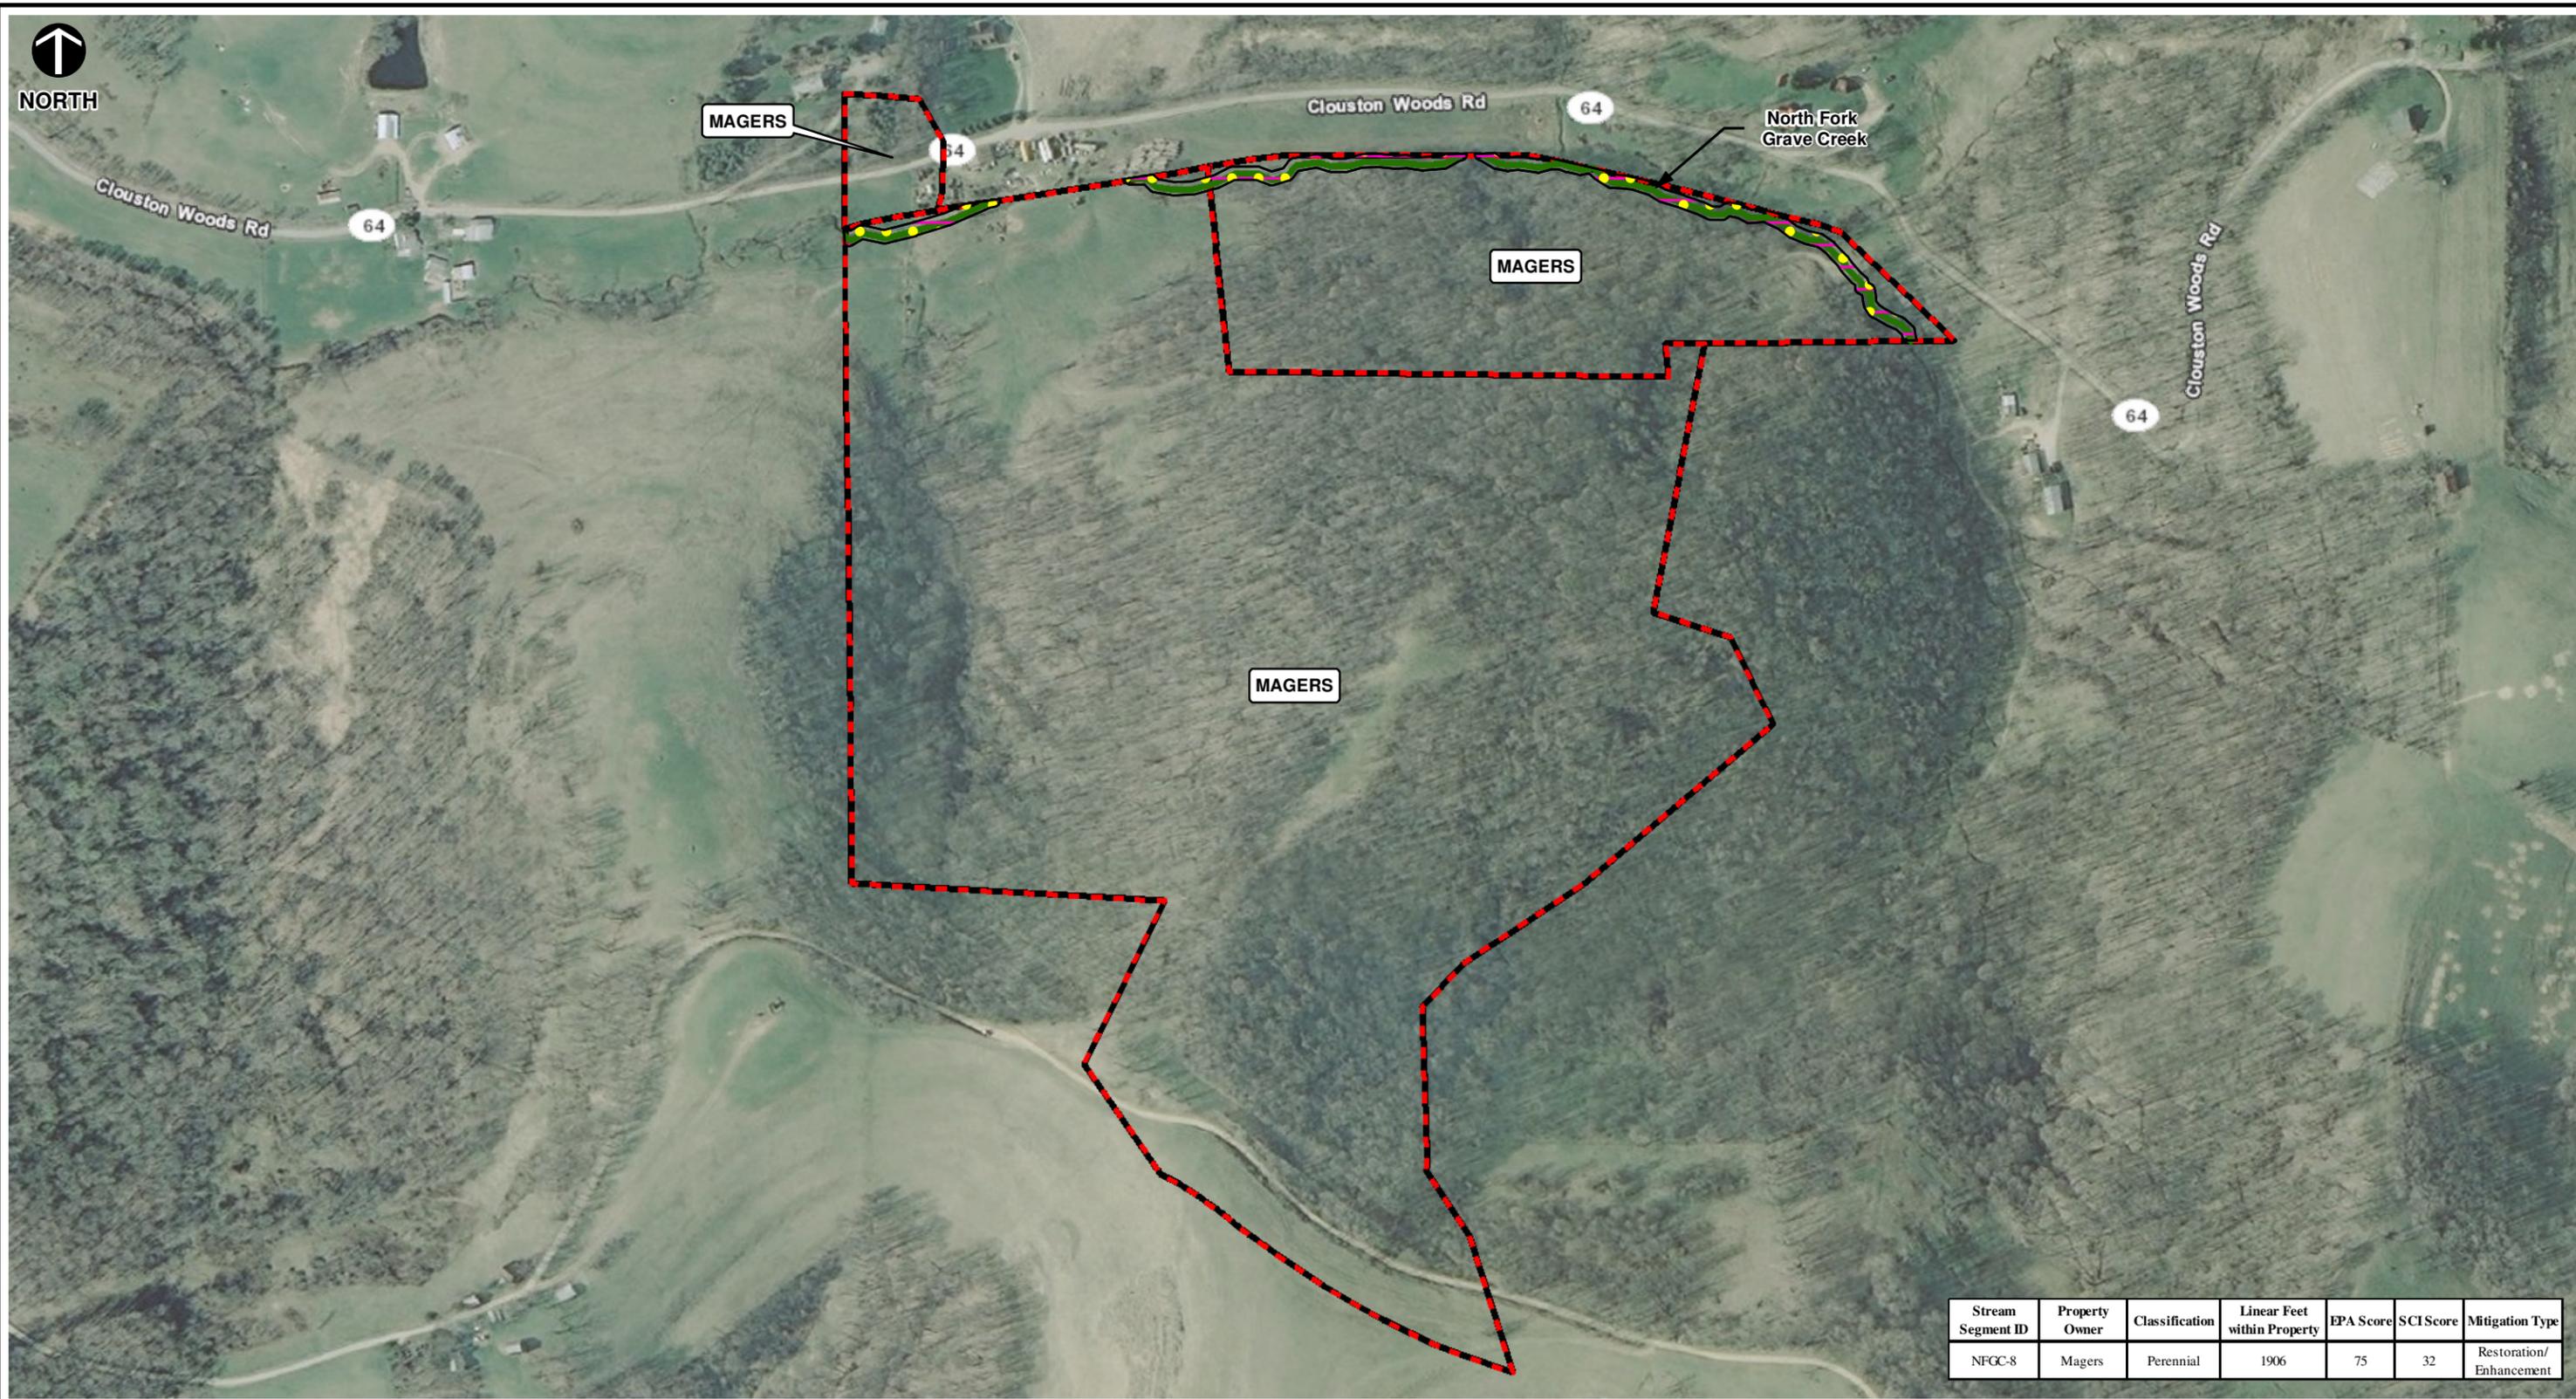
P:\2011\110-416-GIS\Maps\Strm Mitg Prop\Fig 7d.mxd - 4/18/2012 - 9:42:14 AM

Stream Segment ID	Property Owner	Classification	Linear Feet within Property	EPA Score	SCI Score	Mitigation Type
NFGC-8	Magers	Perennial	1906	75	32	Restoration/Enhancement

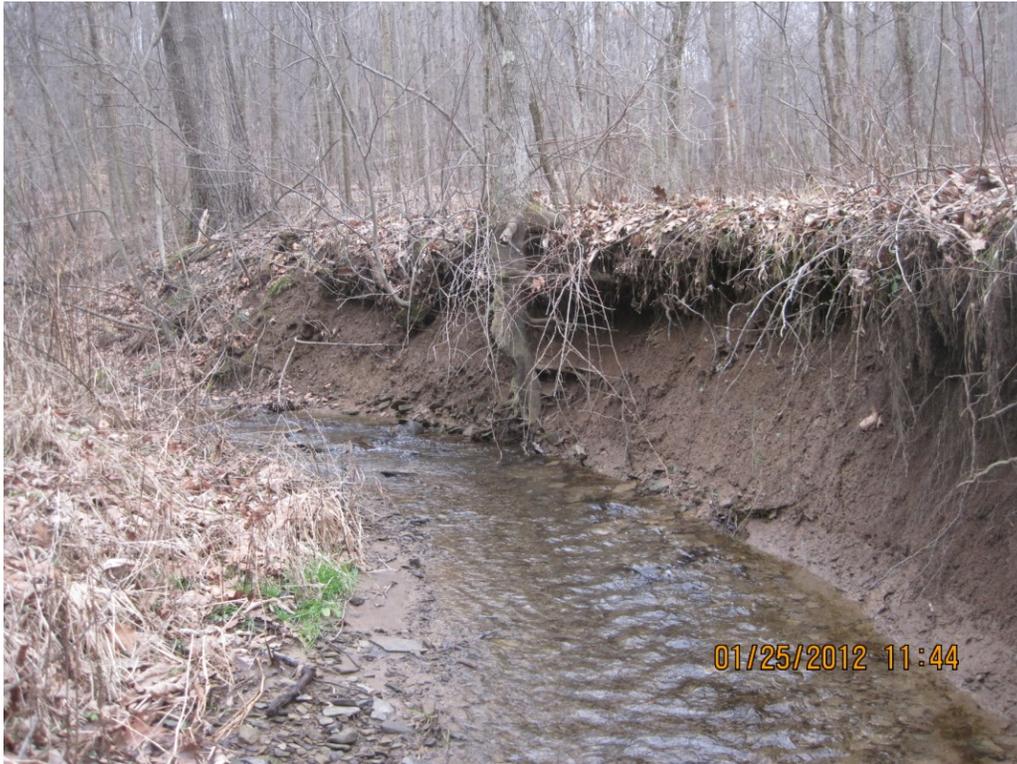
Photograph 1. View of French Run at stream assessment Segment FR-1. Photograph taken facing upstream.

The results of the biological assessments indicate that French Run along Segment FR-1 likely supports marginal benthic macroinvertebrate, stream salamander, and fish communities. No fish or stream salamanders were observed during the biological assessment. Benthic macroinvertebrates including patterned stoneflies (family Perlidae), brush-legged mayflies (family Isonychiidae), non-biting midges (family Chironomidae), black flies (family Simuliidae), crane flies (family Tipulidae), as well as members of the order crayfish, and members of the subclass aquatic worms were observed during the stream assessment.

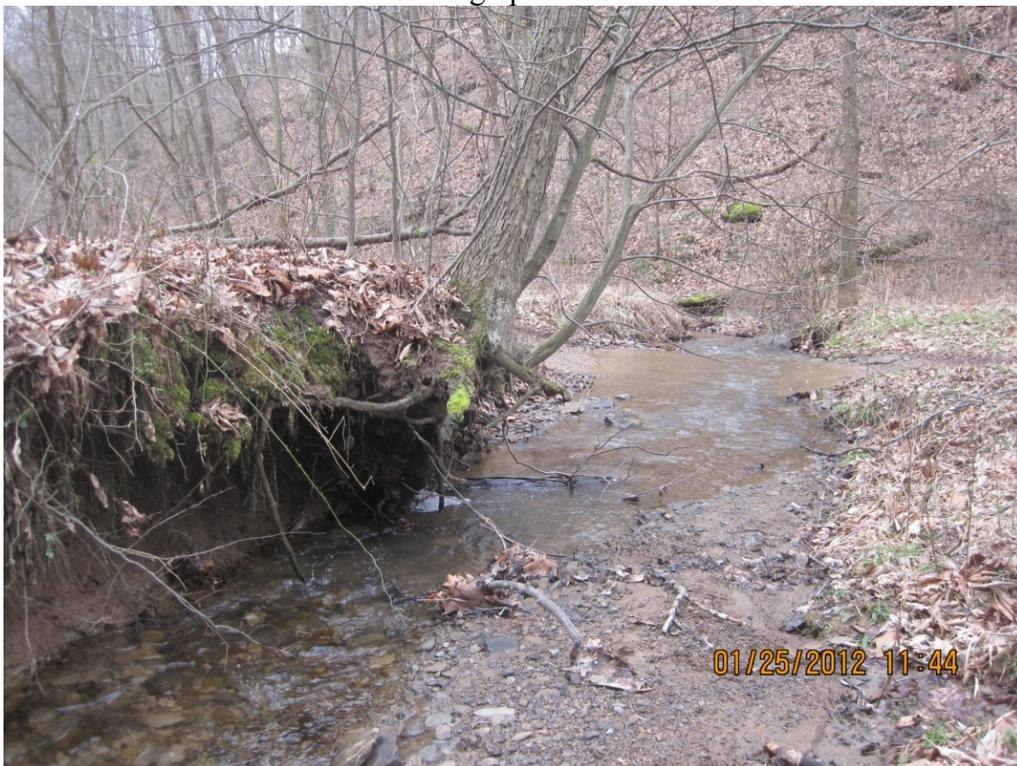
Photograph 2. View of French Run at stream assessment Segment FR-1. Photograph taken facing downstream.

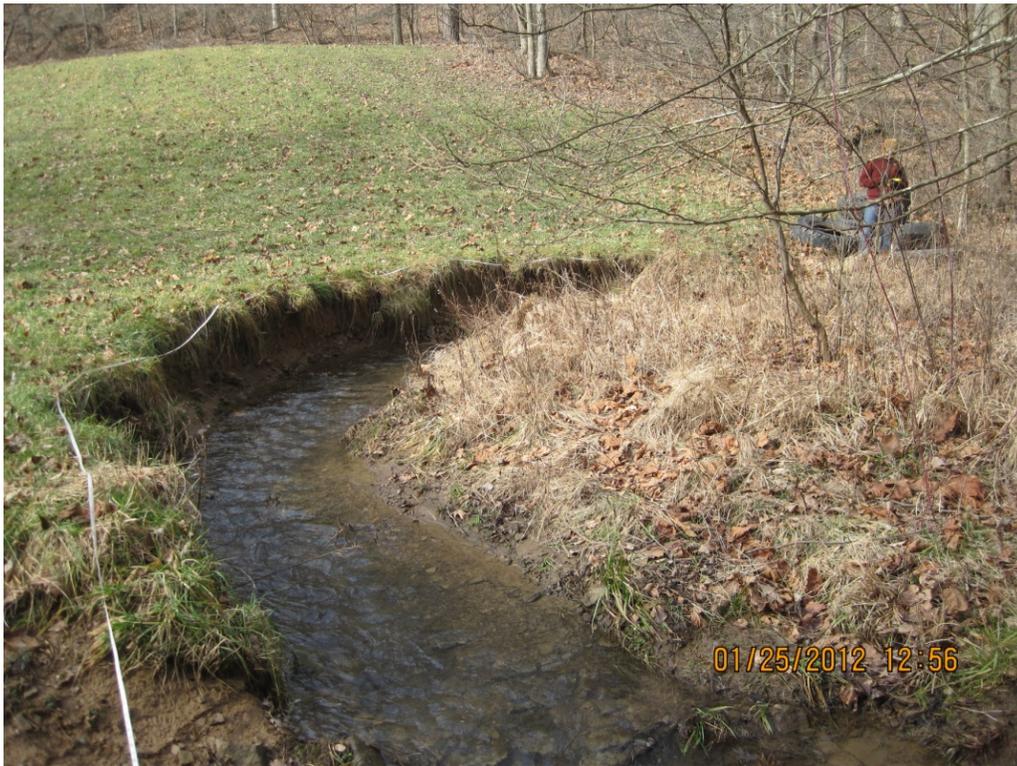
Photograph 3. View of French Run at stream assessment Segment FR-2. Photograph taken facing upstream.

The results of the biological assessments indicate that French Run along Segment FR-2 likely supports marginal benthic macroinvertebrate, stream salamander, and fish communities, although no fish were observed during the biological assessment sampling activities. One larval northern dusky salamander was observed within the stream segment during sampling activities. Benthic macroinvertebrates including flatheaded mayflies (family Heptageniidae), winter stoneflies (family Capniidae), patterned stoneflies, brush-legged mayflies, case-building caddisflies (family Glossosomatidae), common netspinner caddisflies (family Hydropsychidae), non-biting midges, black flies, crane flies, as well as members of the order crayfish and members of the subclass aquatic worms were observed during the stream assessment site visit.

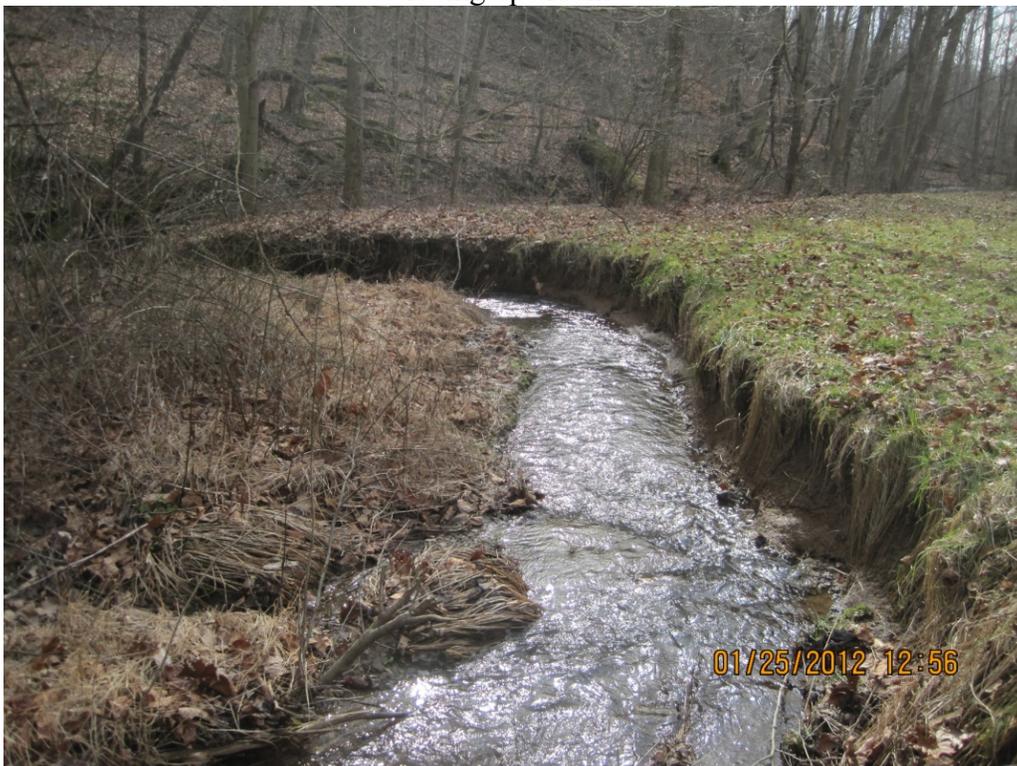
Photograph 4. View of French Run at stream assessment Segment FR-2. Photograph taken facing downstream.

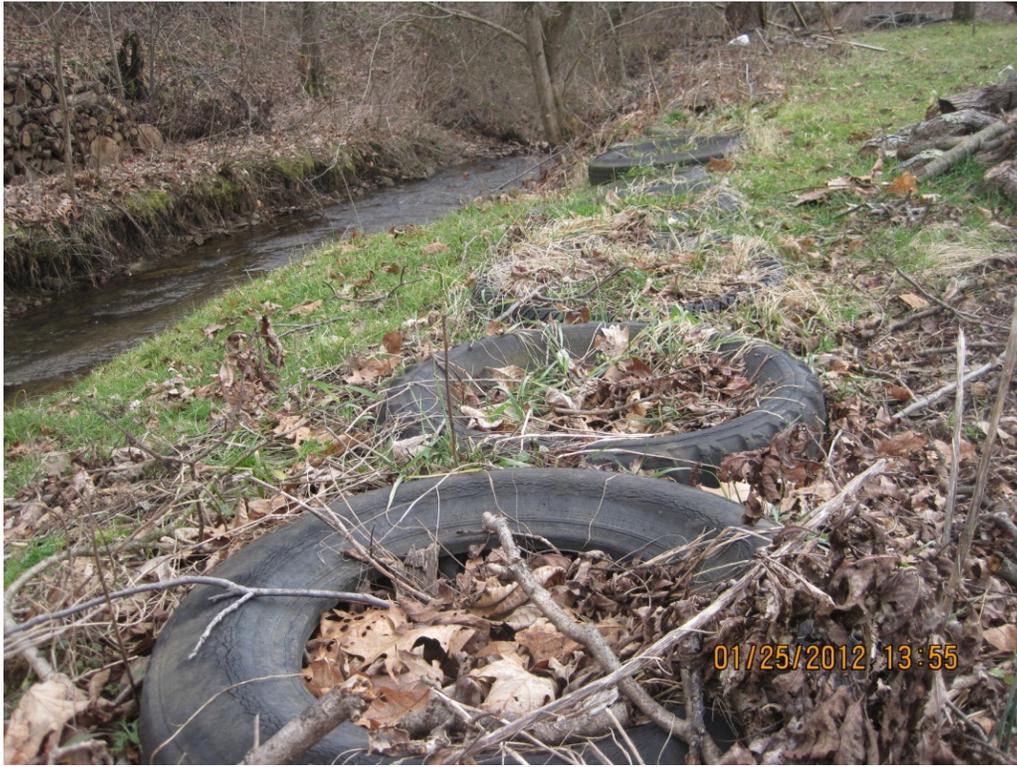
Photograph 5. View of tires used for bank stabilization within French Run. Photograph taken facing downstream.

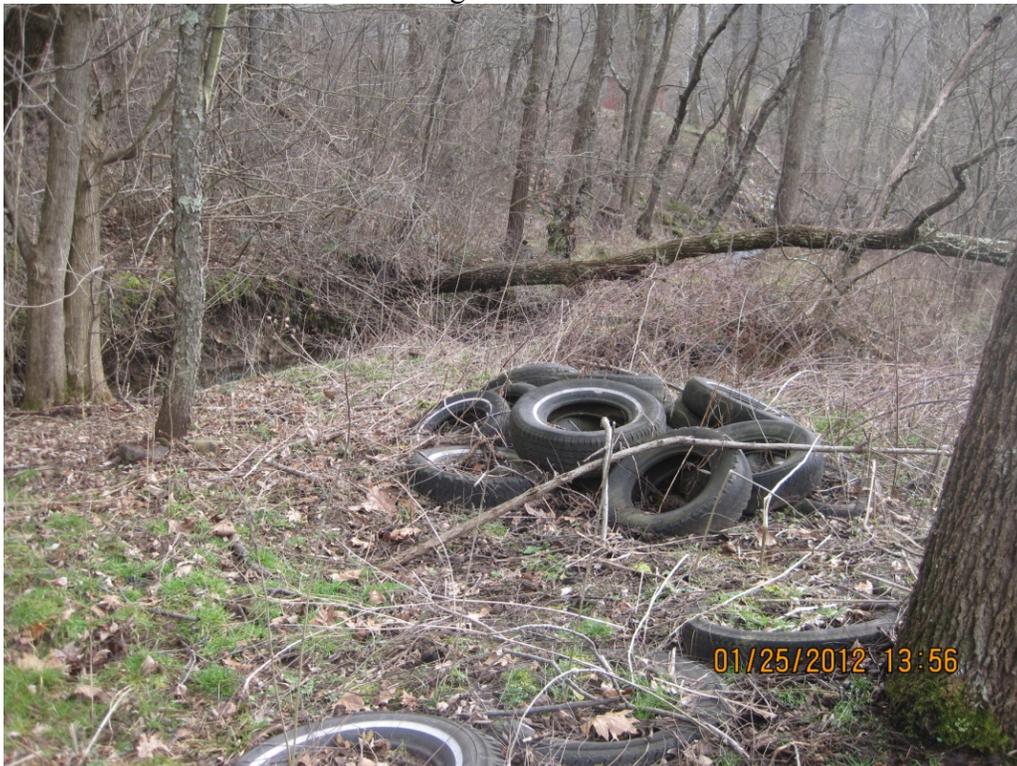
Photograph 6. View of tires along French Run. Photograph taken facing southeast.

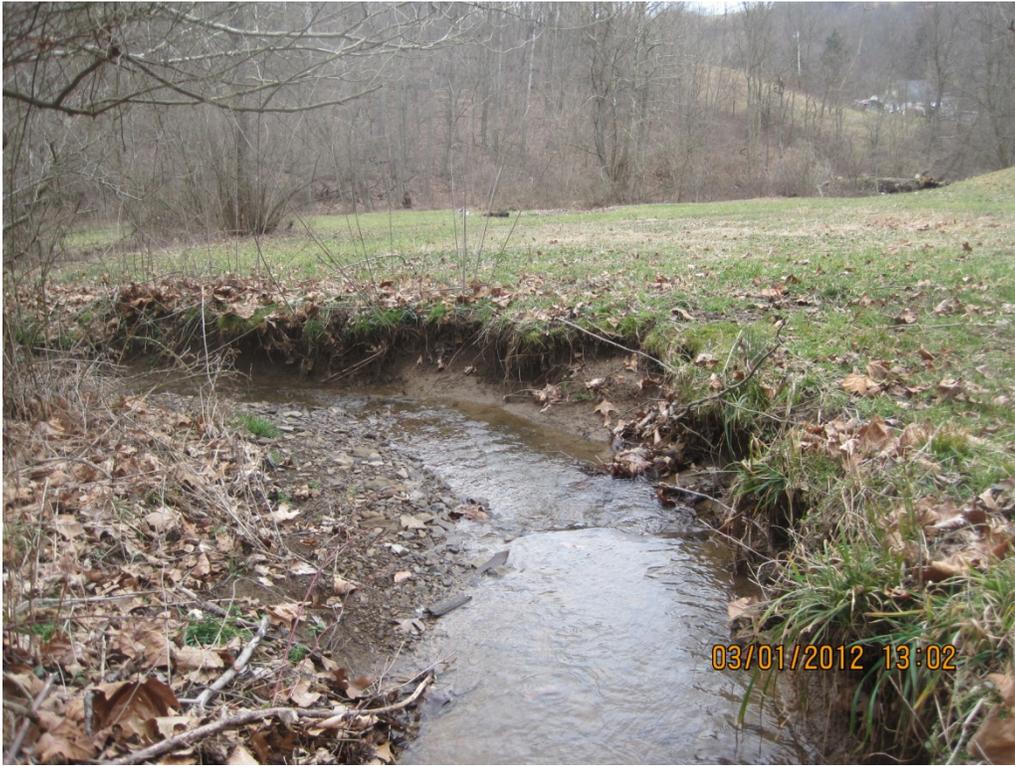
Photograph 7. View of unnamed tributary to French Run (FR-UNT1) within the Lyons Property.
Photograph taken facing downstream.

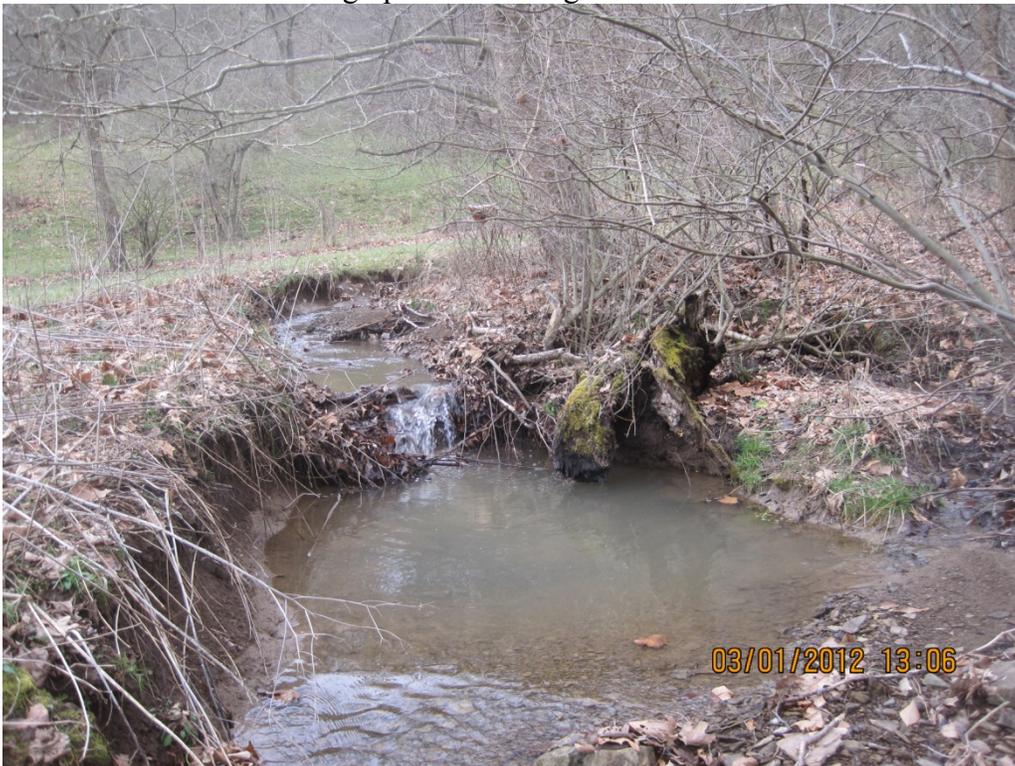
Photograph 8. View of unnamed tributary to French Run (FR-UNT1) within the Lyons Property.
Photograph taken facing upstream.

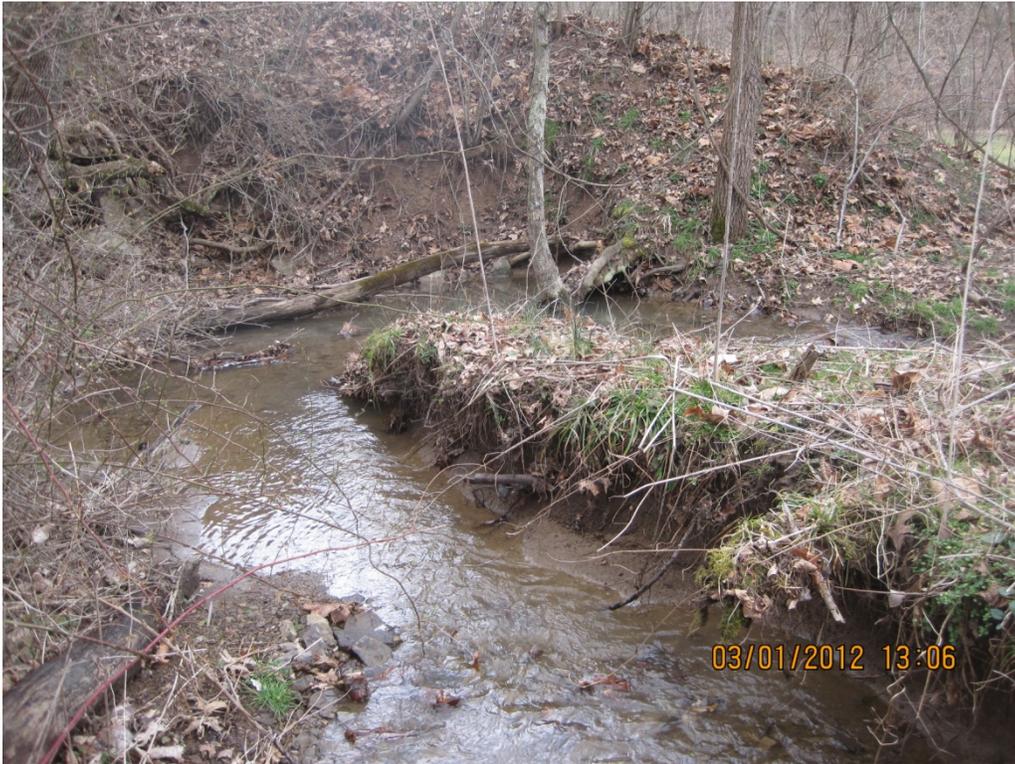
Photograph 9. View of unnamed tributary to French Run (FR-UNT1) within the Lyons Property.
Photograph taken facing downstream.

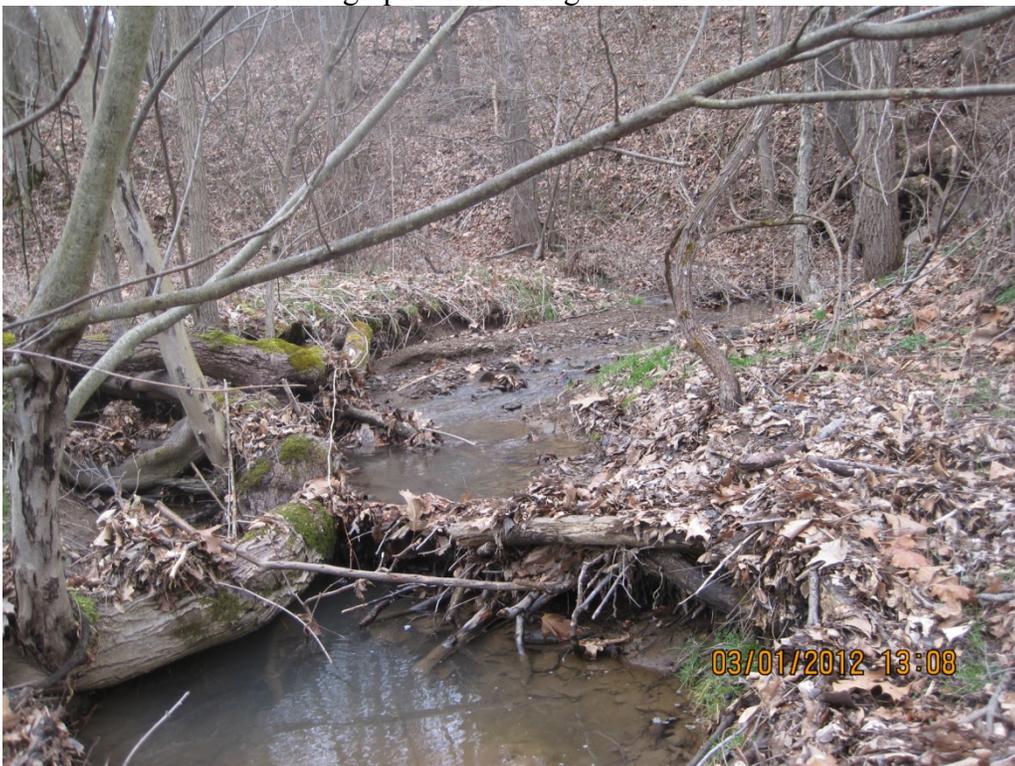
Photograph 10. View of unnamed tributary to French Run (FR-UNT1) within the Lyons
Property. Photograph taken facing downstream.

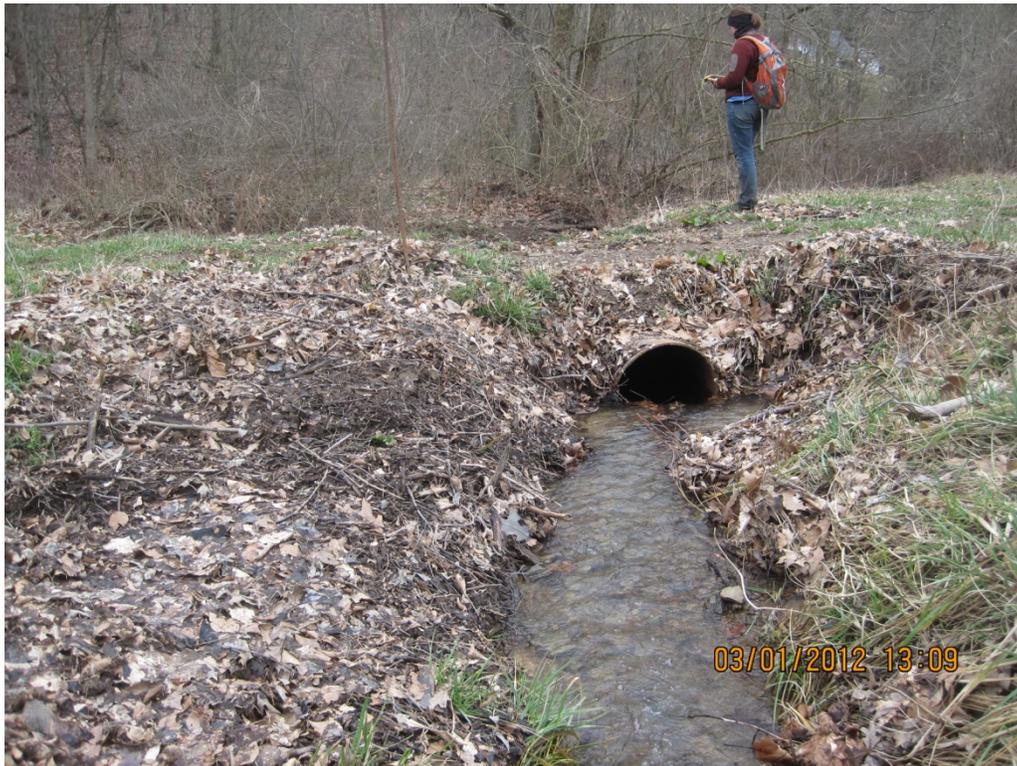
Photograph 11. View of the upstream side of a culvert within unnamed tributary to French Run (FR-UNT1) on the Lyons Property. Photograph taken facing downstream.

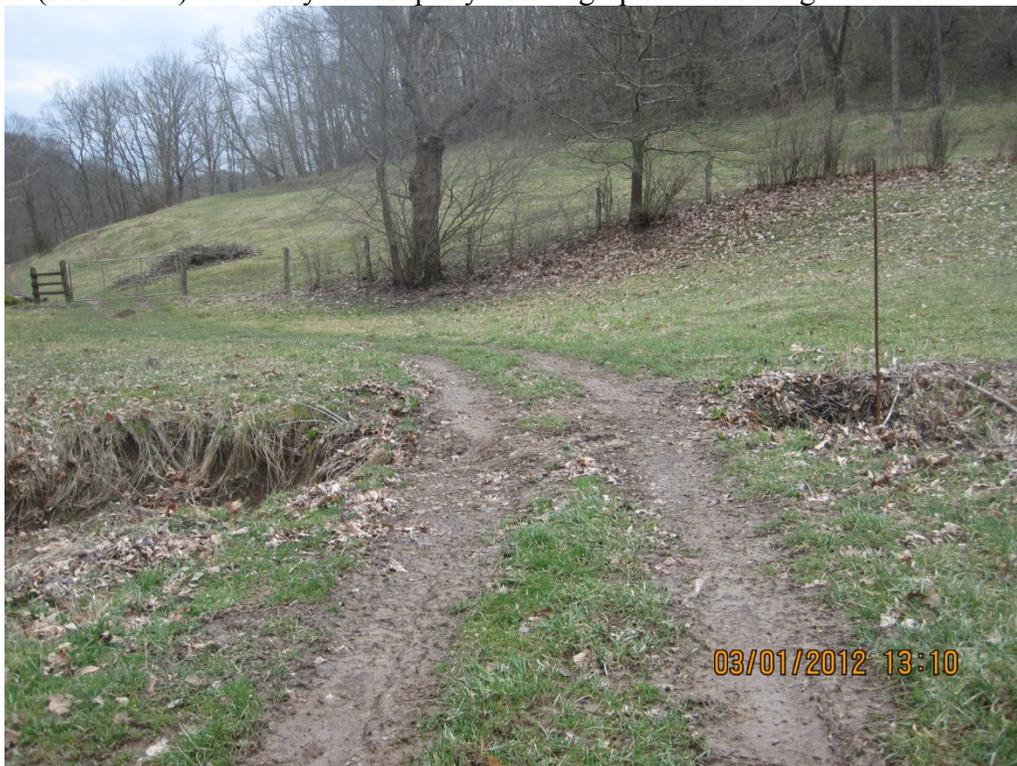
Photograph 12. View of a road crossing through unnamed tributary to French Run (FR-UNT1) located on the Lyons Property. Photograph taken facing south.

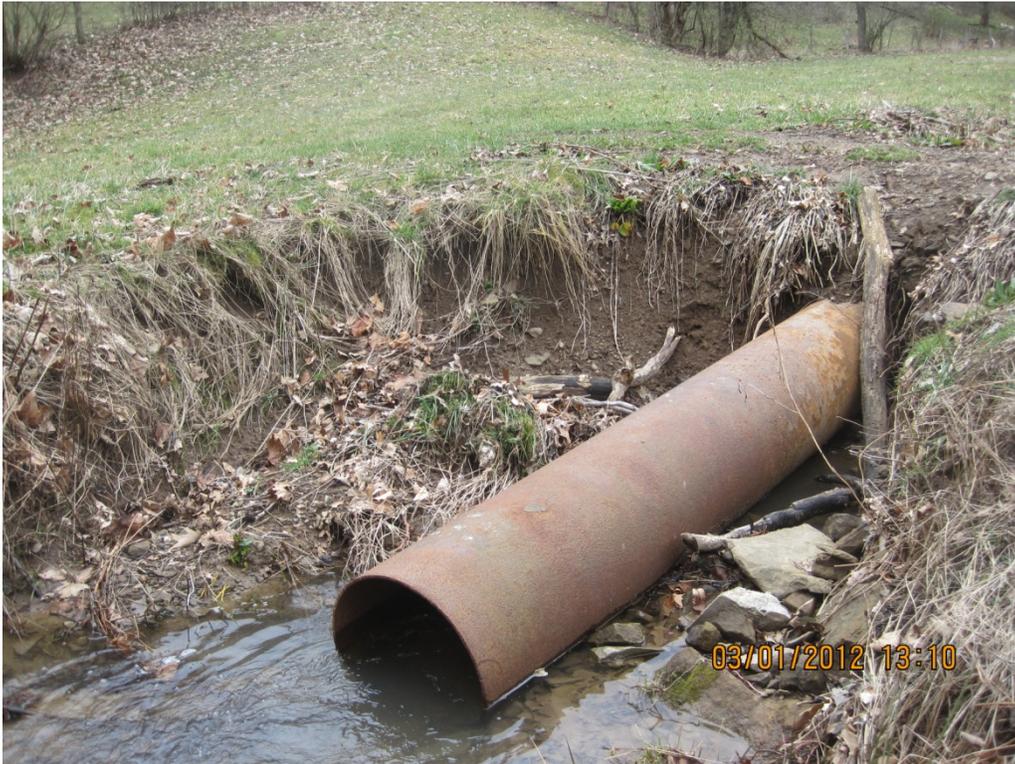
Photograph 13 View of the downstream side of the culvert within unnamed tributary to French Run (FR-UNT1) located on the Lyons Property. Photograph taken facing southwest.

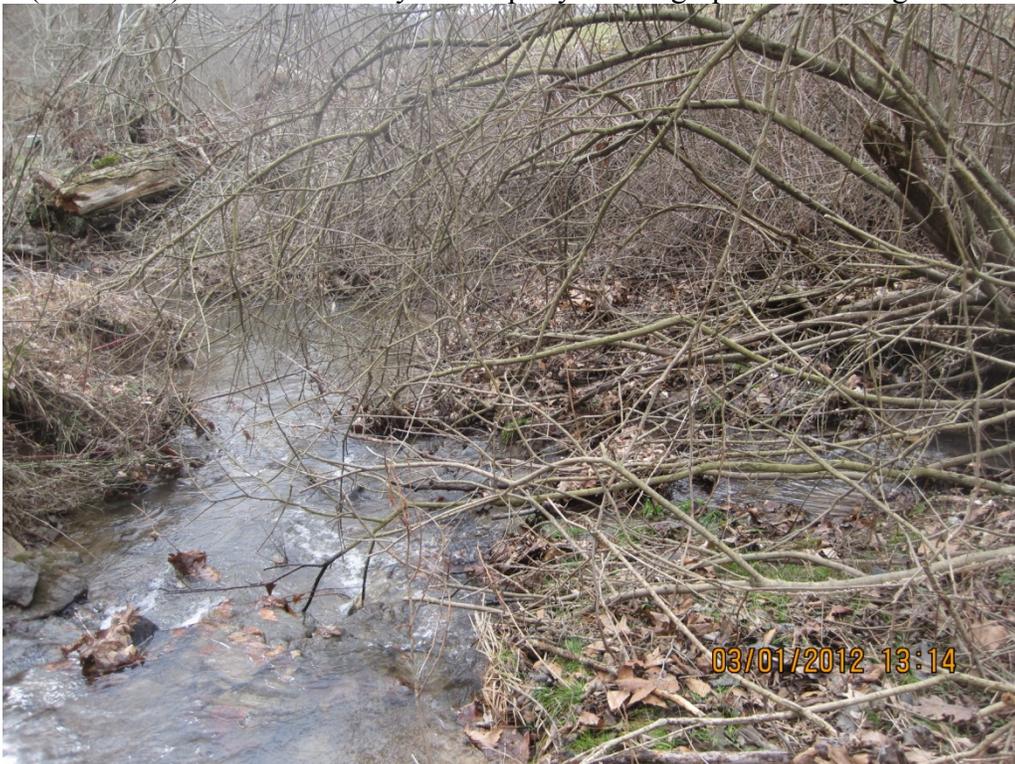
Photograph 14. View of the confluence of unnamed tributary to French Run (FR-UNT1) and French Run on the Lyons Property. Photograph taken facing downstream.

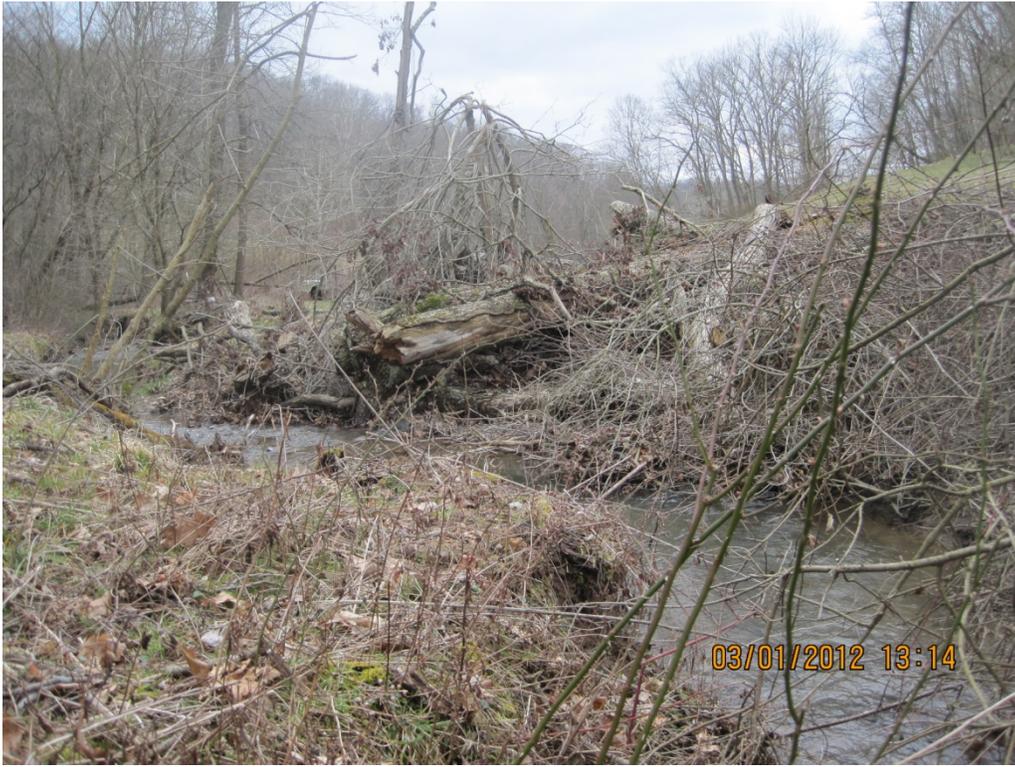
Photograph 15. View of French Run within the Lyons Property. Photograph taken facing downstream.
