CONCEPTUAL MITIGATION PLAN

AMERICAN ELECTRIC POWER CO., INC.
PROPOSED MITCHELL LANDFILL PROJECT
CRESAP, MARSHALL COUNTY, WEST VIRGINIA

CIVIL & ENVIRONMENTAL CONSULTANTS, INC.
CINCINNATI, OHIO

April 26, 2012

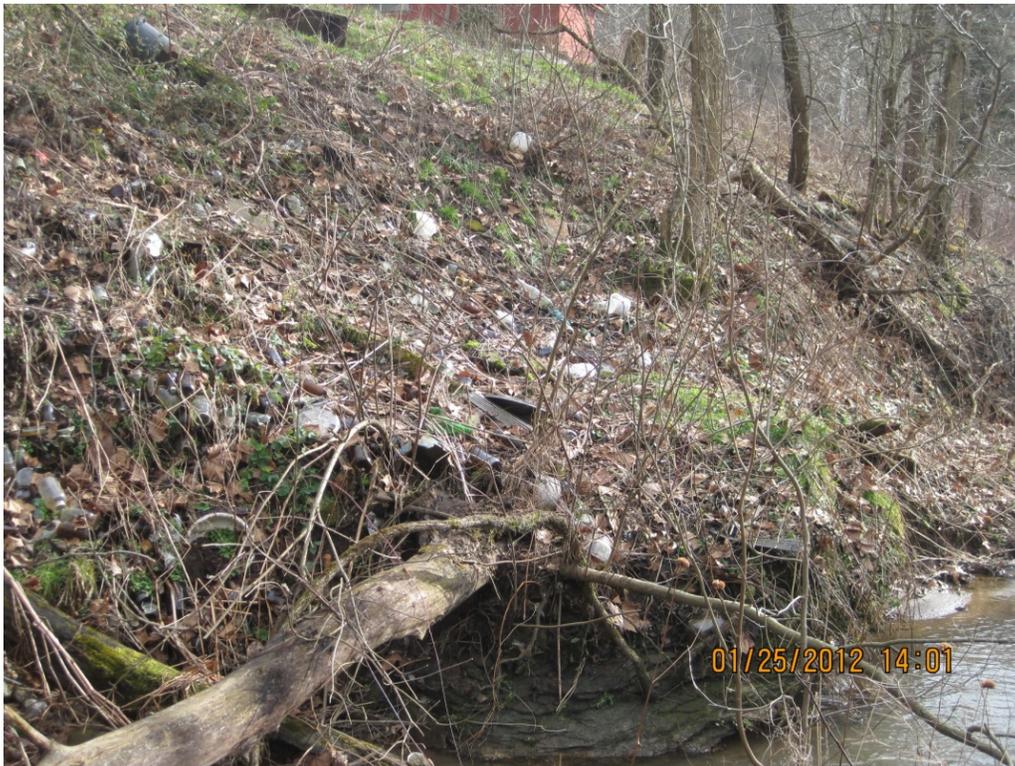
Photograph 16. View of garbage located on the left/descending bank of French Run within the Lyons Property. Photograph taken facing southeast.

The results of the biological assessment indicate that French Run within the Lyons Property supports marginal benthic macroinvertebrate and stream salamander communities. No fish were observed within the sampling reach. Three larval northern dusky salamanders were observed during the biological assessment sampling activities. Benthic macroinvertebrates identified within the sample reach included flatheaded mayflies, winter stoneflies, patterned stoneflies, brush-legged mayflies, case-building caddisflies, common netspinner caddisflies, non-biting midges, black flies, crane flies, crayfish, riffle beetles (family Elmidae), darners (family Aeshnidae), dobsonflies (family Corydalidae), and aquatic worms. The majority of French Run and the unnamed tributary within this property drain open pasture with no riparian buffer. The livestock have caused mechanical damage (sloughing, shearing) to the stream banks. There is an unstable in-stream ford within this portion of French Run. There is also a large garbage/debris pile located along the left stream bank below the property owners home and outbuildings.

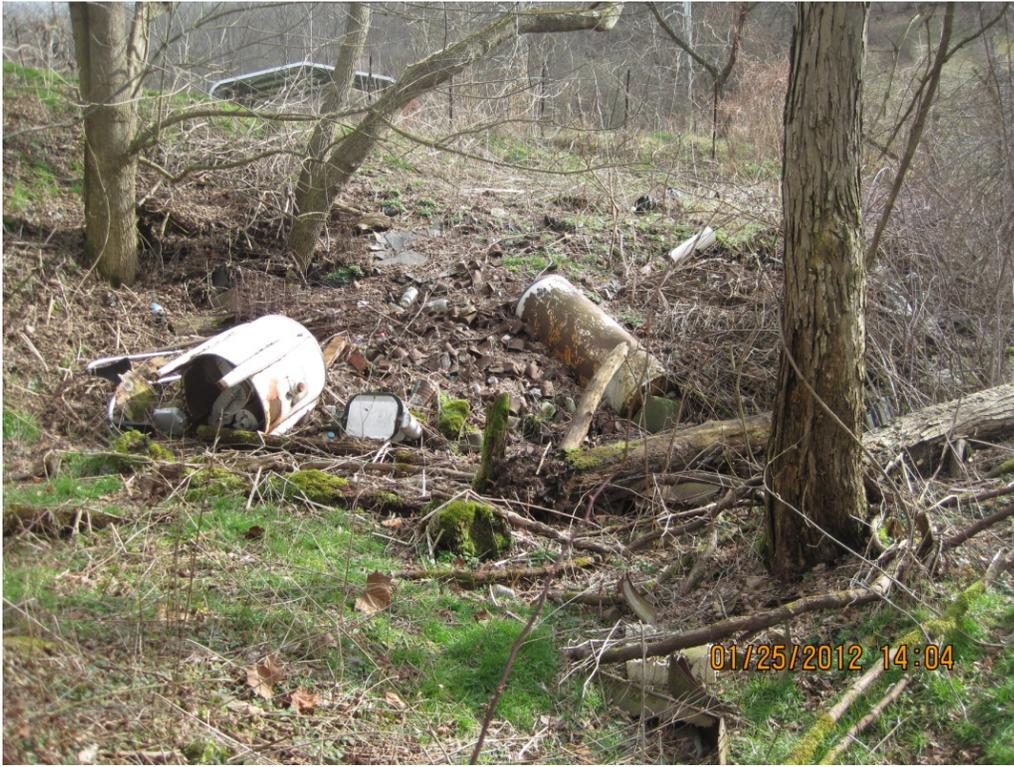
Photograph 17. View of garbage located on the left/descending bank of French Run within the Lyons Property. Photograph taken facing east/southeast.

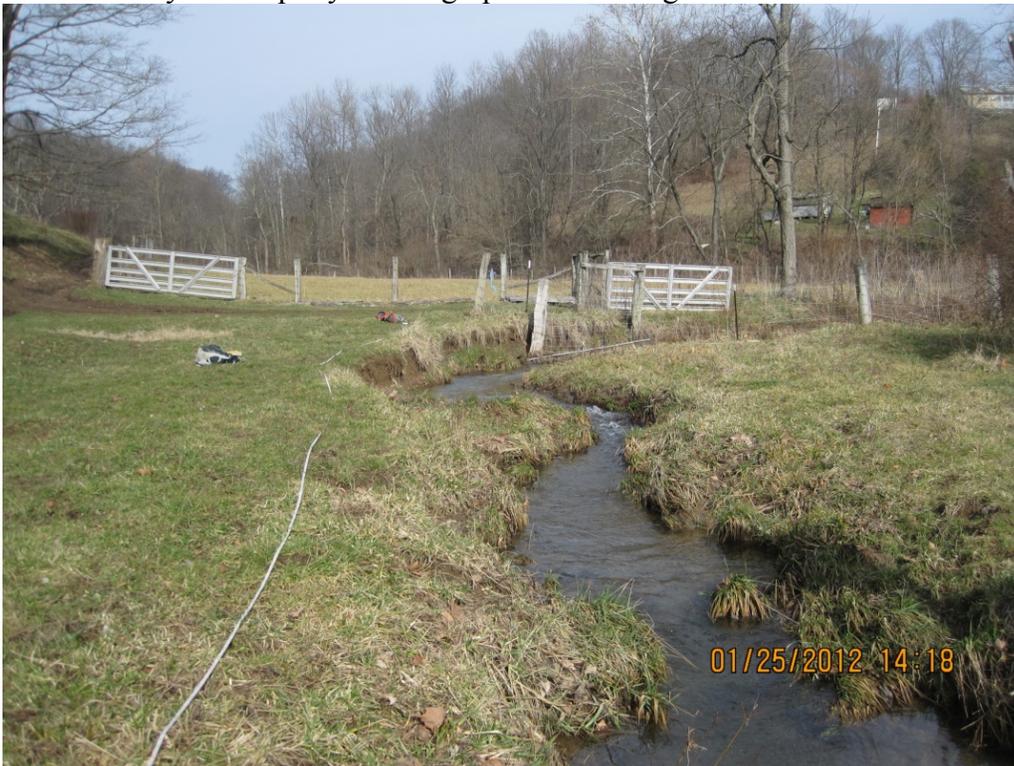
Photograph 18. View of French Run at stream assessment Segment FR-3 on the Lyons Property. Photograph taken facing upstream.

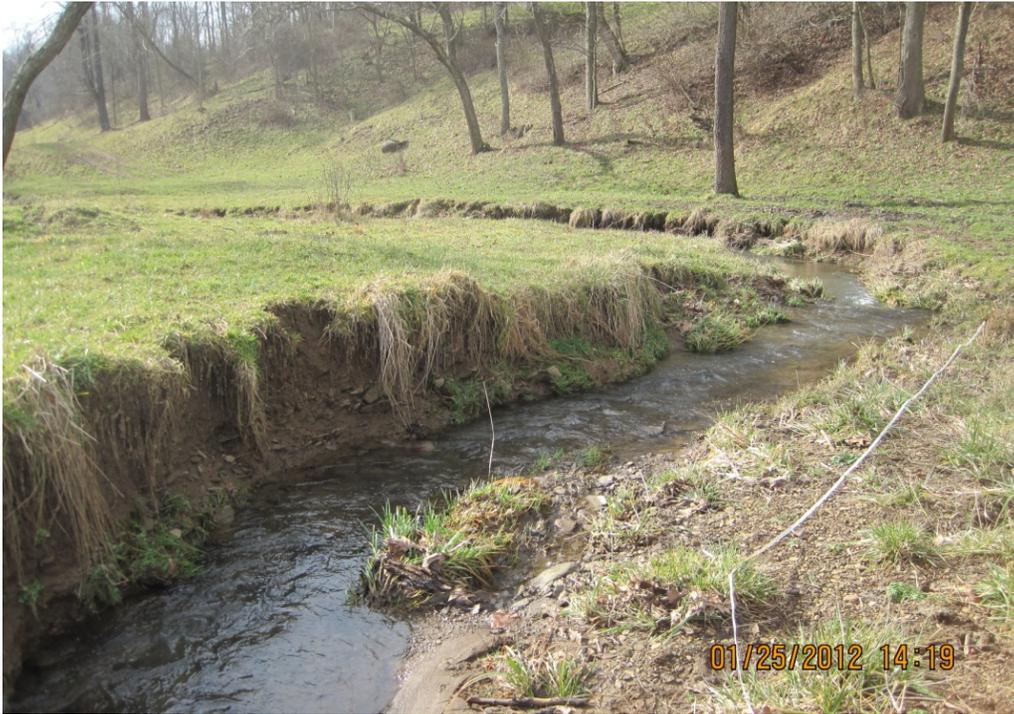
Photograph 19. View of French Run at stream assessment Segment FR-3 on the Lyons Property. Photograph taken facing downstream.

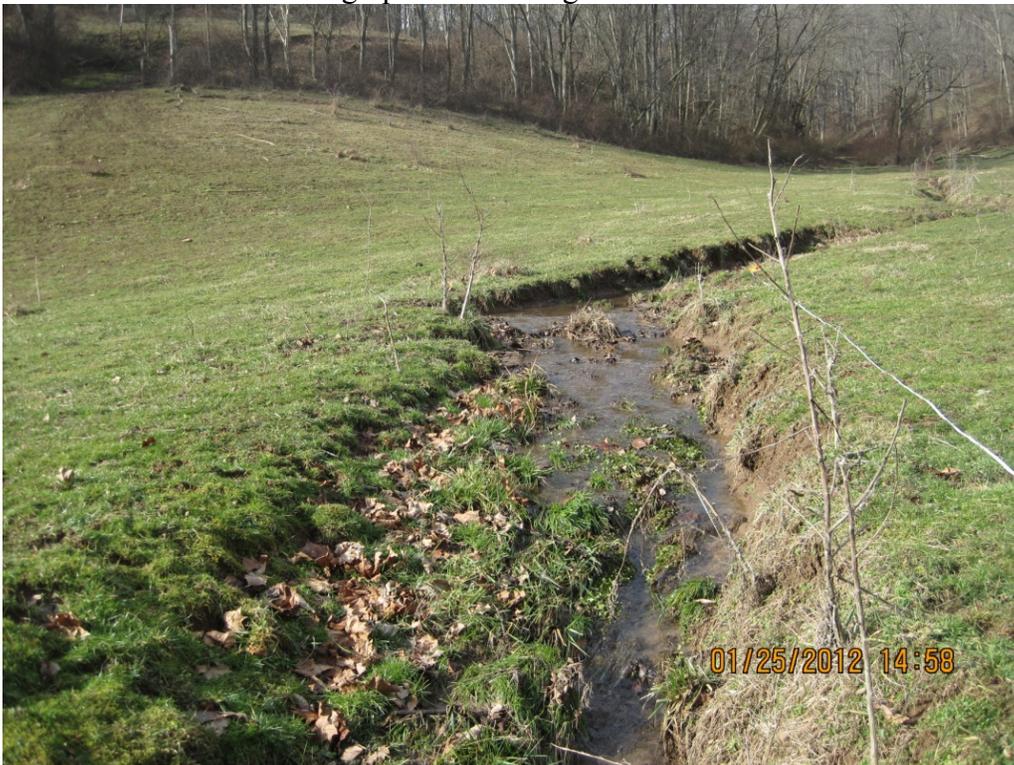
Photograph 20. View of unnamed tributary to French Run (FR-UNT2) at stream assessment Segment FR-4 on the Aston Property. Photograph taken facing upstream.

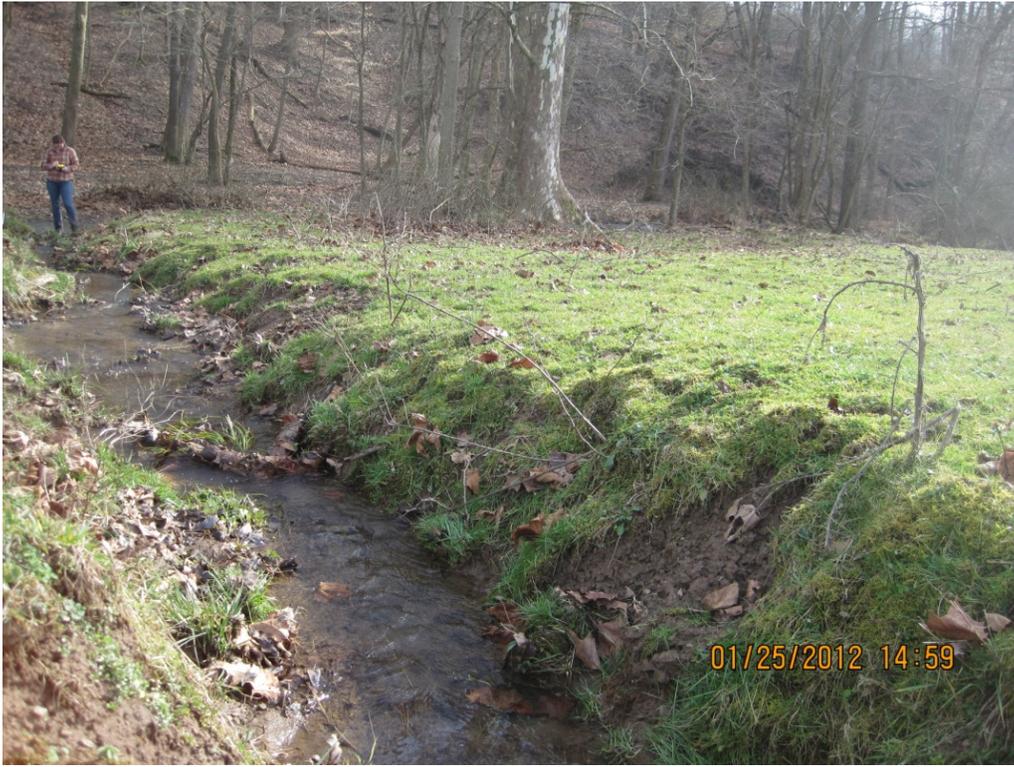
Photograph 21. View of unnamed tributary to French Run (FR-UNT2) at stream assessment Segment FR-4 on the Aston Property. Photograph taken facing downstream.

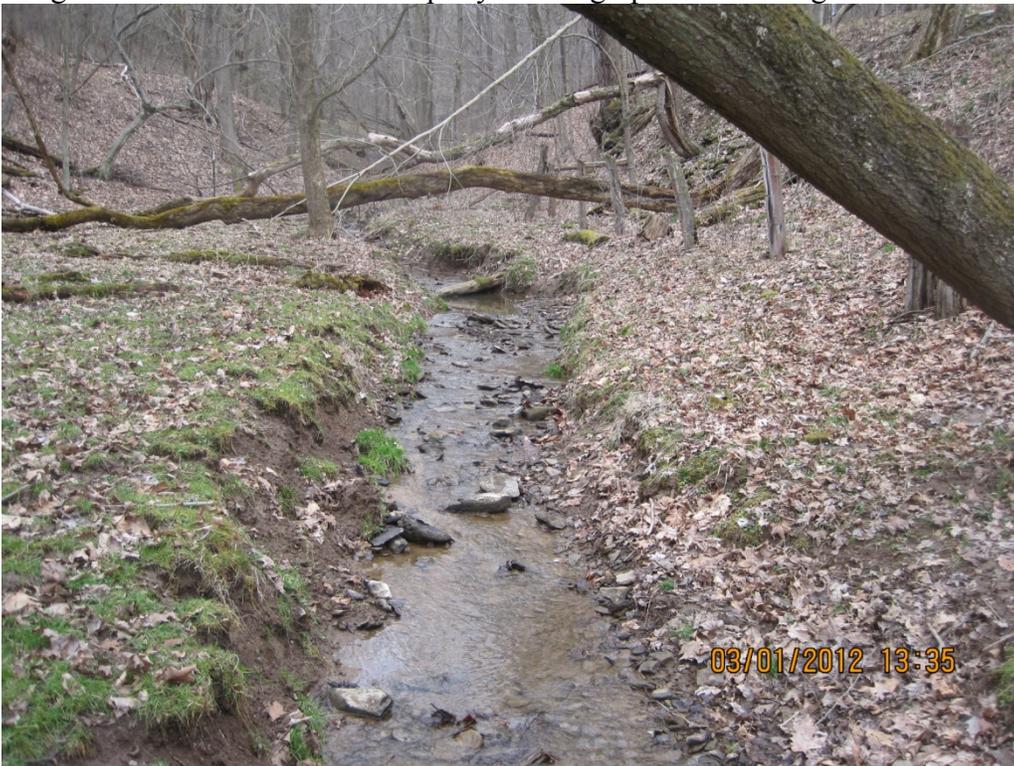
Photograph 22. View of unnamed tributary to French Run (FR-UNT2) upstream of stream assessment Segment FR-4 on the Aston Property. Photograph taken facing upstream.

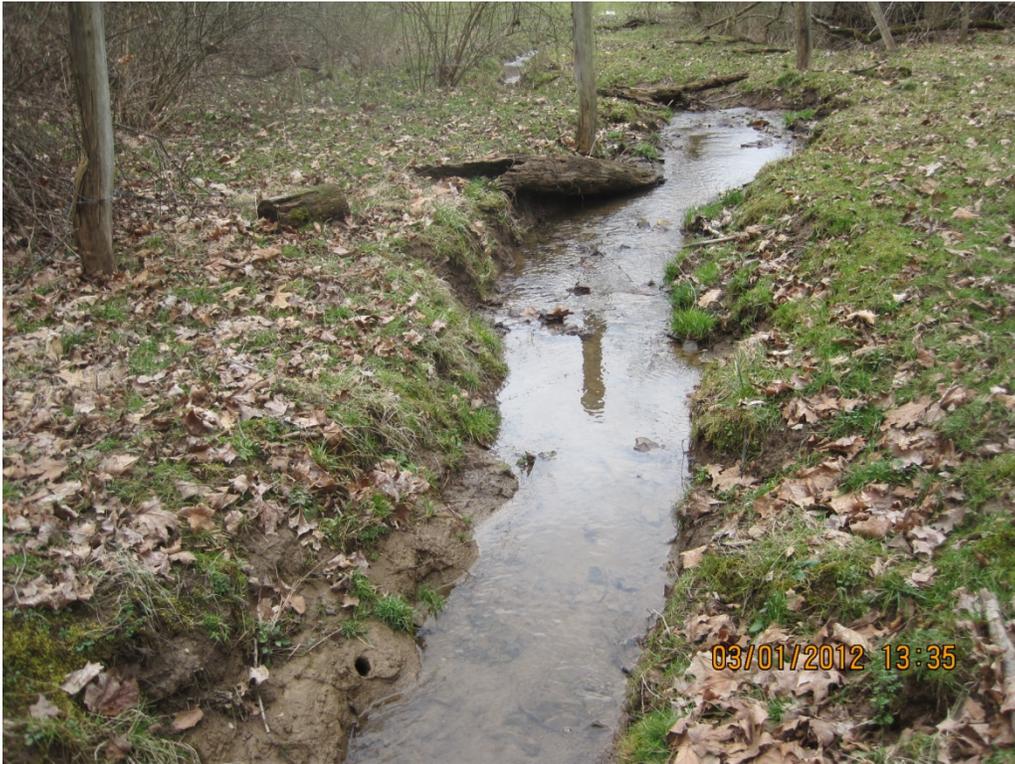
Photograph 23. View of unnamed tributary to French Run (FR-UNT2) upstream of stream assessment Segment FR-4 on the Aston Property. Photograph taken facing downstream.

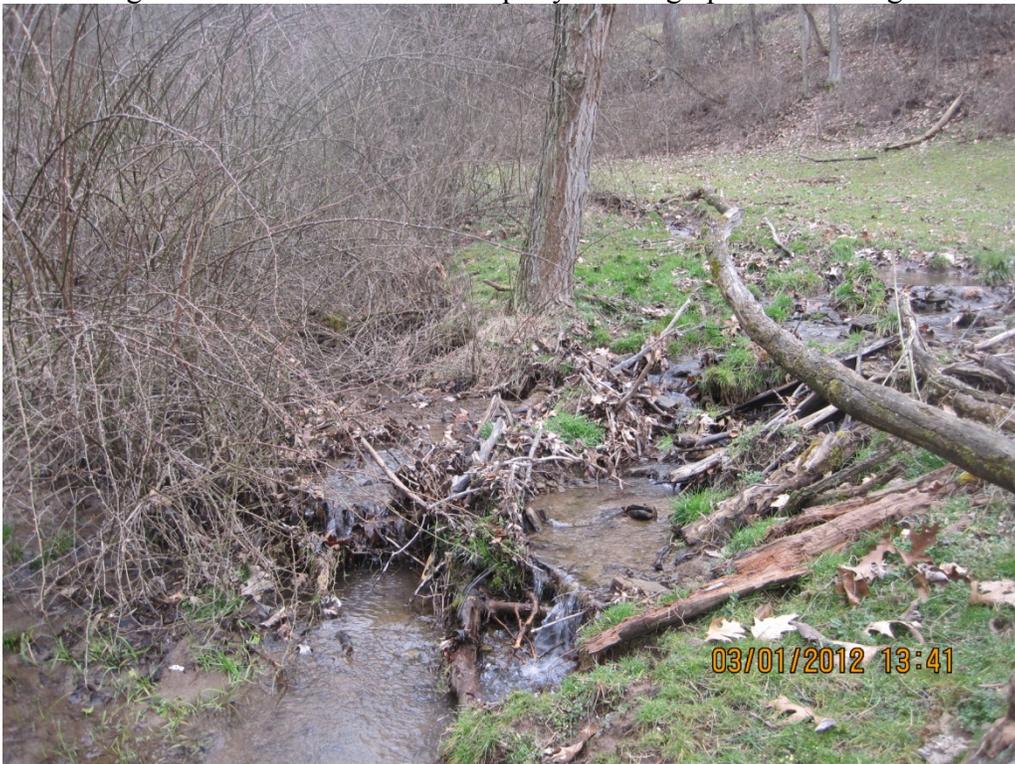
Photograph 24. View of unnamed tributary to French Run (FR-UNT2) upstream of stream assessment Segment FR-4 on the Aston Property. Photograph taken facing upstream.

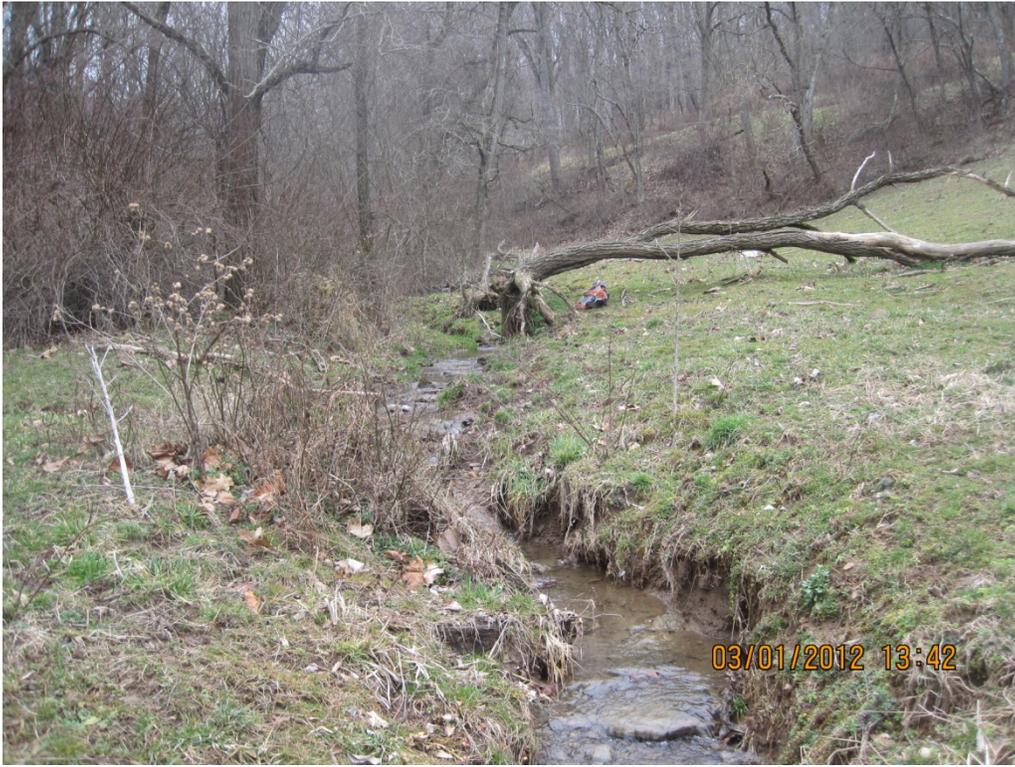
Photograph 25. View of unnamed tributary to French Run (FR-UNT2) upstream of stream assessment Segment FR-4. Photograph taken facing upstream.

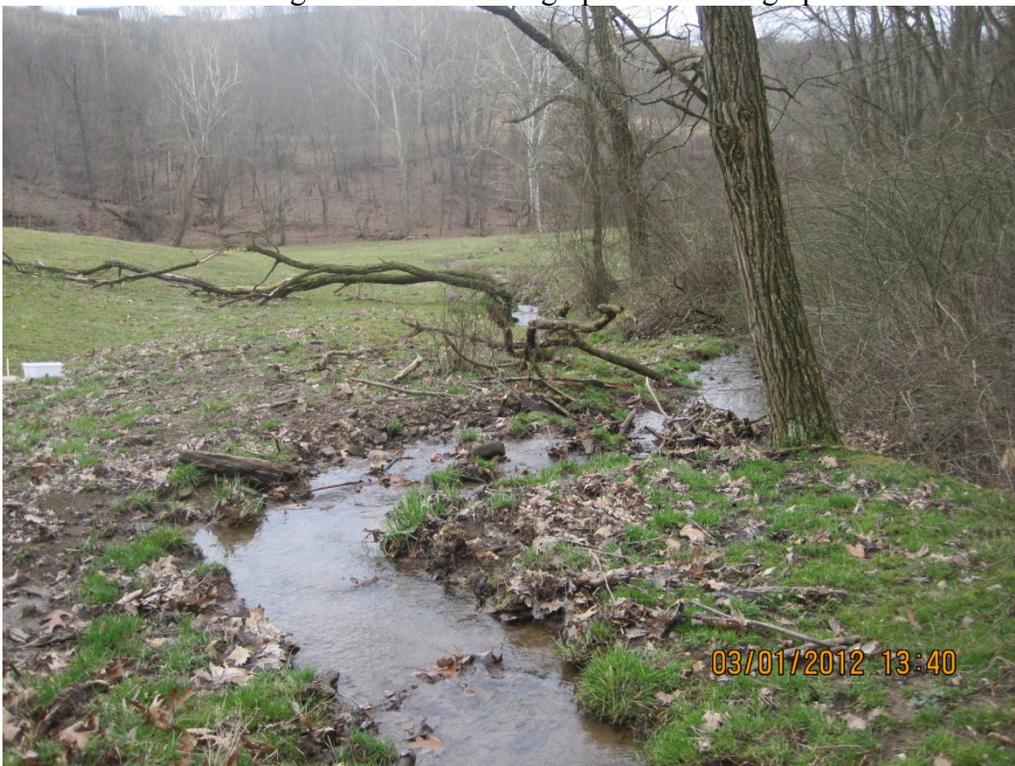
Photograph 26. View of unnamed tributary to French Run (FR-UNT2) upstream of stream assessment Segment FR-4. Photograph taken facing downstream.

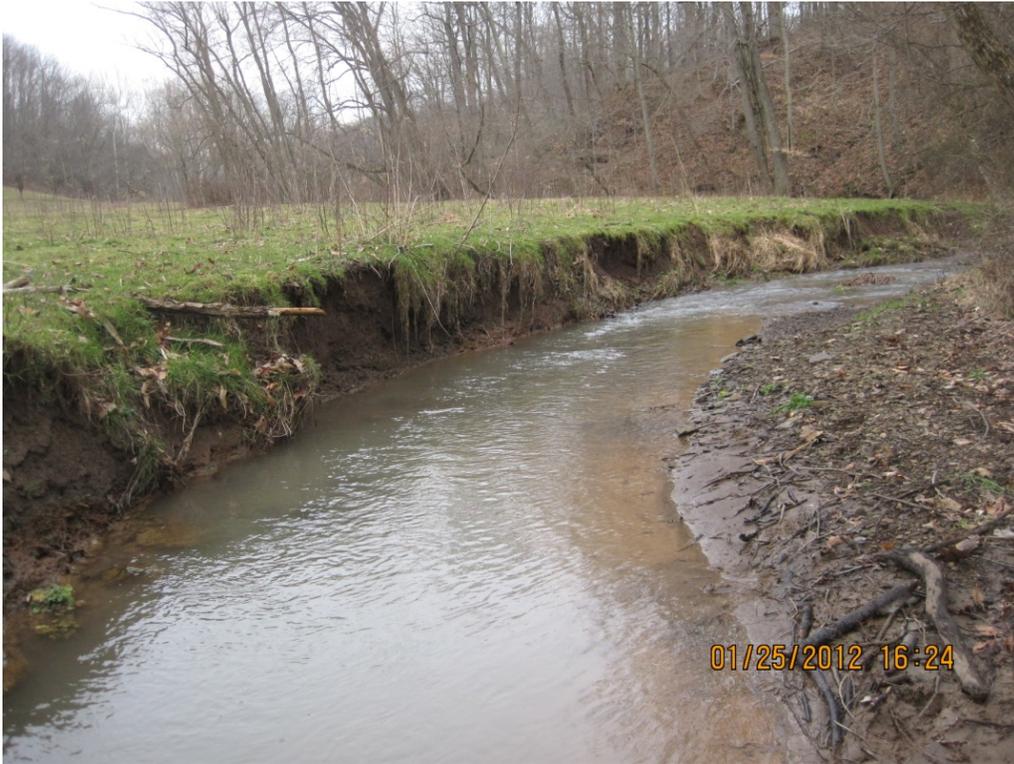
Photograph 27. View of French Run at stream assessment Segment FR-5. Photograph taken facing upstream.

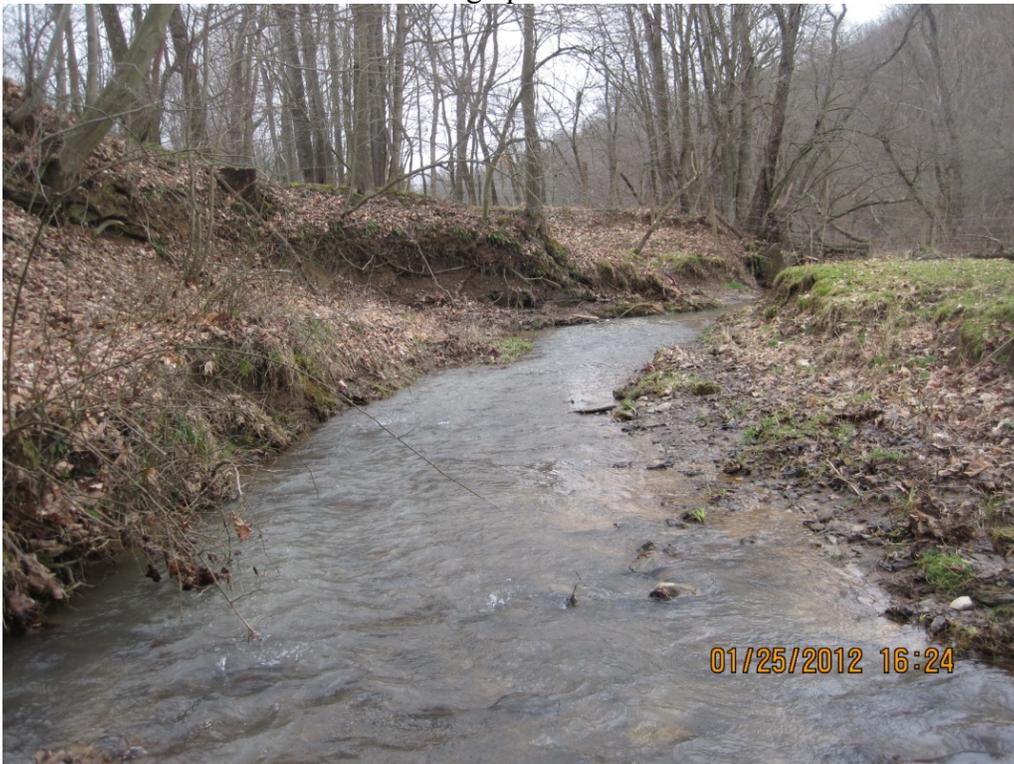
Photograph 27. View of French Run at stream assessment Segment FR-5. Photograph taken facing downstream.

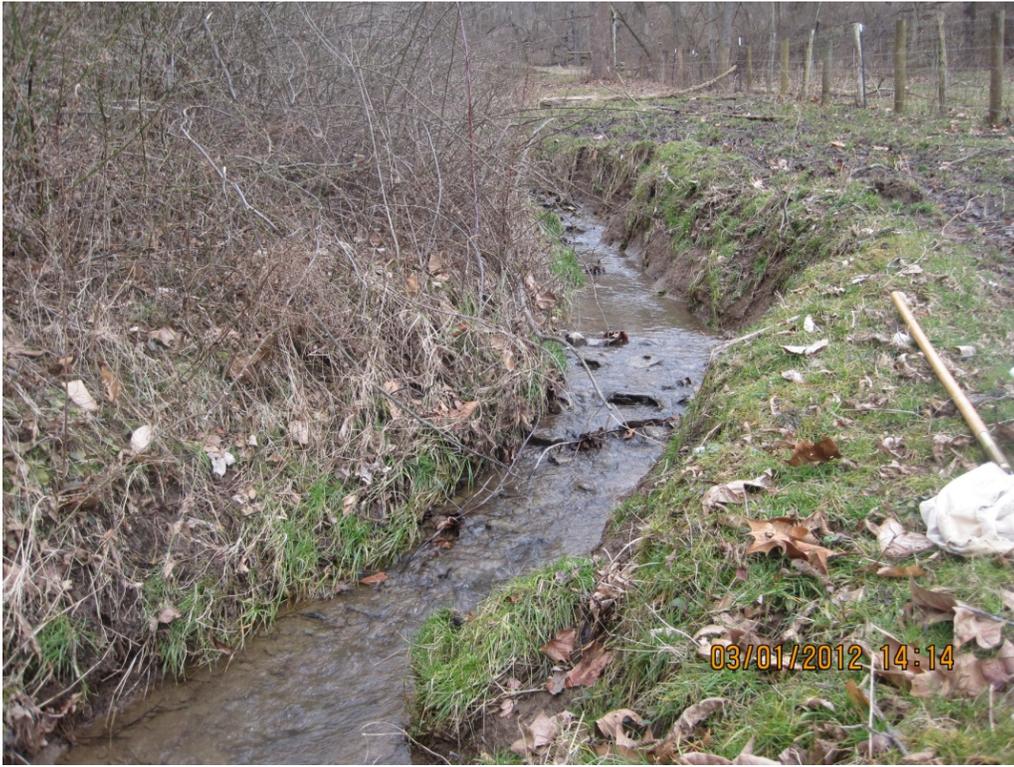
Photograph 28. View of unnamed tributary to French Run (FR-UNT3) at stream assessment Segment FR-7. Photograph taken facing upstream.

Segment FR-7 of Stream FR-UNT3 was characterized by an OHWM width of approximately 4 feet and a bankfull width of approximately 7 feet. Water filled about 80 percent of the channel. Approximately 90 percent of the channel is deeply incised and 10 percent of the channel substrate was hardpan. An approximate 3 foot drop in channel elevation within the sampling segment was observed approximately 100 feet upstream of its confluence with French Run. The substrates of this section consisted of hardpan, gravel, cobble, silt, boulders, and sand. Leaf litter/woody debris covered approximately 10 percent of the channel. The USEPA Low Gradient Stream score for this section of FR-UNT3 was 91/marginal. The SCI score was 38/suboptimal.

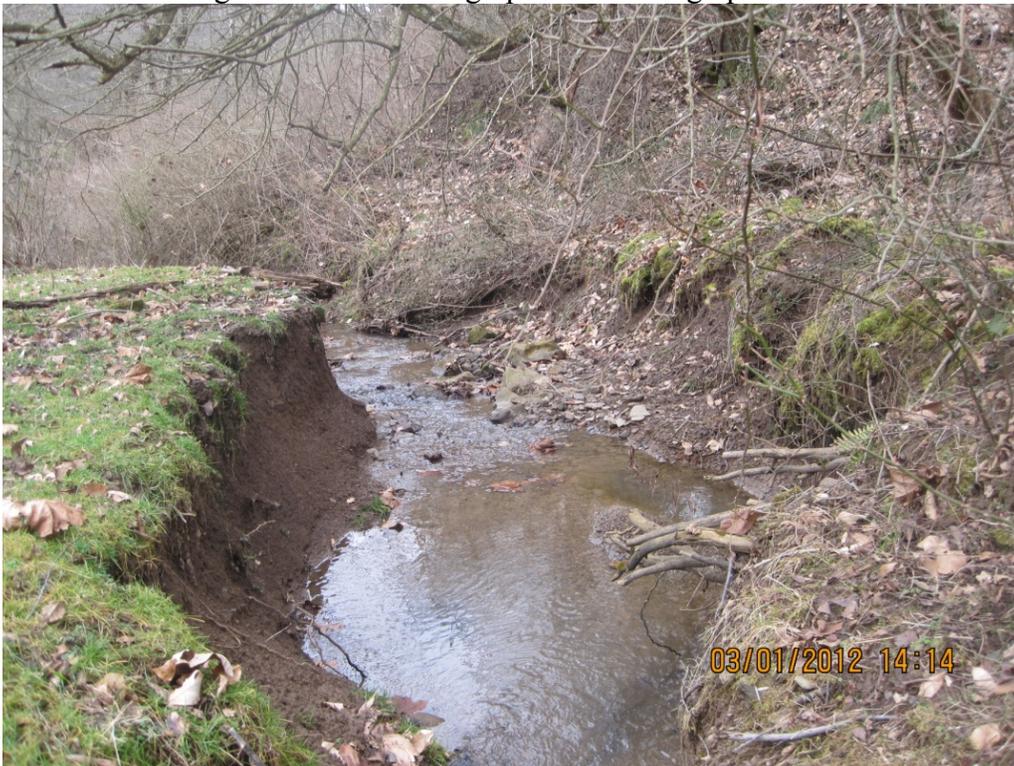
Photograph 29. View of unnamed tributary to French Run (FR-UNT3) at stream assessment Segment FR-7. Photograph taken facing downstream.

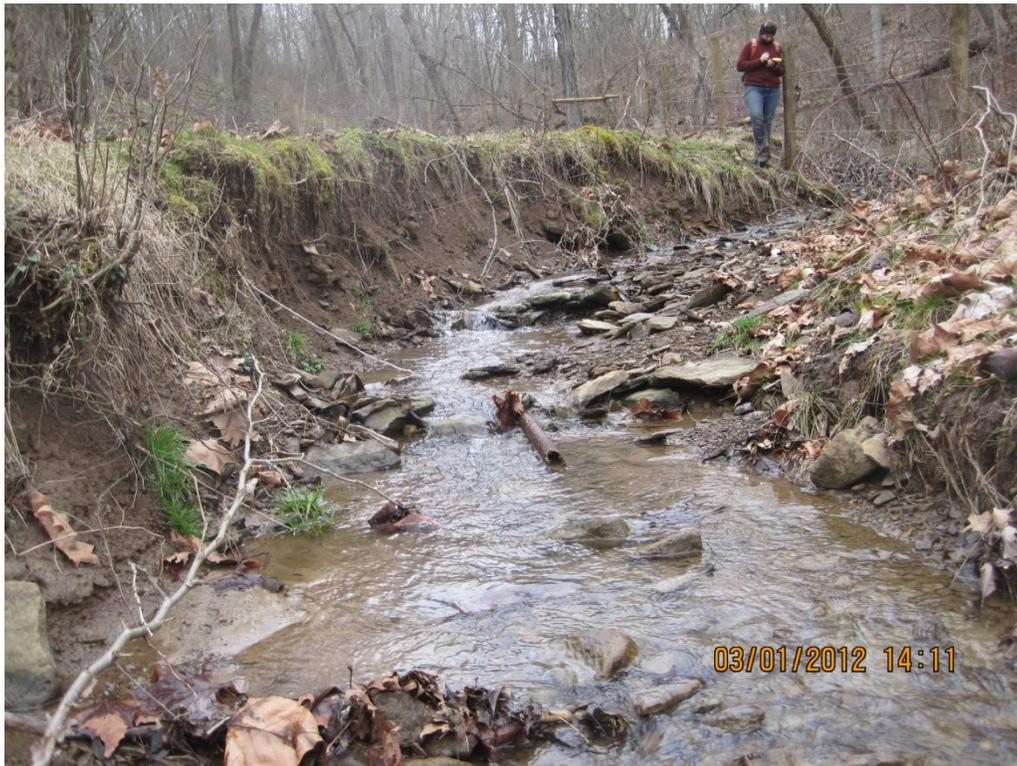
Photograph 30. View of unnamed tributary to French Run (FR-UNT3) on the Hall Property upstream of stream assessment Segment FR-7. Photograph taken facing downstream.

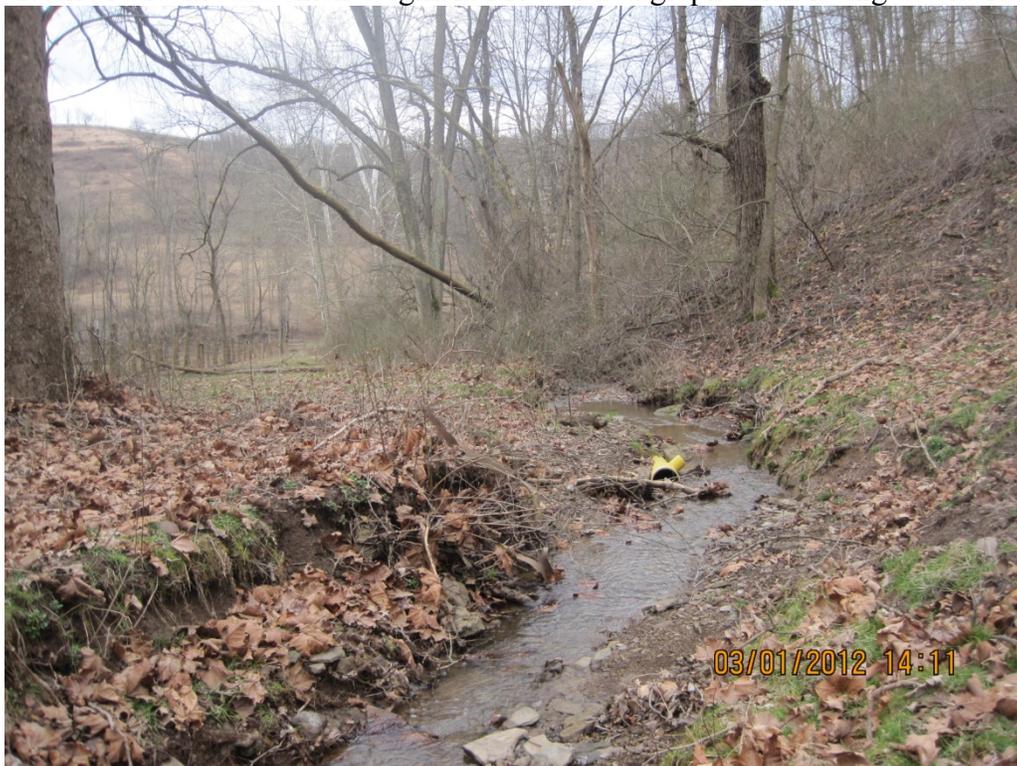
Photograph 31. View of unnamed tributary to French Run (FR-UNT3) on the Hall Property upstream of stream assessment Segment FR-7. Photograph taken facing downstream.

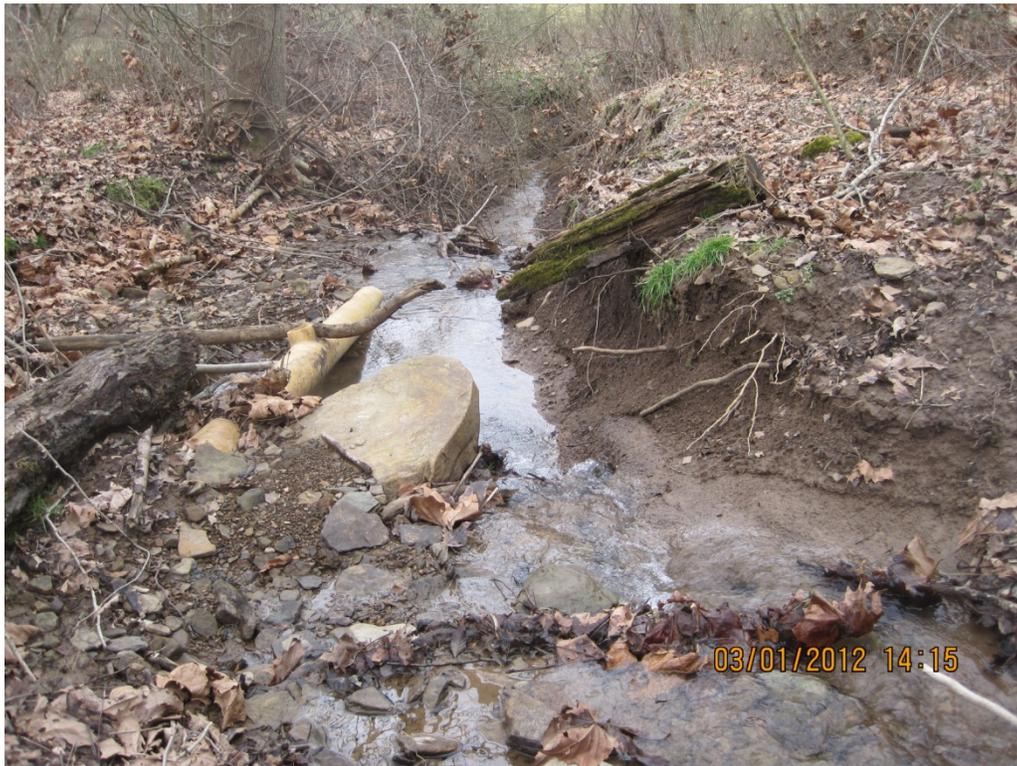
Photograph 32. View of unnamed tributary to French Run (FR-UNT3) on the Hall Property at stream assessment Segment FR-7. Photograph taken facing downstream.

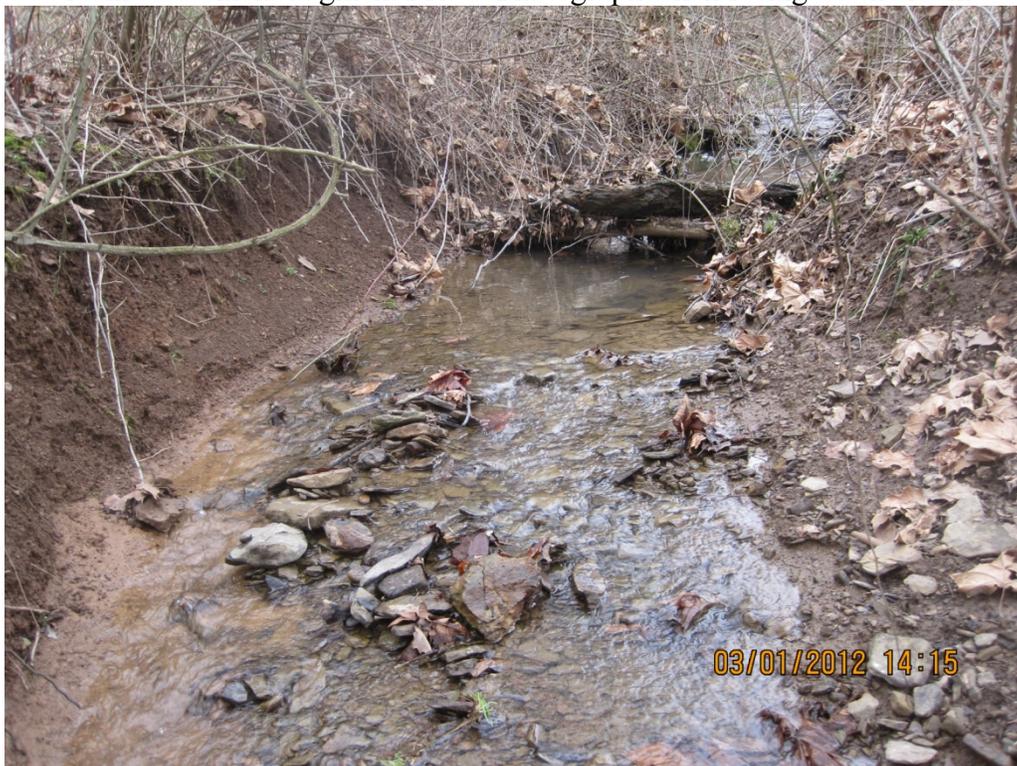
Photograph 33. View of unnamed tributary to French Run (FR-UNT3) on the Hall Property at stream assessment Segment FR-7. Photograph taken facing upstream.

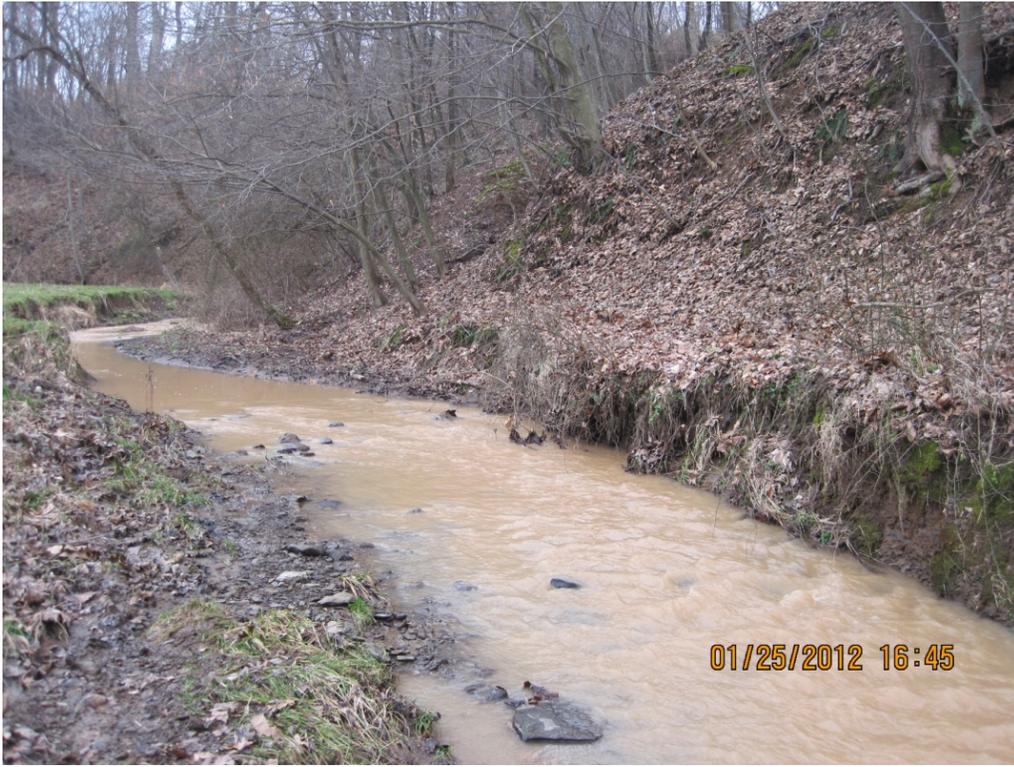
Photograph 34. View of sediment laden runoff within French Run at stream assessment Segment FR-5. Photograph taken facing upstream.

The results of the biological assessment indicate that French Run located within the Hall Property minimally supports benthic macroinvertebrate, stream salamander, and fish communities. No fish were observed during the sampling event. Larval northern dusky salamanders were observed within the sample reach. Benthic macroinvertebrate families observed within the Segment FR-5 sample reach consisted of flatheaded mayflies, patterned

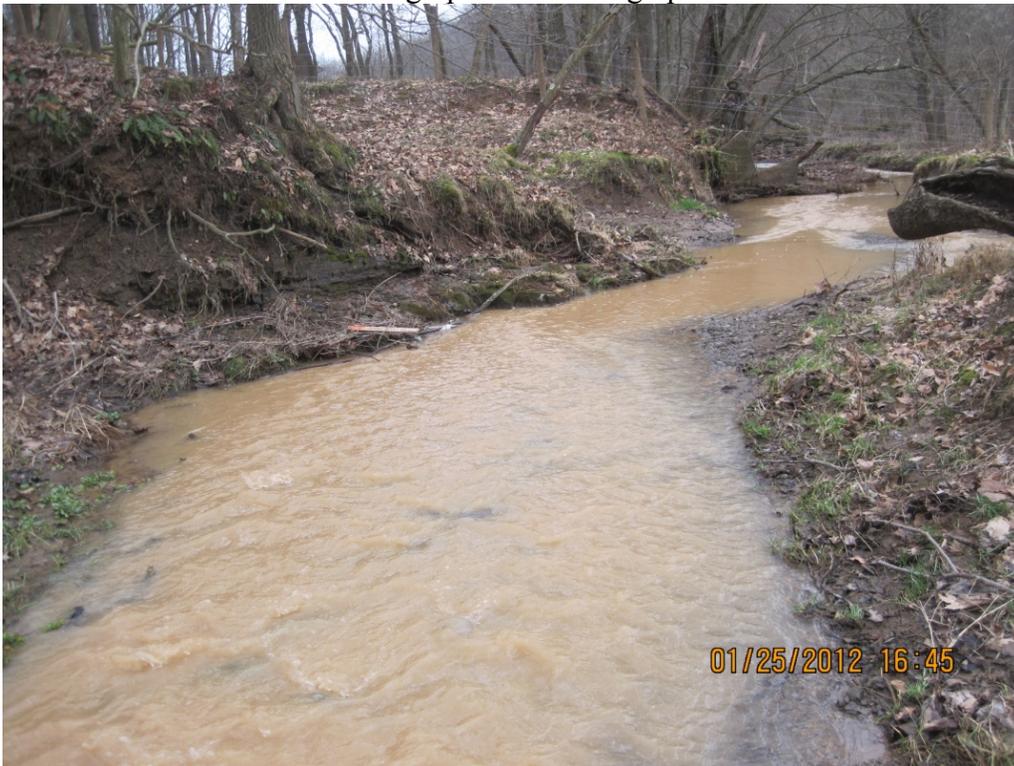
Photograph 35. View of sediment laden runoff within French Run at stream assessment Segment FR-5. Photograph taken facing downstream.

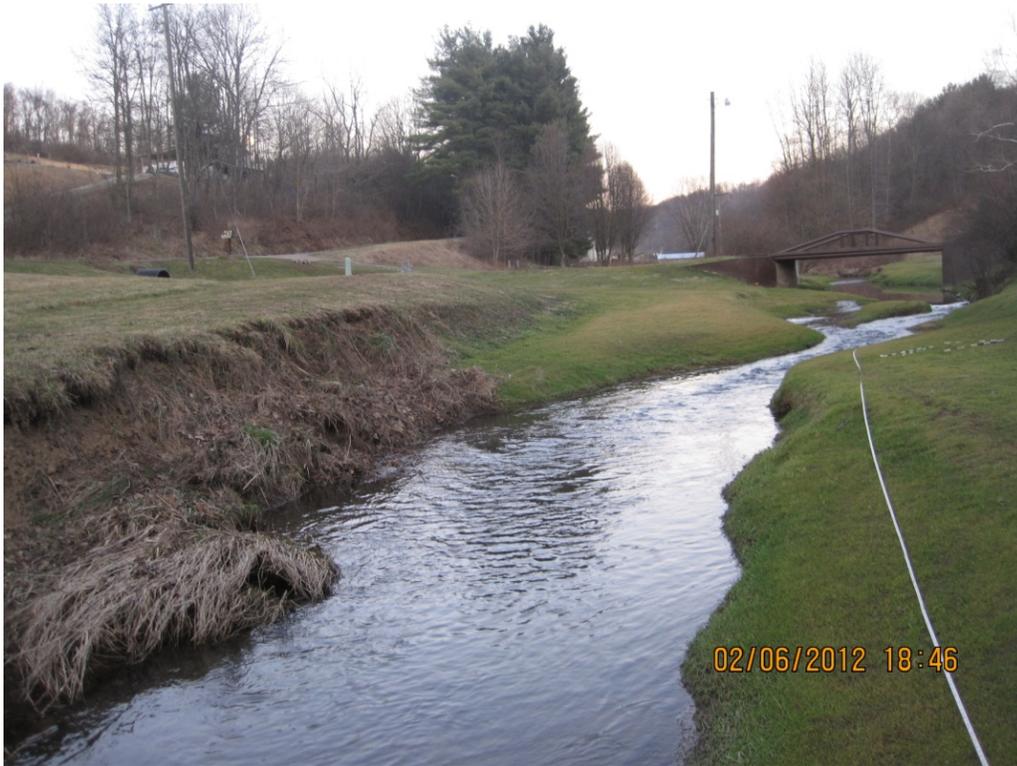
Photograph 1. View of North Fork Grave Creek within the Hackathorn Property at stream assessment Segment NFGC-1. Photograph taken facing upstream.

The section of North Fork Grave Creek within the Hackathorn/Robinson Properties was characterized by an OHWM width of approximately 8.5 feet and a bankfull width of approximately 10 feet. Water filled approximately 100 percent of the channel. The substrates of Segment NFGC-1 consisted of cobble, gravel, boulders, and sand. Very little leaf litter/woody debris was observed within the sampled stream segment. Mr. Hackathorn stated he removes leaf litter and woody debris frequently. The USEPA Low Gradient Stream score for this section of North Fork Grave Creek was 92/marginal. The SCI score was 22/poor.

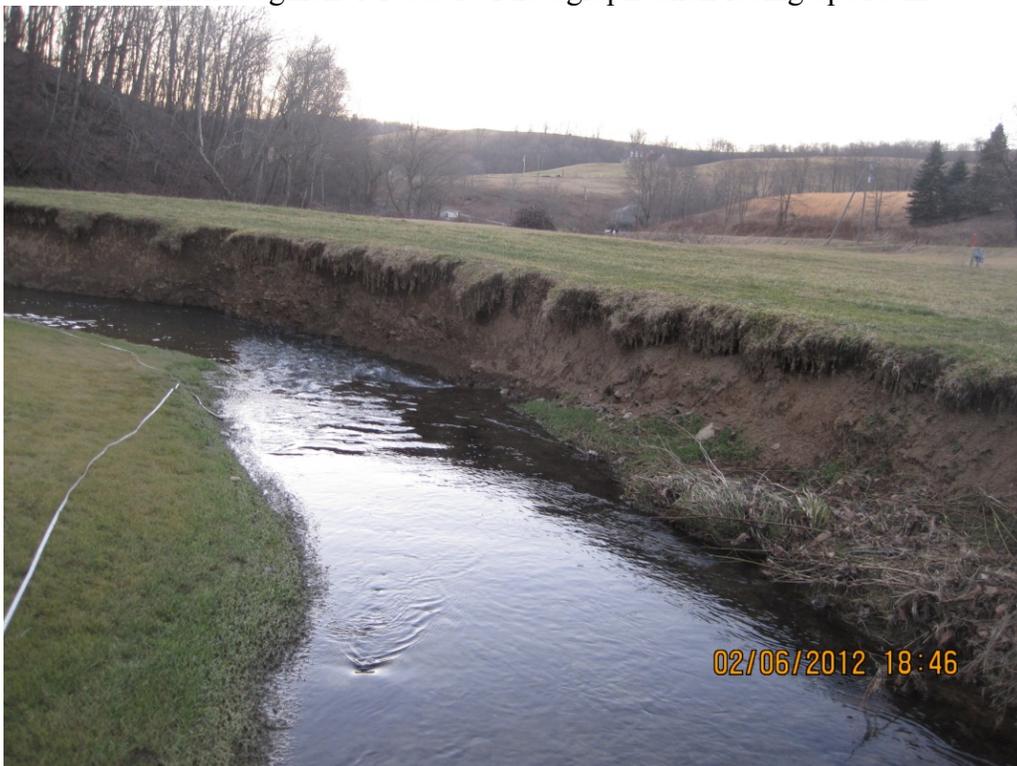
Photograph 2. View of North Fork Grave Creek within the Hackathorn Property at stream assessment Segment NFGC-1. Photograph taken facing downstream.

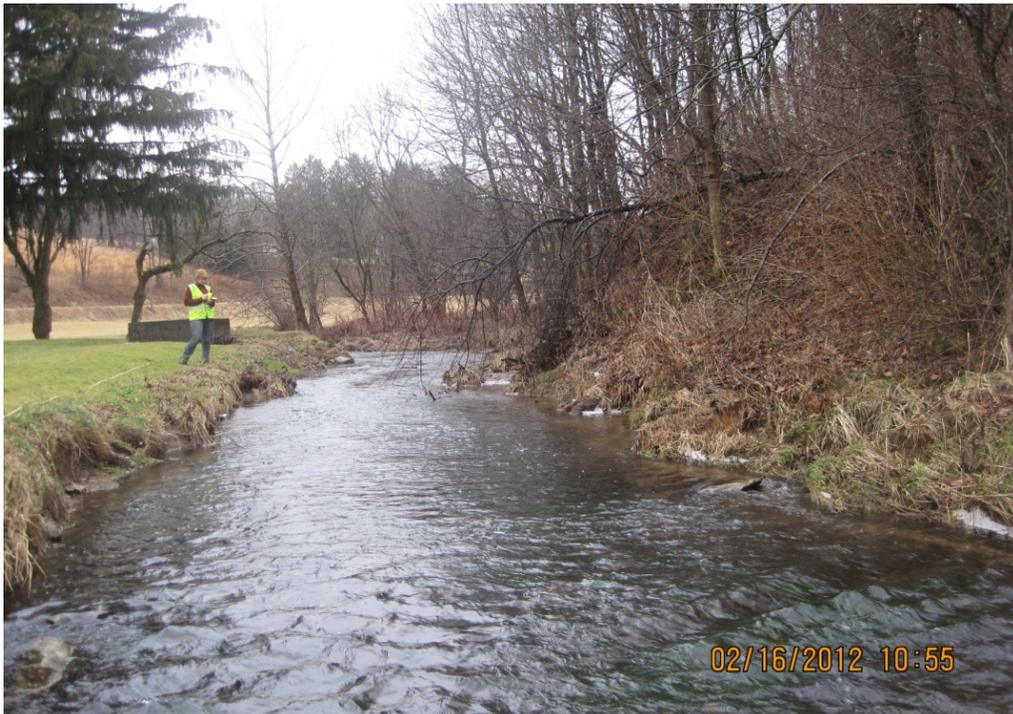
Photograph 3. View of North Fork Grave Creek within the Cumpston Property at stream assessment Segment NFGC-3. Photograph taken facing upstream.

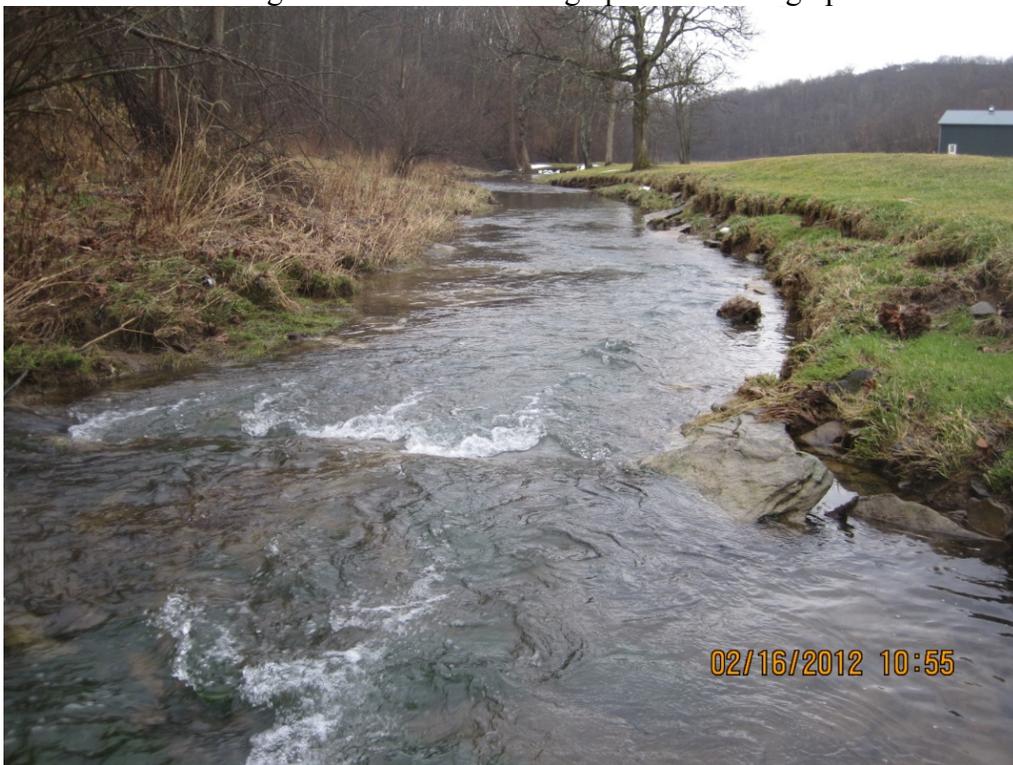
Photograph 4. View of North Fork Grave Creek within the Cumpston Property at stream assessment Segment NFGC-3. Photograph taken facing downstream.

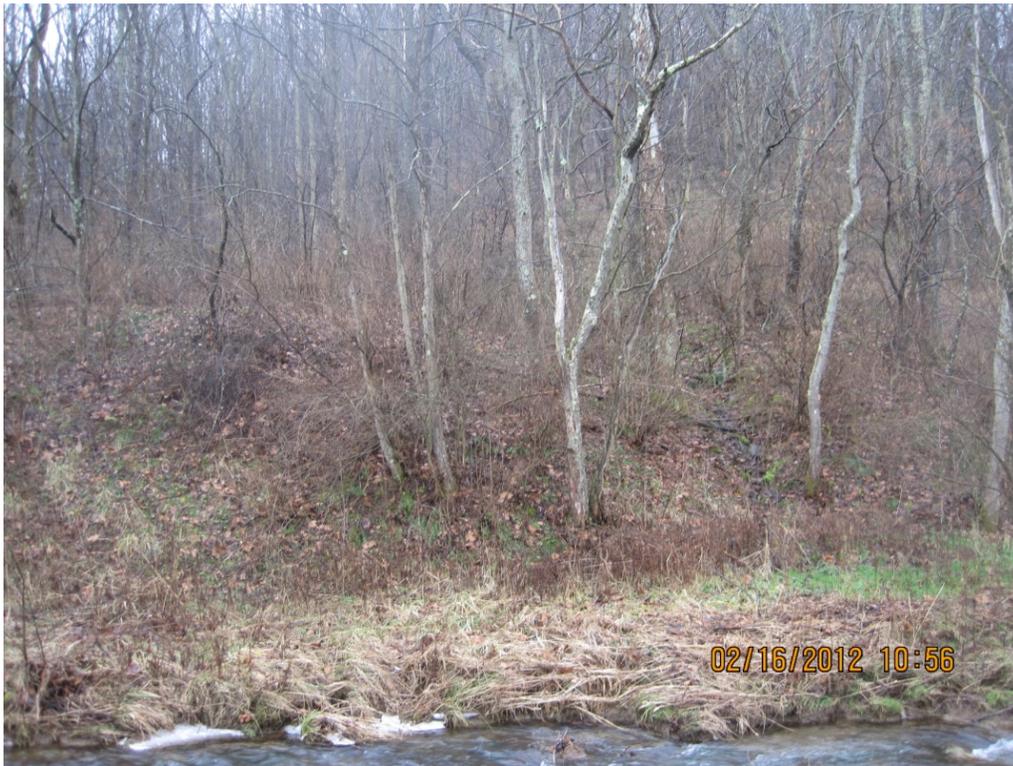
Photograph 5. View of the left/descending bank of North Fork Grave Creek within the Cumpston Property at stream assessment Segment NFGC-3. Photograph taken facing south.

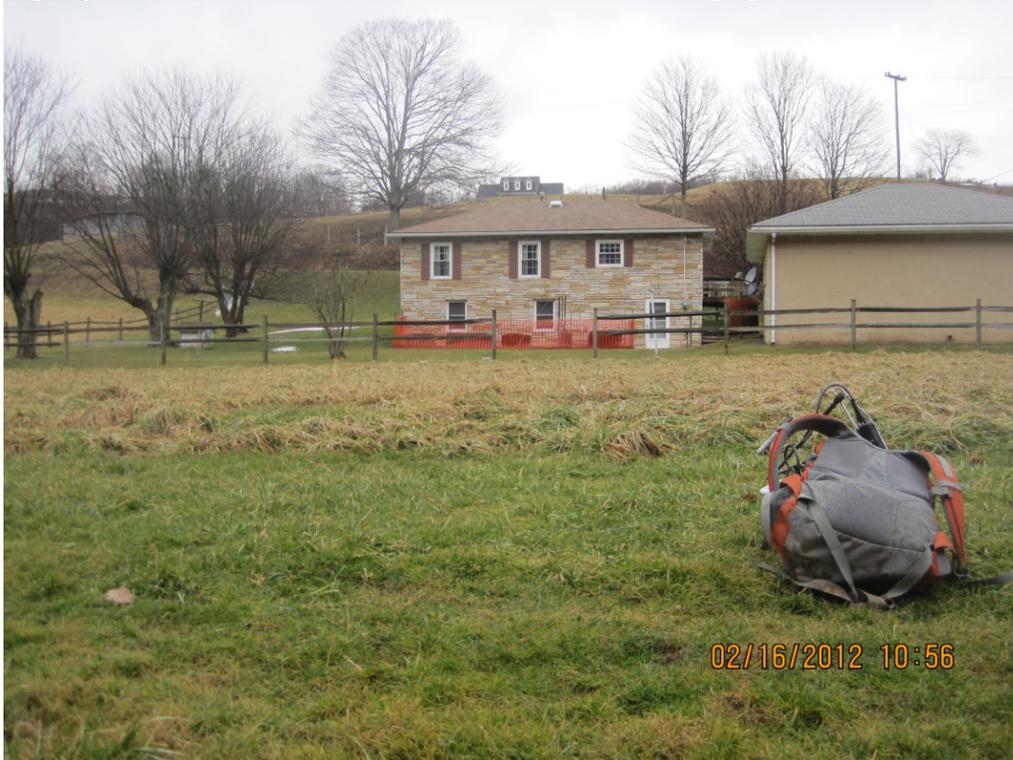
Photograph 6. View of the right/descending bank of North Fork Grave Creek within the Cumpston Property at stream assessment Segment NFGC-3. Photograph taken facing north.
