CONCEPTUAL MITIGATION PLAN

AMERICAN ELECTRIC POWER CO., INC.
PROPOSED MITCHELL LANDFILL PROJECT
CRESAP, MARSHALL COUNTY, WEST VIRGINIA

CIVIL & ENVIRONMENTAL CONSULTANTS, INC.
CINCINNATI, OHIO

April 26, 2012

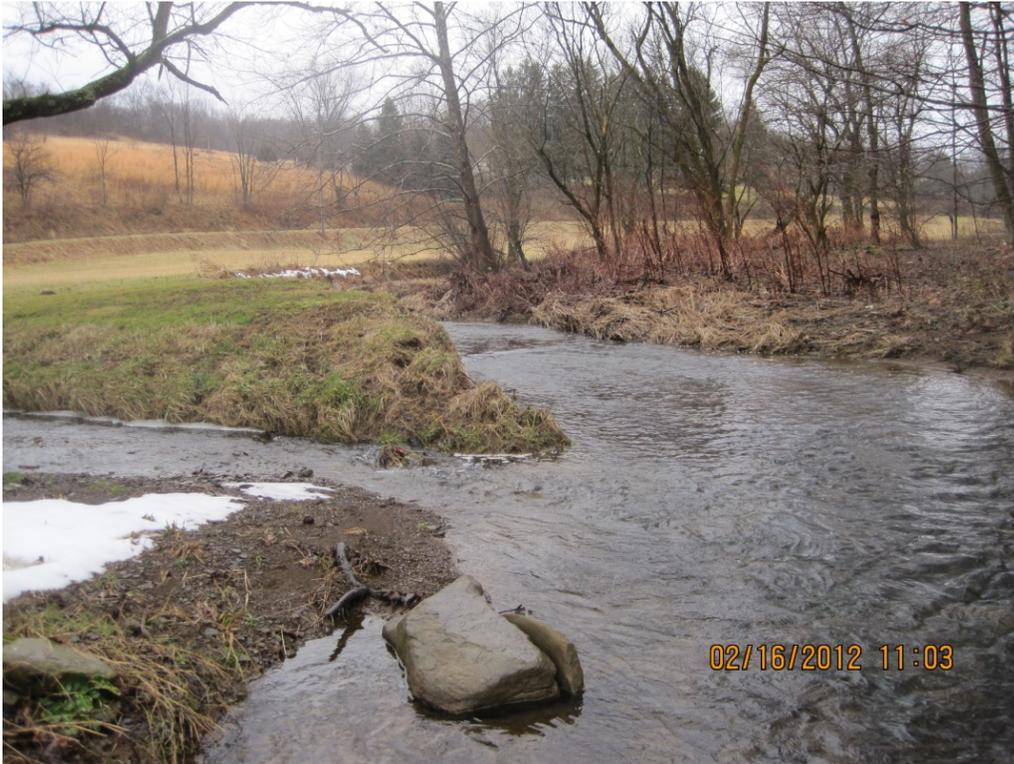
Photograph 7. View of the confluence of unnamed tributary to North Fork Grave Creek (NFGC-UNT1) and North Fork Grave Creek within the Cumpston Property. Photograph taken facing upstream above stream assessment Segment NFGC-3.

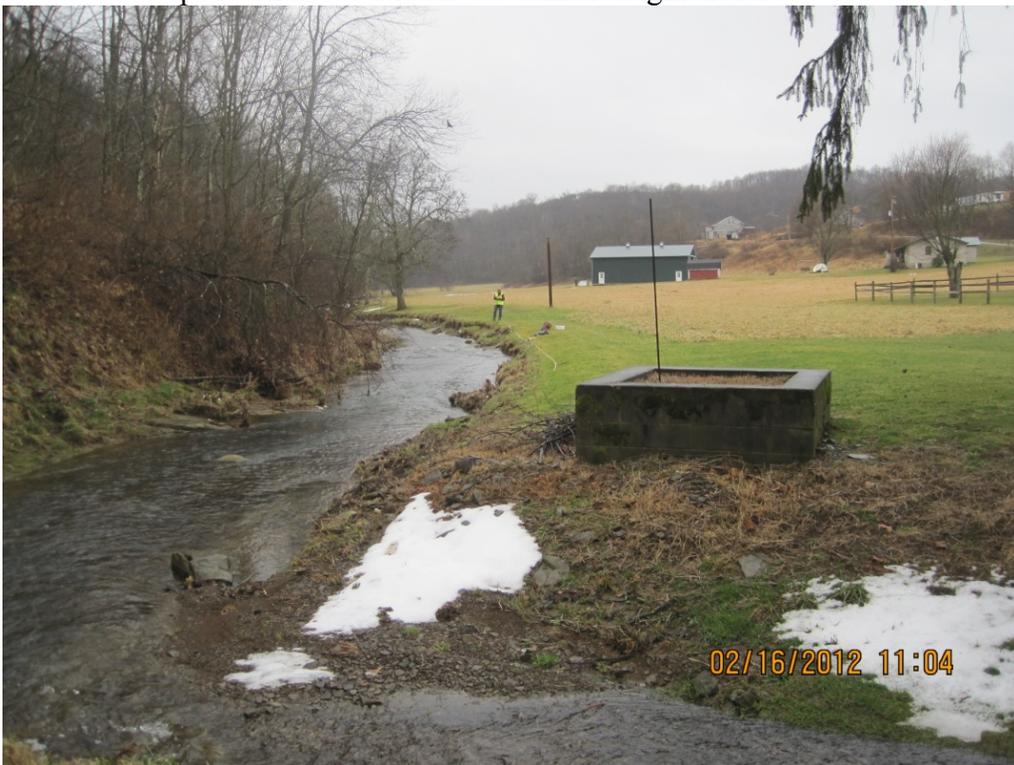
Photograph 8. View of confluence of unnamed tributary to North Fork Grave Creek (NFGC-UNT1) and North Fork Grave Creek within the Cumpston Property. Photograph taken facing downstream above stream assessment Segment NFGC-3.

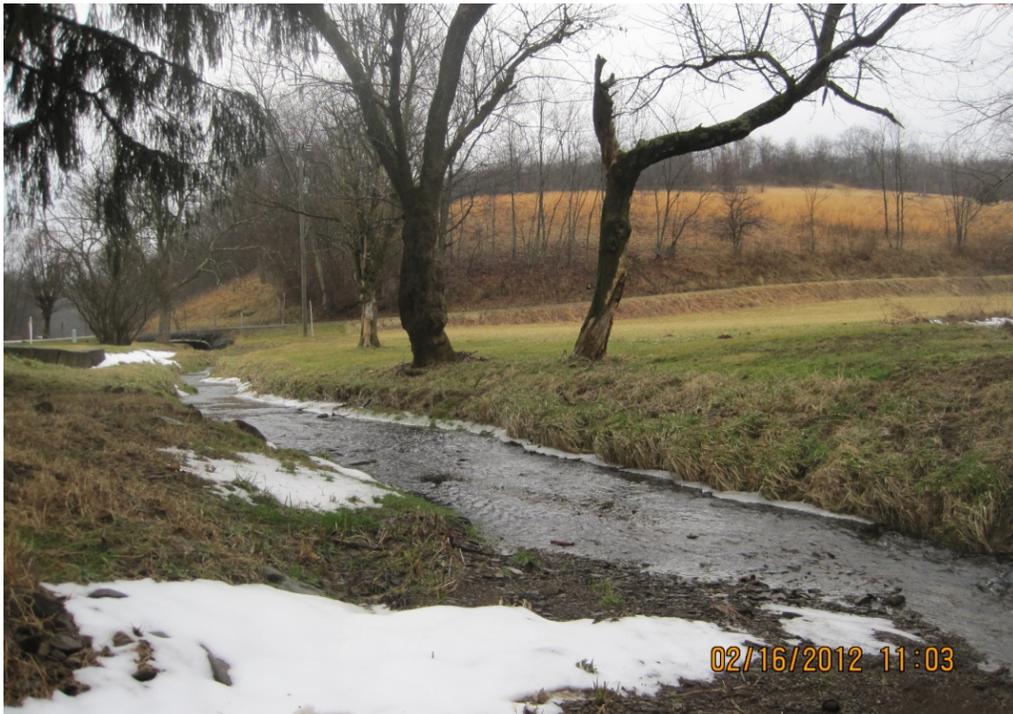
Photograph 9. View of unnamed tributary to North Fork Grave Creek (NFGC-UNT1) within the Cumpston Property. Photograph taken facing upstream.

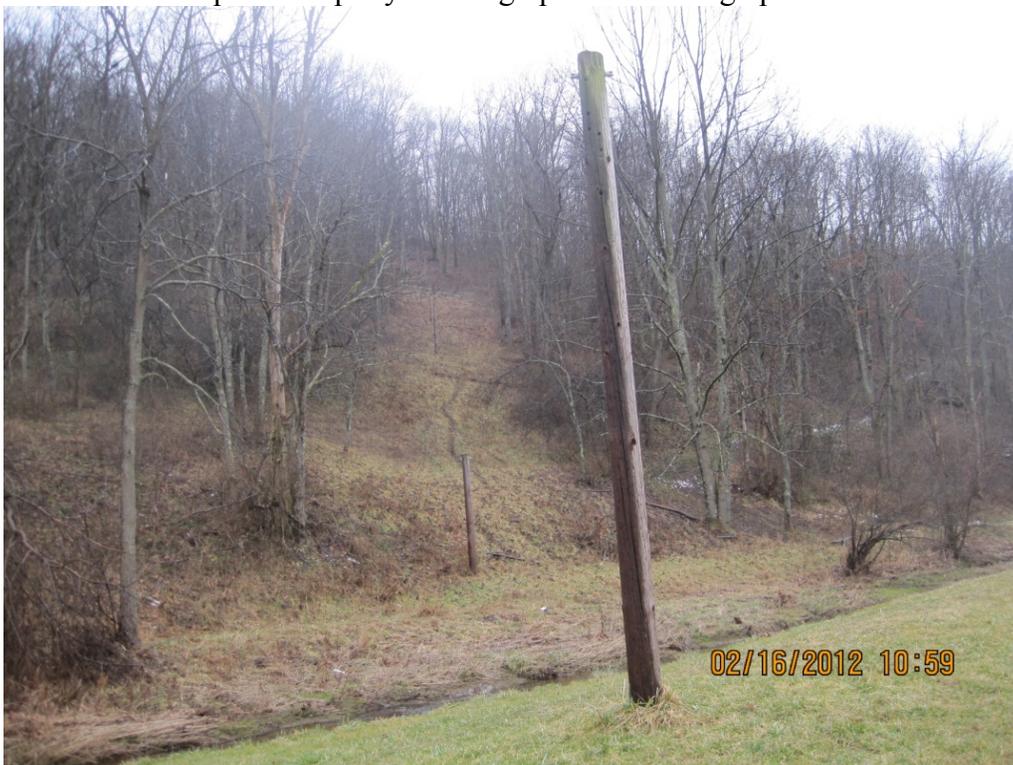
Photograph 10. View of powerline right-of-way crossing North Fork Grave Creek on the Cumpston Property. Photograph taken facing south.

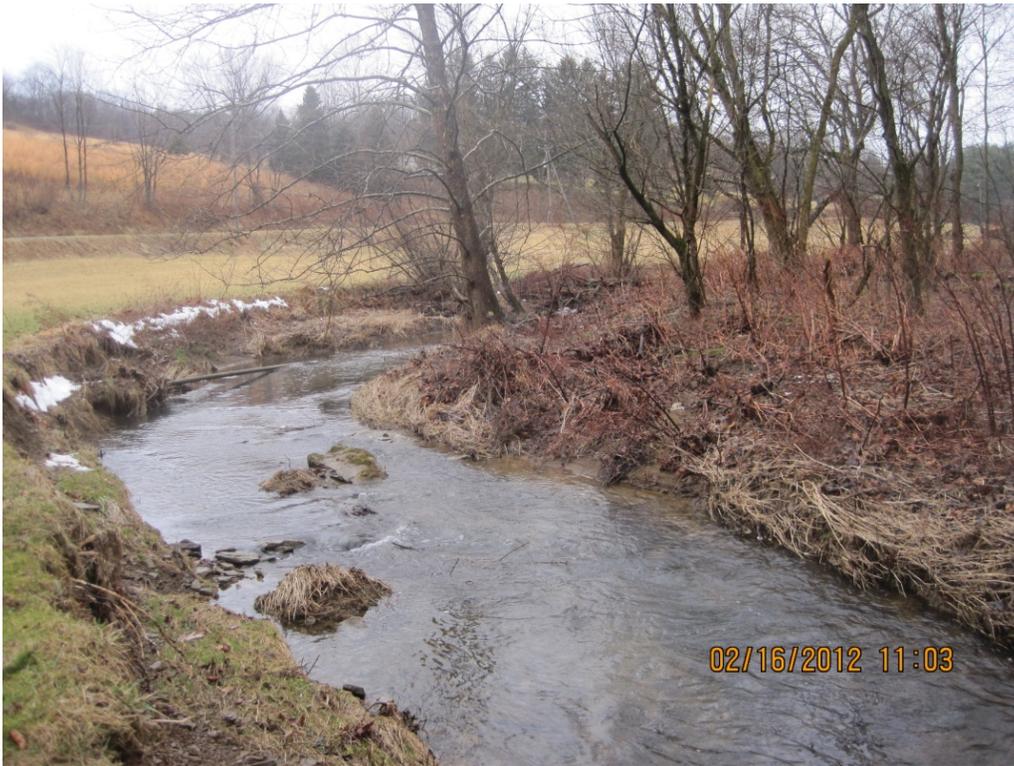
Photograph 11. View of North Fork Grave Creek at the Hackathorn/Cumpston Property line. Photograph taken facing upstream.

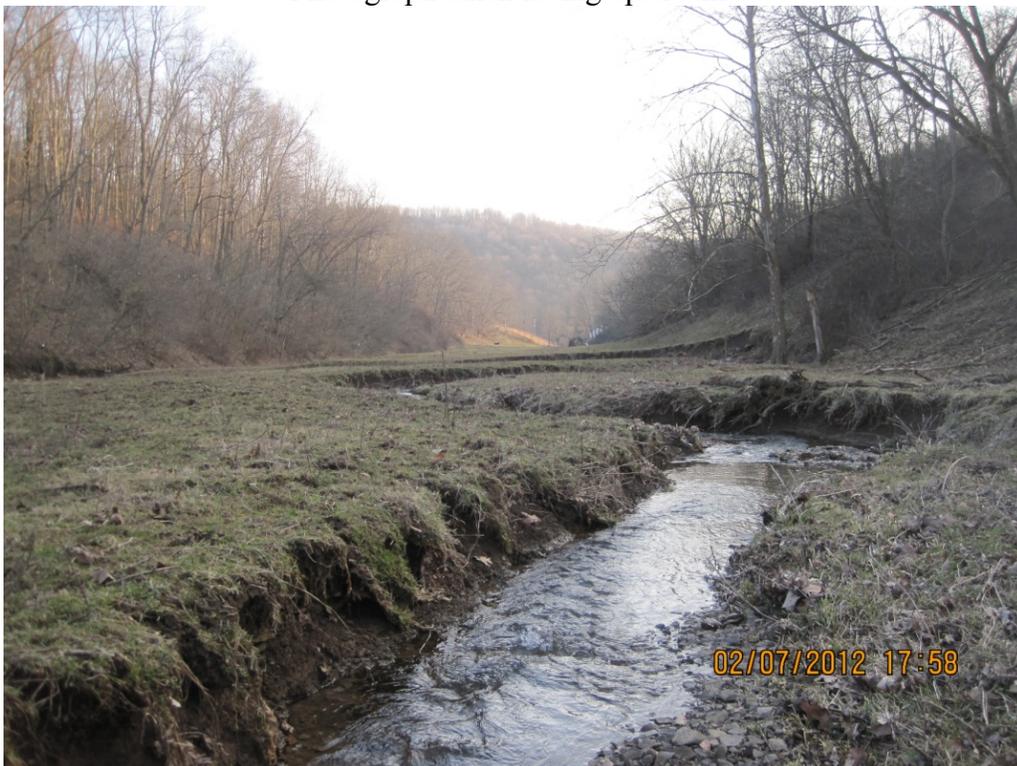
Photograph 12. View of unnamed tributary to North Fork Grave Creek (NFGC-UNT1) within open pasture on the Cumpston Property. Photograph taken facing downstream.

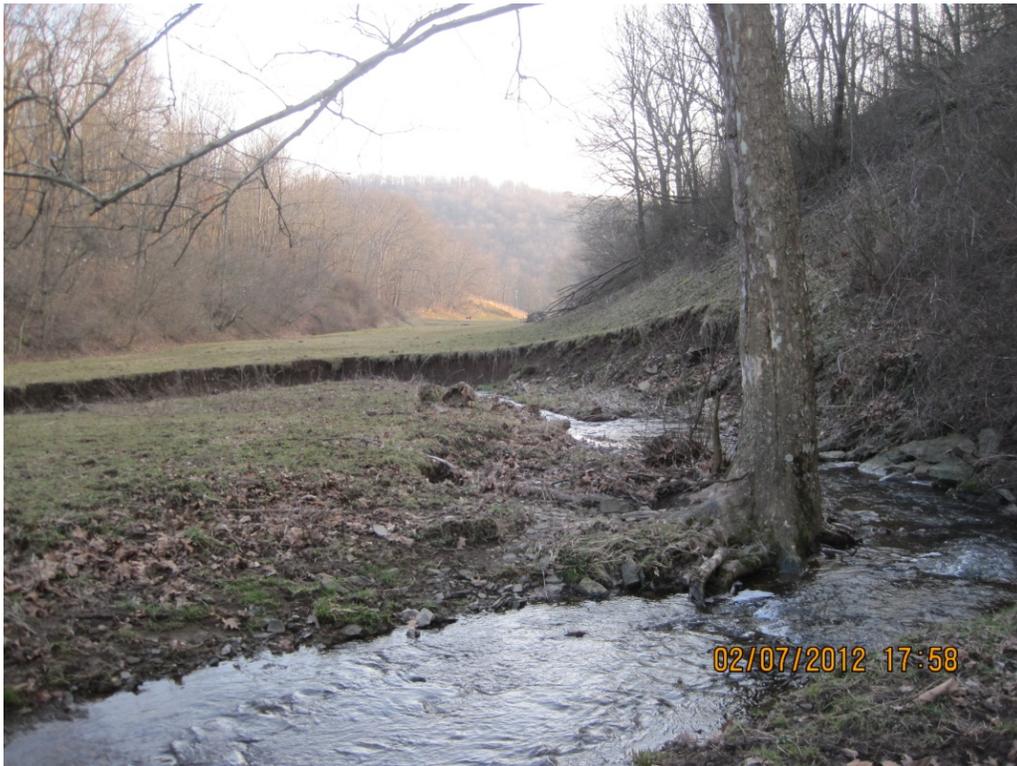
Photograph 13. View of unnamed tributary to North Fork Grave Creek (NFGC-UNT1) within open pasture on the Cumpston Property. Photograph taken facing downstream.

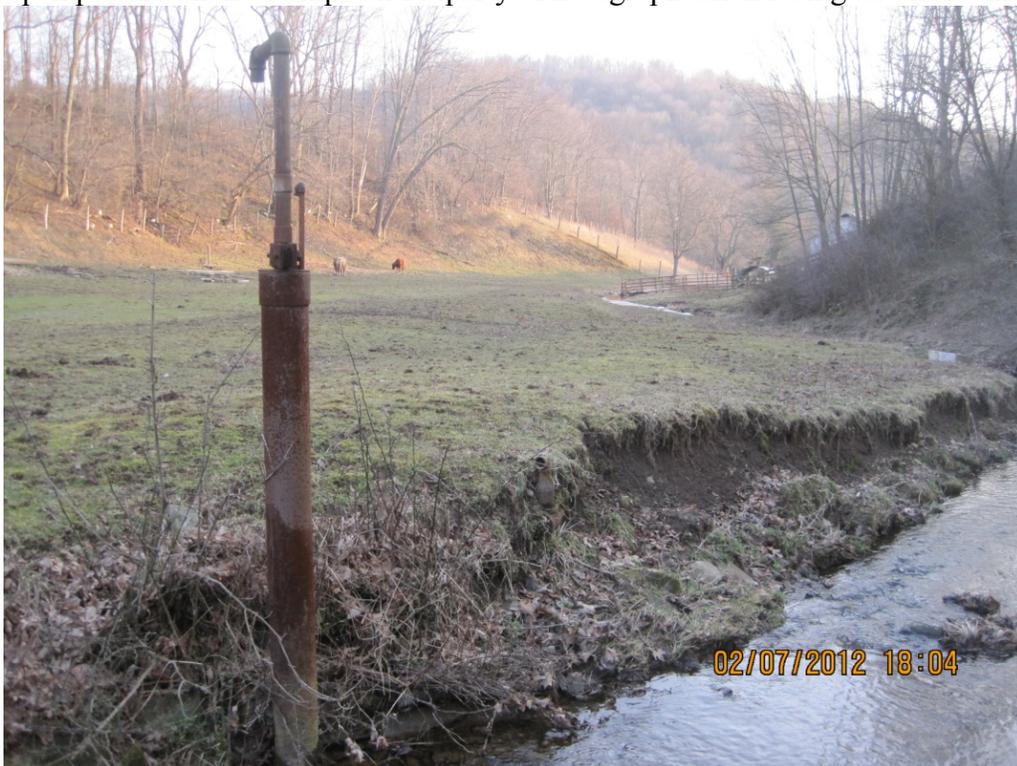
Photograph 14. View of unnamed tributary to North Fork Grave Creek (NFGC-UNT1) within open pasture on the Cumpston Property. Photograph taken facing downstream.

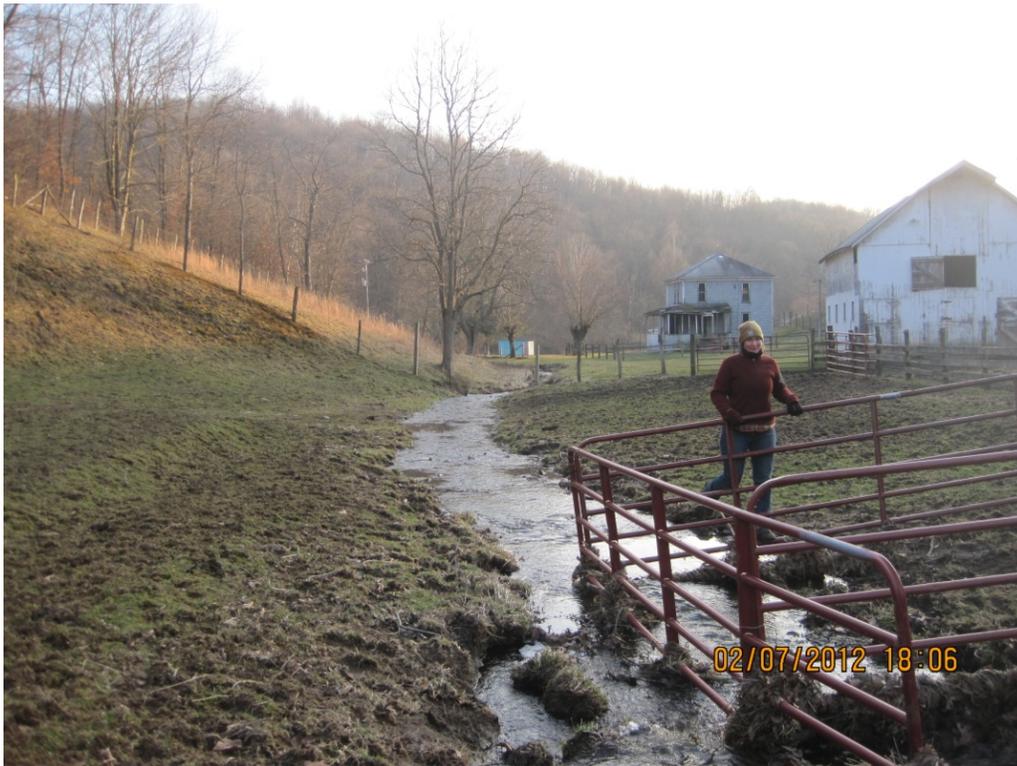
Photograph 15. View of unnamed tributary to North Fork Grave Creek (NFGC-UNT1) within open pasture on the Cumpston Property at stream assessment Segment NFGC-5. Photograph taken facing downstream.

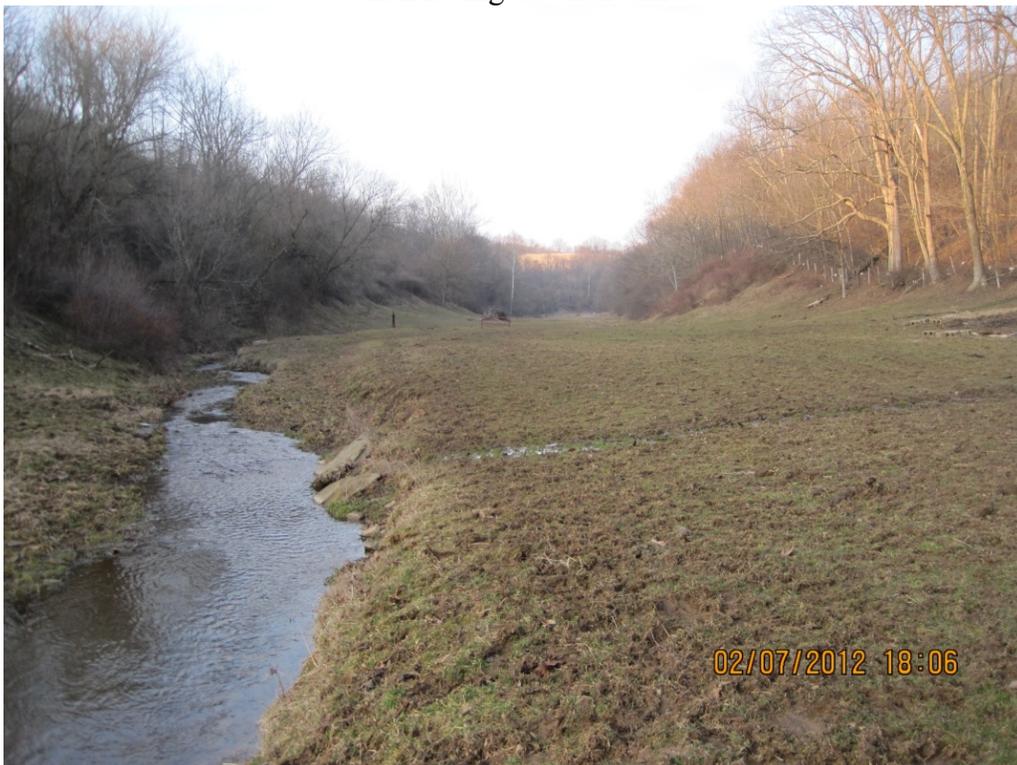
Photograph 16. View of unnamed tributary to North Fork Grave Creek (NFGC-UNT1) within open pasture on the Cumpston Property at stream assessment Segment NFGC-5. Photograph taken facing upstream.

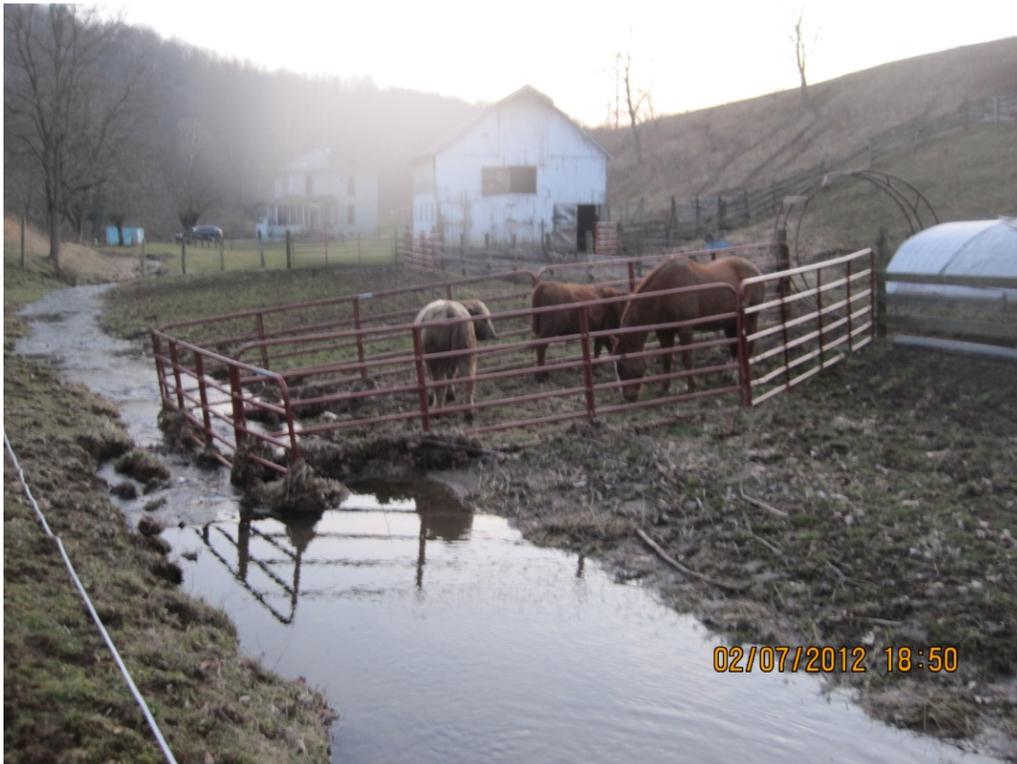
Photograph 17. View of an unnamed tributary to North Fork Grave Creek (NFGC-UNT1) within open pasture on the Cumpston Property at stream assessment Segment NFGC-5. Photograph taken facing downstream.

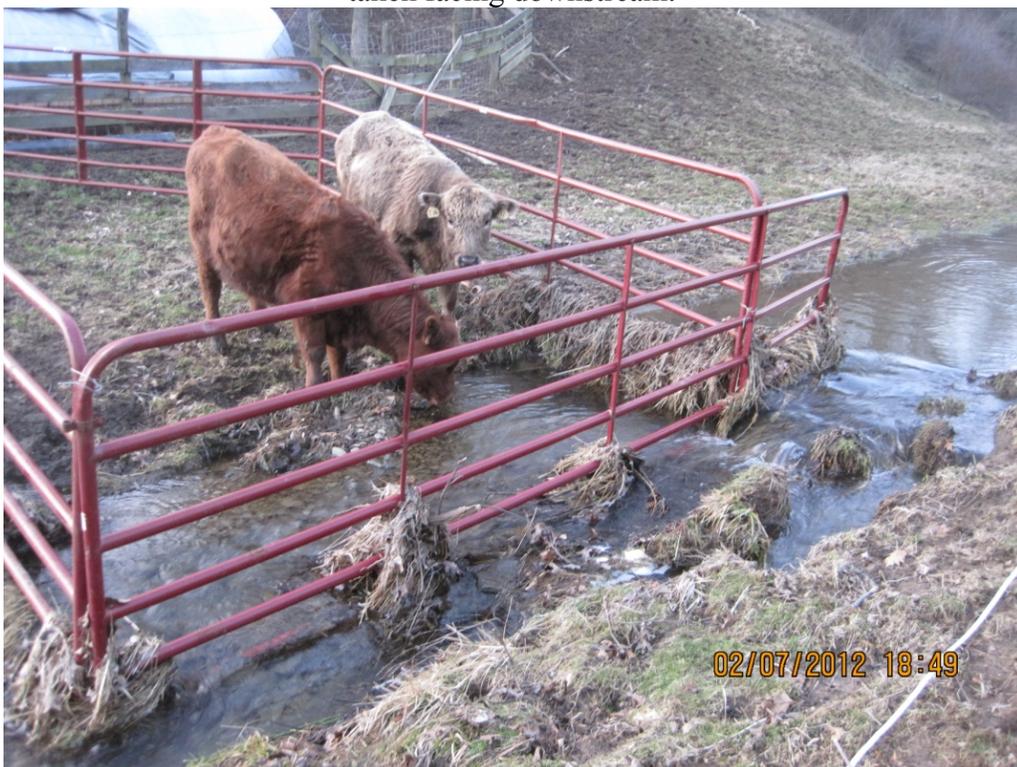
Photograph 18. View of unnamed tributary to North Fork Grave Creek (NFGC-UNT1) within open pasture on the Cumpston Property at stream assessment location Segment NFGC-5. Photograph taken facing upstream.

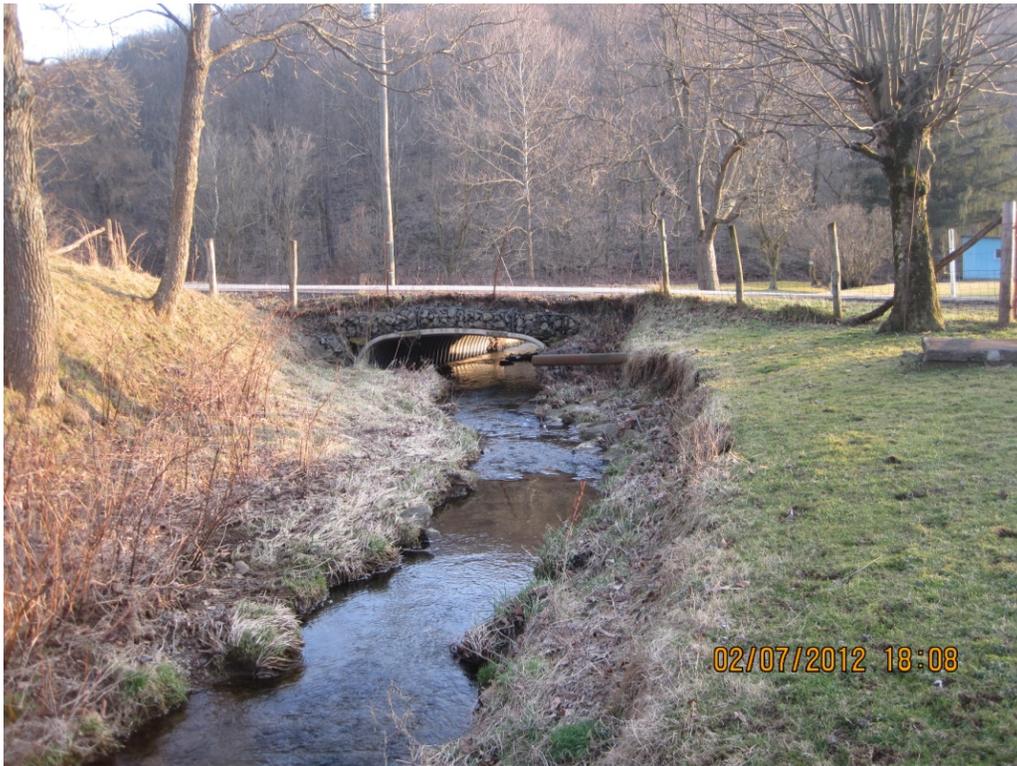
Photograph 19. View of unnamed tributary to North Fork Grave Creek (NFGC-UNT1) at Clouston Woods Road. Photograph taken facing downstream.

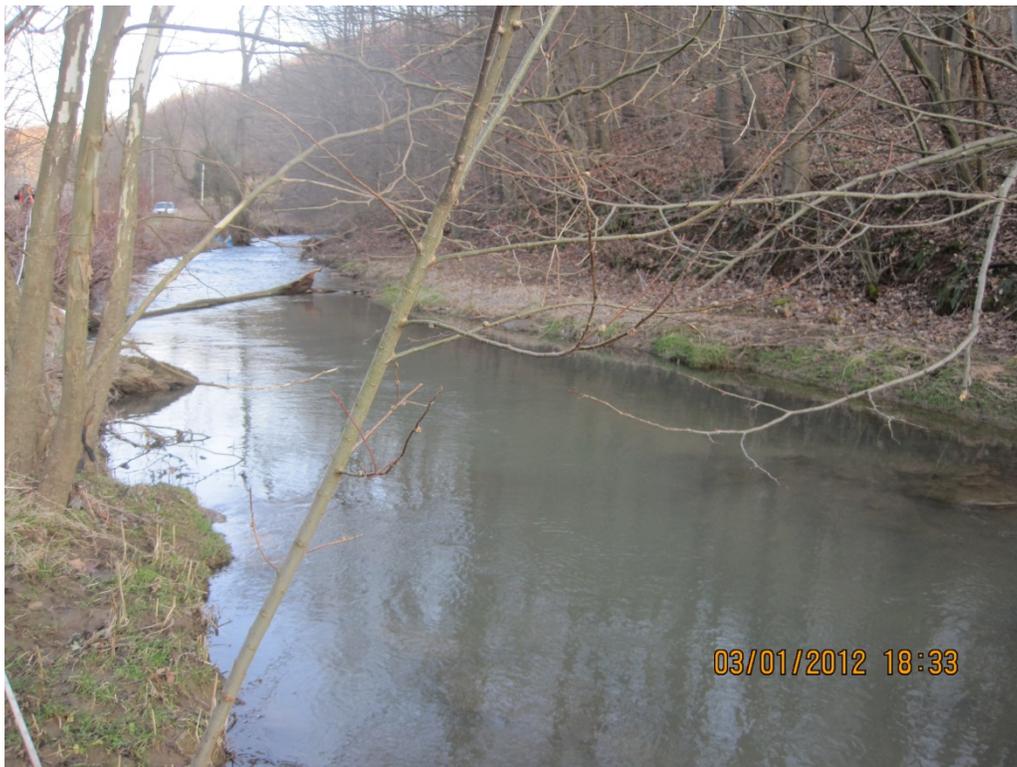
Photograph 20. View of North Fork Grave Creek within the Lewis Property at stream assessment Segment NFGC-4. Photograph taken facing upstream.

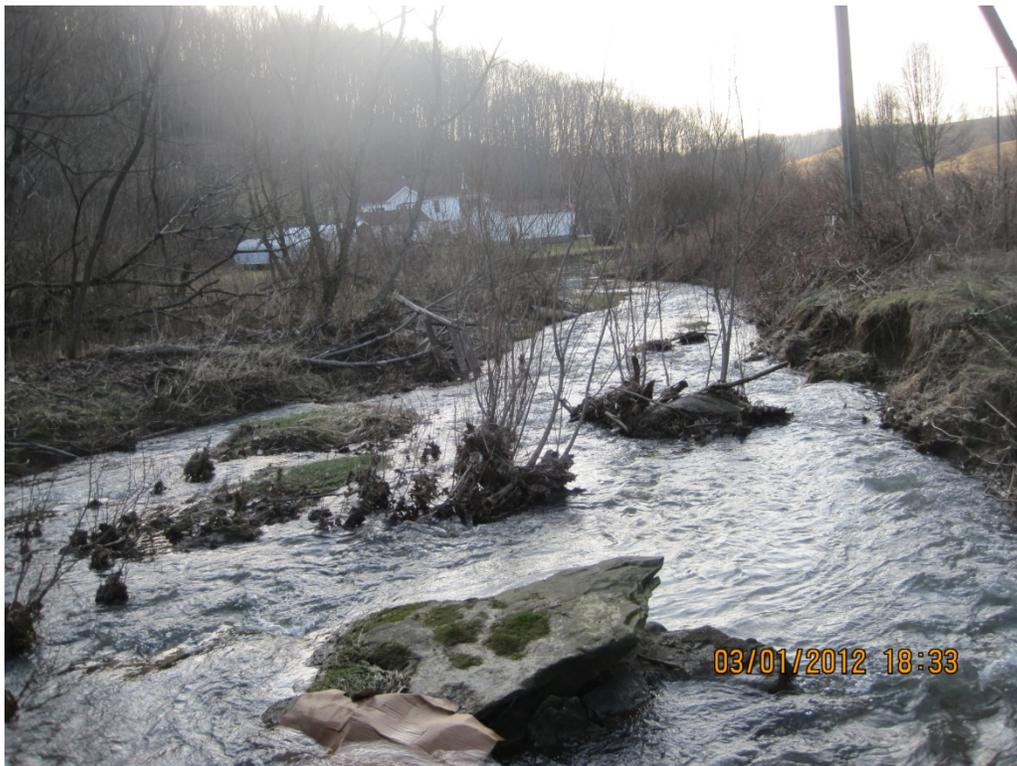
Photograph 21. View of North Fork Grave Creek within the Lewis Property at stream assessment Segment NFGC-4. Photograph taken facing downstream.

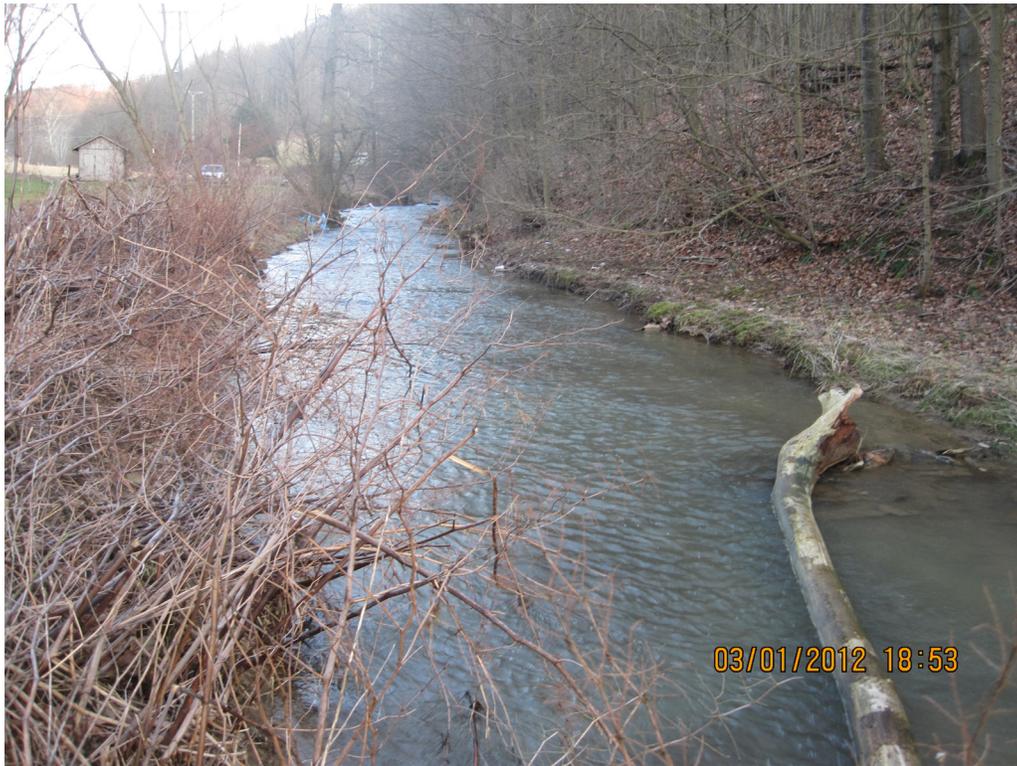
Photograph 23. View of North Fork Grave Creek within the Lewis Property at stream assessment Segment NFGC-4. The right/descending bank is covered with the invasive Japanese knotweed. Photograph taken facing upstream.

Two existing ponds are located on the right bank of North Fork Grave Creek within the Lewis Property. One of the ponds partially lies within the Hackathorn Property. The stream is eroding the banks of both of these ponds and one of the pond's banks has failed. Japanese knotweed (*Polygonum cuspidatum*) was growing along approximately 60 percent of the right descending bank within the Lewis/Robinson Properties. A well developed riparian buffer is present along the left descending bank.

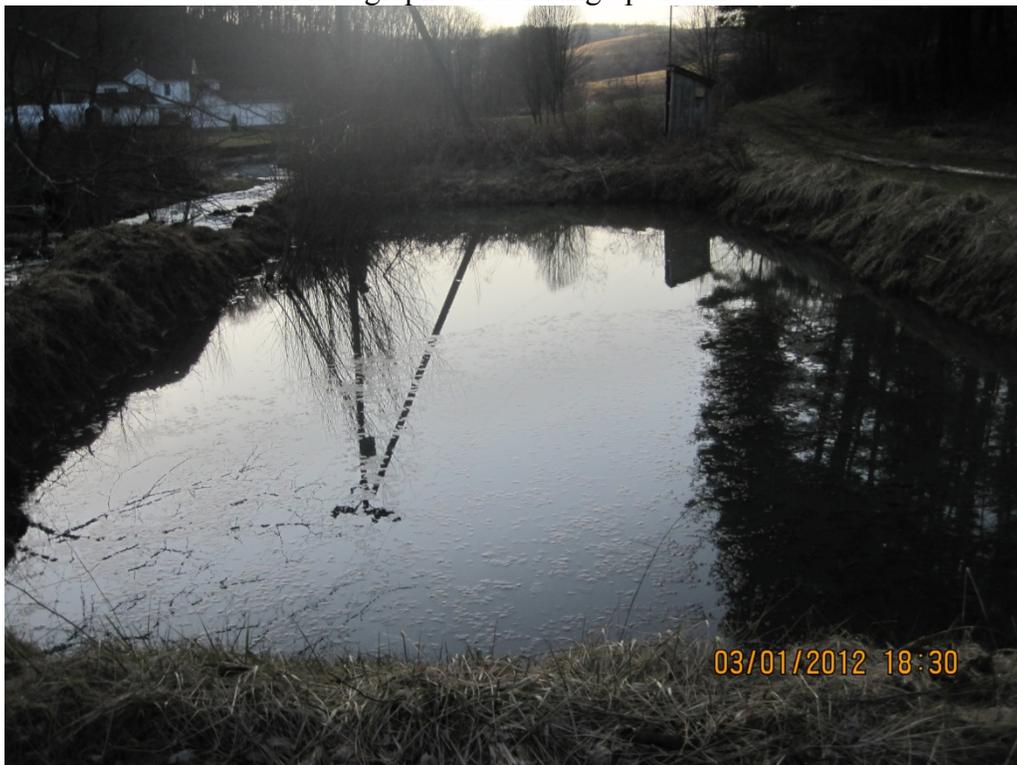
Photograph 24. View of one of the ponds located adjacent to North Fork Grave Creek on the Lewis Property. Photograph taken facing west.

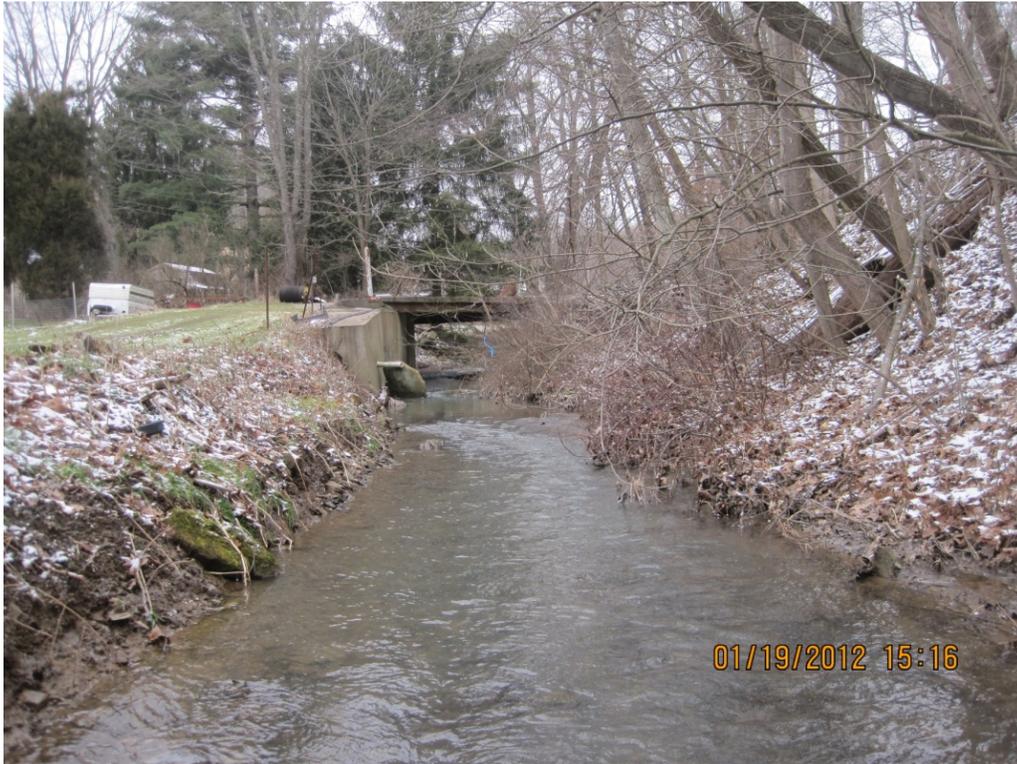
Photograph 25. View of unnamed tributary to North Fork Grave Creek (NFGC-UNT2) at stream assessment Segment NFGC-7 within the Cox Property. Photograph taken facing upstream.

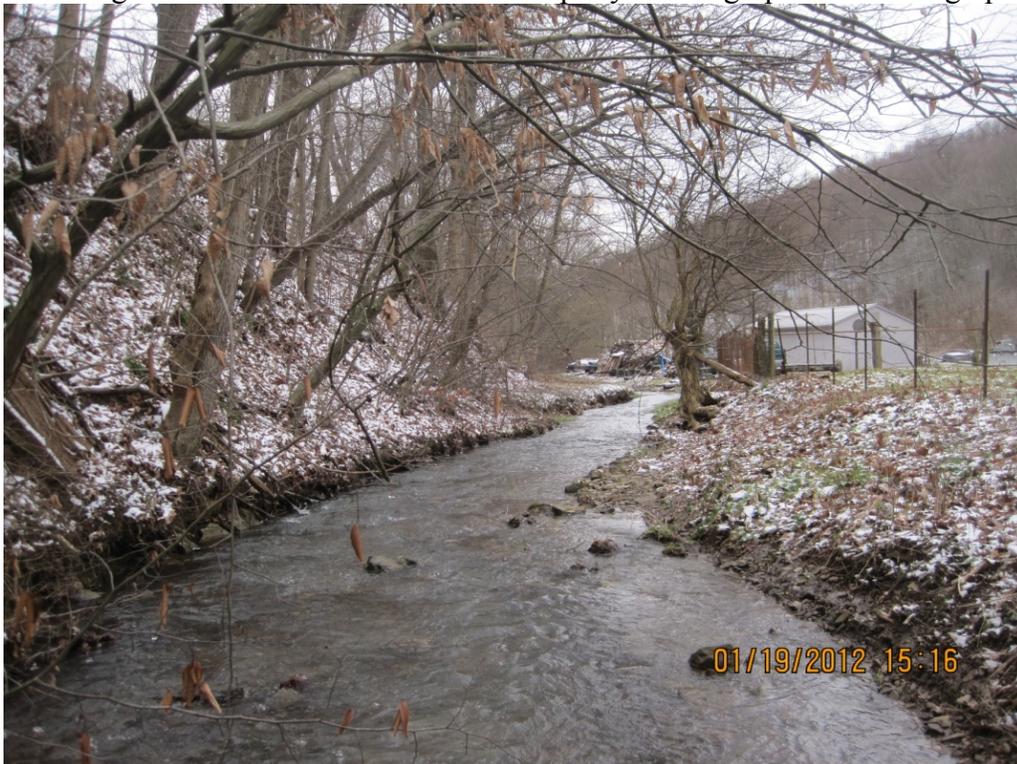
Photograph 26. View of unnamed tributary to North Fork Grave Creek (NFGC-UNT2) at stream assessment Segment NFGC-7 within the Cox Property. Photograph taken facing downstream.

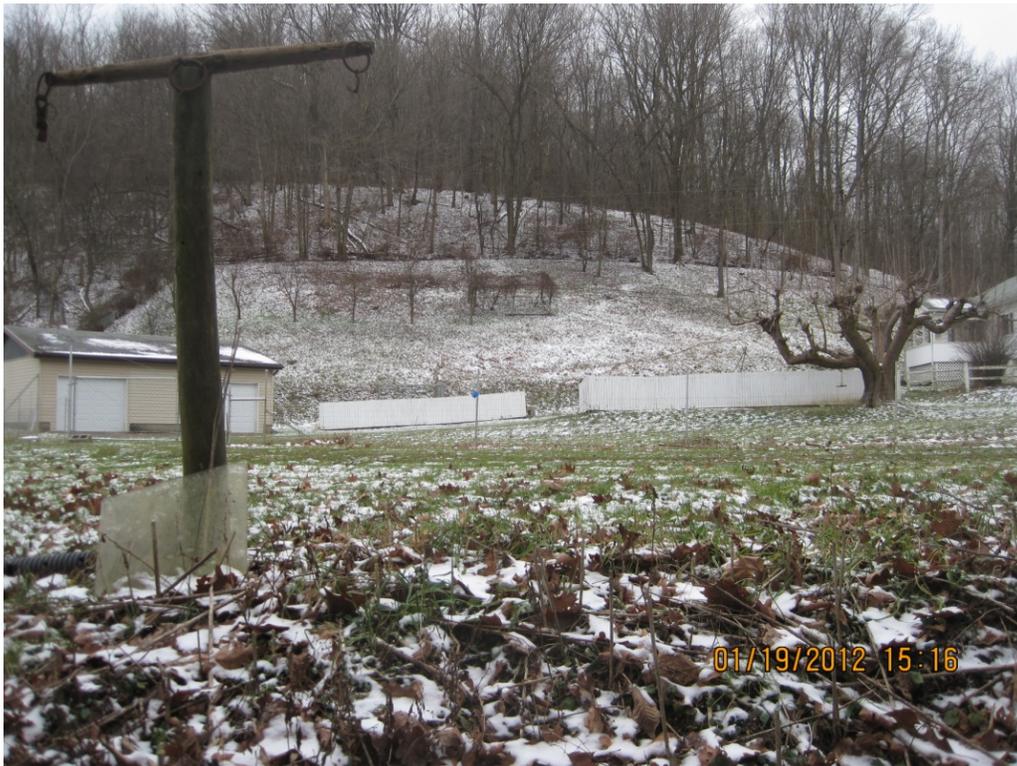
Photograph 27. View of mowed lawn on right/descending bank of NFGC-UNT2 at stream assessment Segment NFGC-7 on Cox Property. Photograph taken facing west.

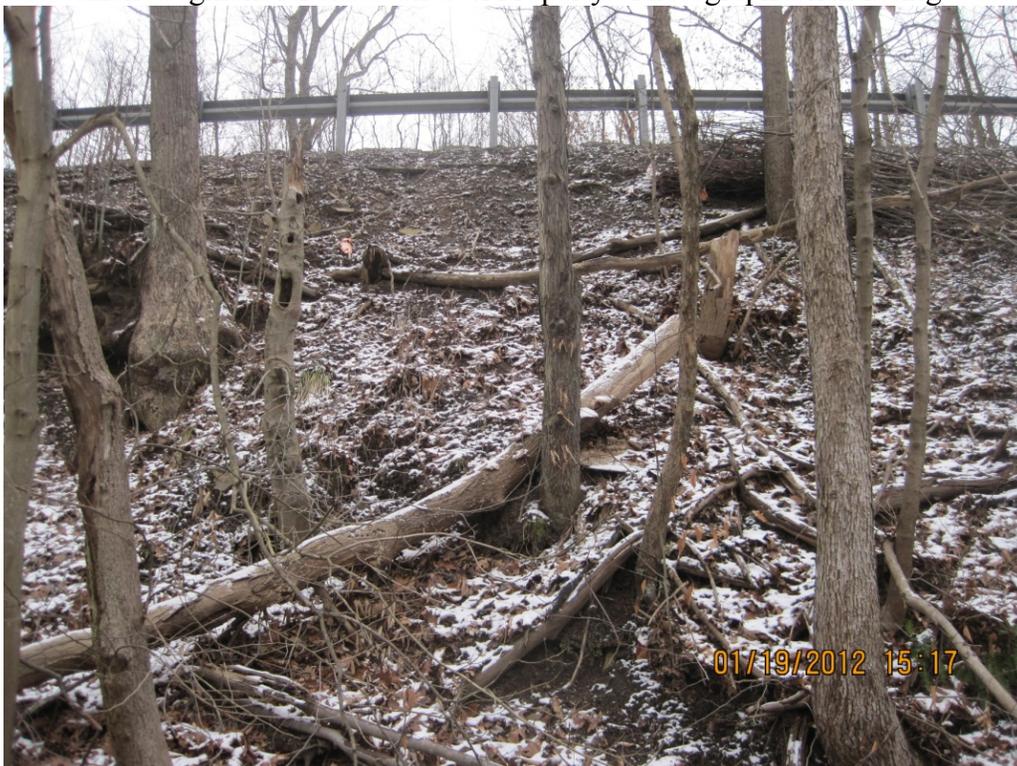
Photograph 28. View of left/descending bank of NFGC-UNT2 at stream assessment Segment NFGC-7 on Cox Property. Highway 250 is located approximately 30 feet from the stream. Photograph taken facing east.

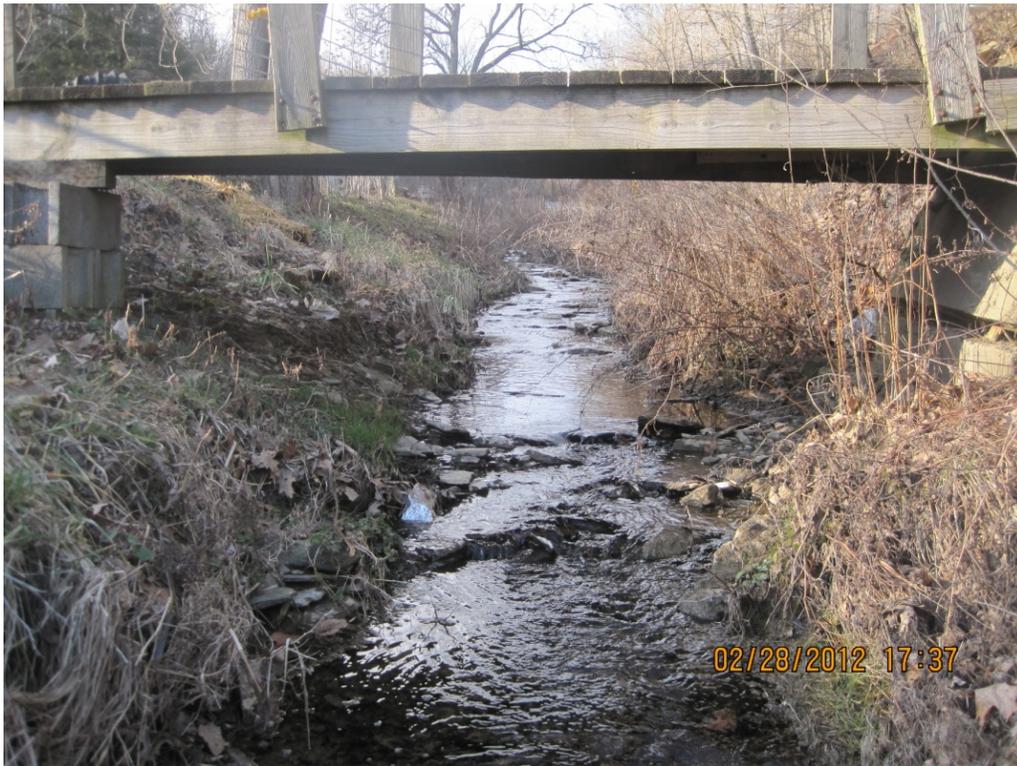
Photograph 29. View of unnamed tributary to North Fork Grave Creek (NFGC-UNT2) within Roskelly Property at stream assessment Segment NFGC-6. Photograph taken facing upstream.

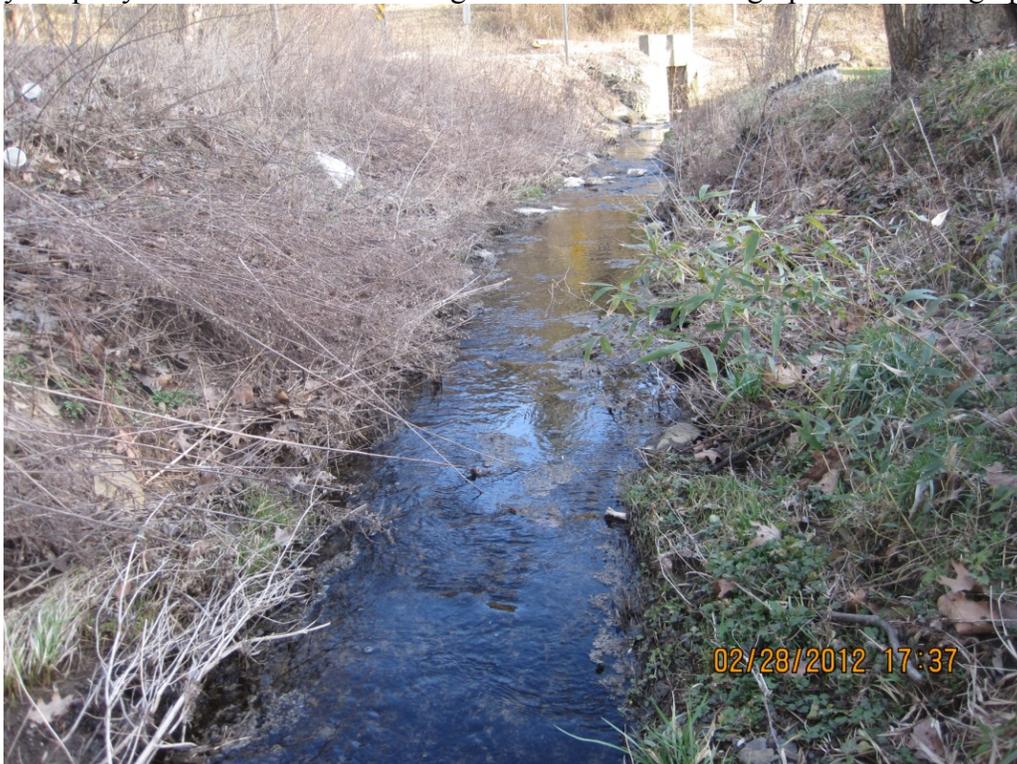
Photograph 30. View of unnamed tributary to North Fork Grave Creek (NFGC-UNT2) within Roskelly Property at stream assessment Segment NFGC-6. Photograph taken facing downstream.

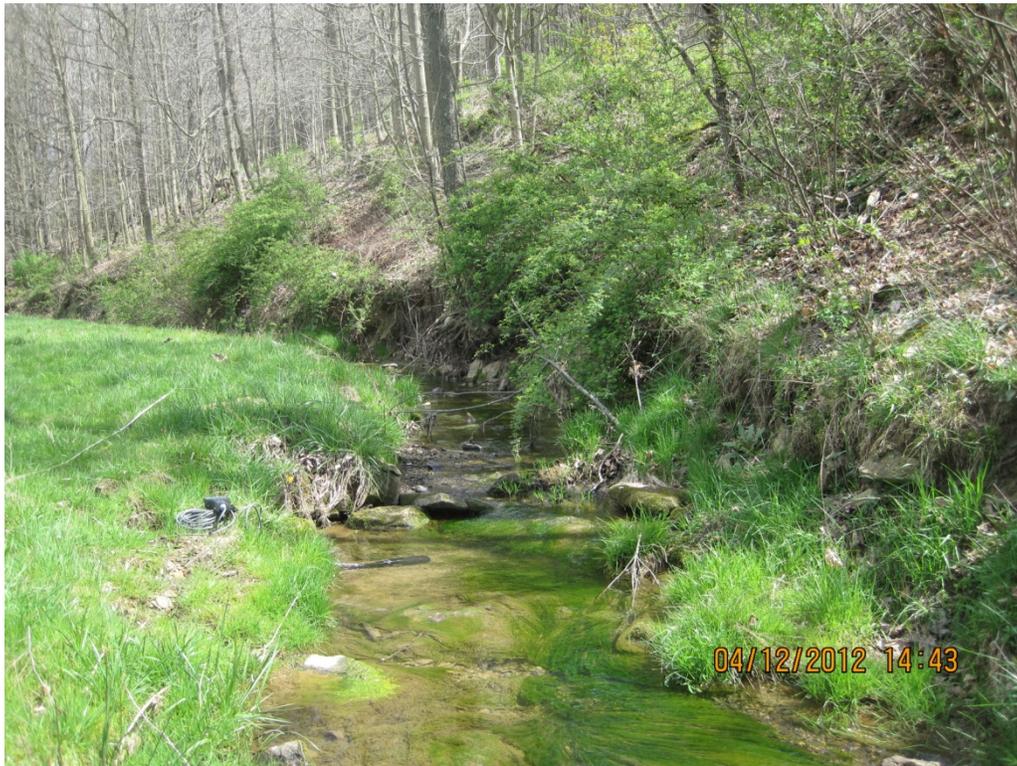
Photograph 31. View of North Fork Grave Creek within the Magers Property at stream assessment Segment NFGC-8. Photograph taken facing upstream.

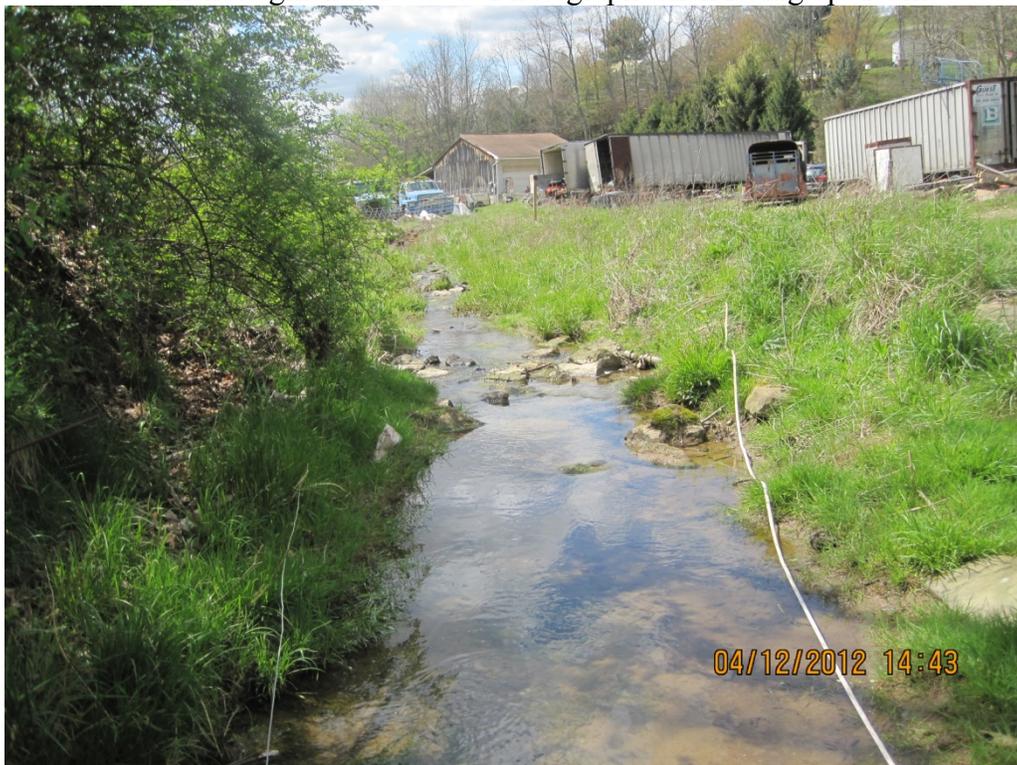
Photograph 32. View of North Fork Grave Creek within the Magers Property at stream assessment Segment NFGC-8. Photograph taken facing downstream.

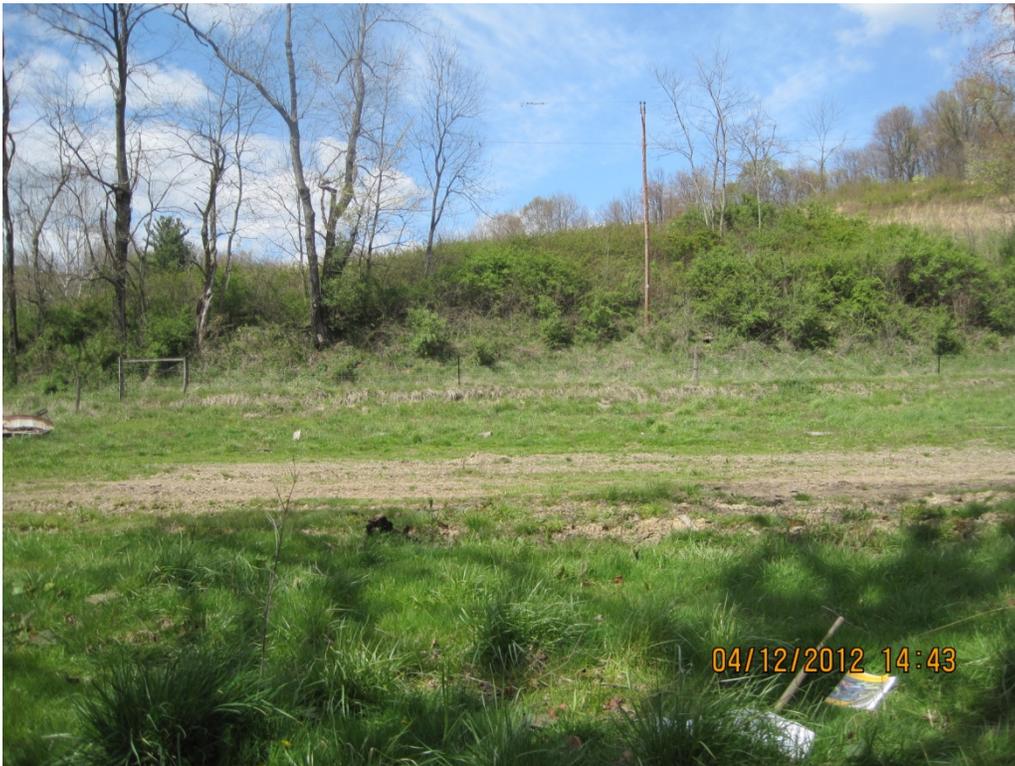
Photograph 33. View of the right/descending bank of North Fork Grave Creek at stream assessment Segment NFGC-8. Photograph taken facing north.

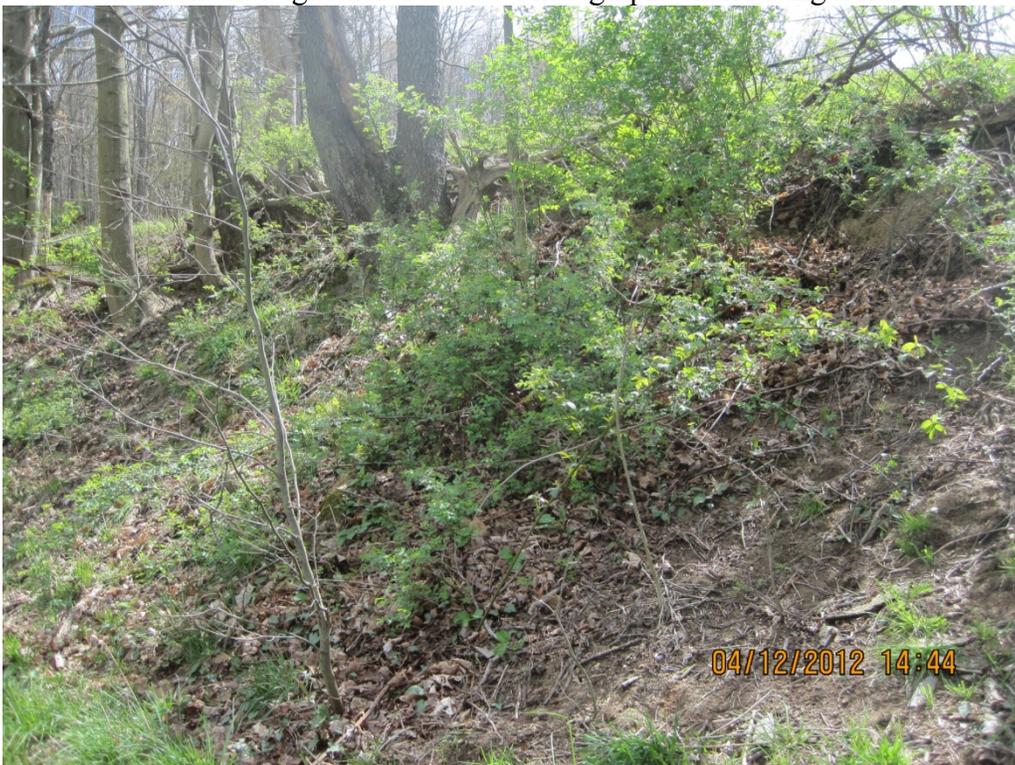
Photograph 34. View of the left/descending bank of North Fork Grave Creek at stream assessment Segment NFGC-8. Photograph taken facing south.

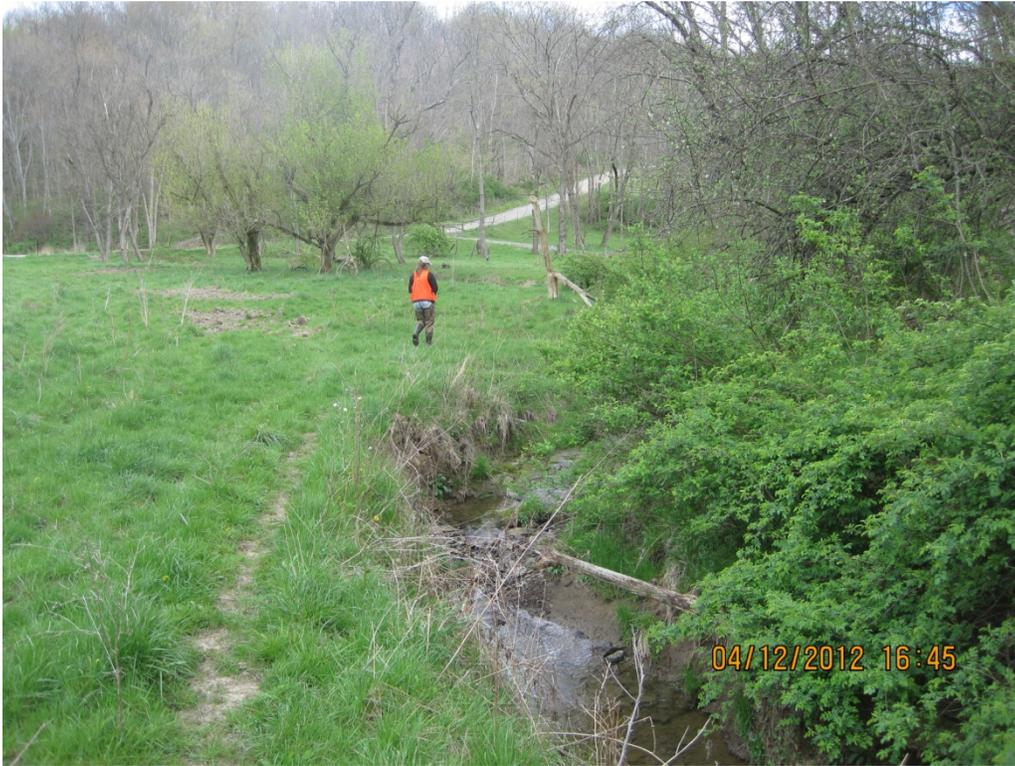
Photograph 35. View of North Fork Grave Creek within the Magers Property. Photograph taken facing upstream.
