CONCEPTUAL MITIGATION PLAN

AMERICAN ELECTRIC POWER CO., INC.
PROPOSED MITCHELL LANDFILL PROJECT
CRESAP, MARSHALL COUNTY, WEST VIRGINIA

CIVIL & ENVIRONMENTAL CONSULTANTS, INC.
CINCINNATI, OHIO

April 26, 2012

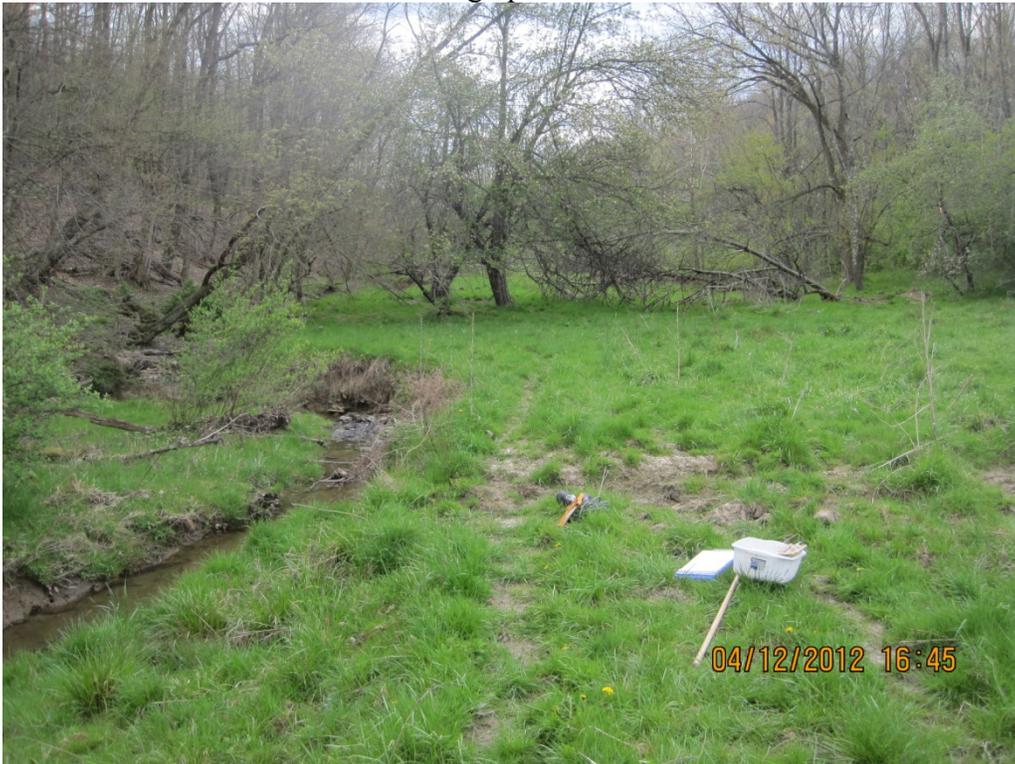
Photograph 36. View of North Fork Grave Creek within the Magers Property. Photograph taken facing downstream.

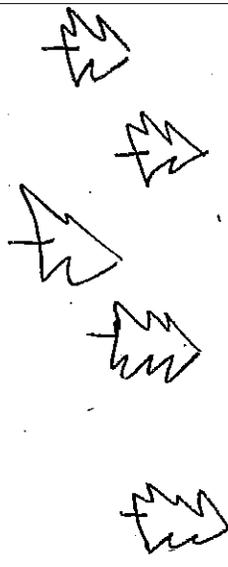
14.3' wide

14" deep
119" wide

Riffle

Grassy island
