# North Park Lake Aquatic Ecosystem Restoration Project

**Presented by:**  
**Jennifer Savitz, P.E.**  
**Craig Carney, P.E.**  
**USACE Pittsburgh District**

## North Park Lake

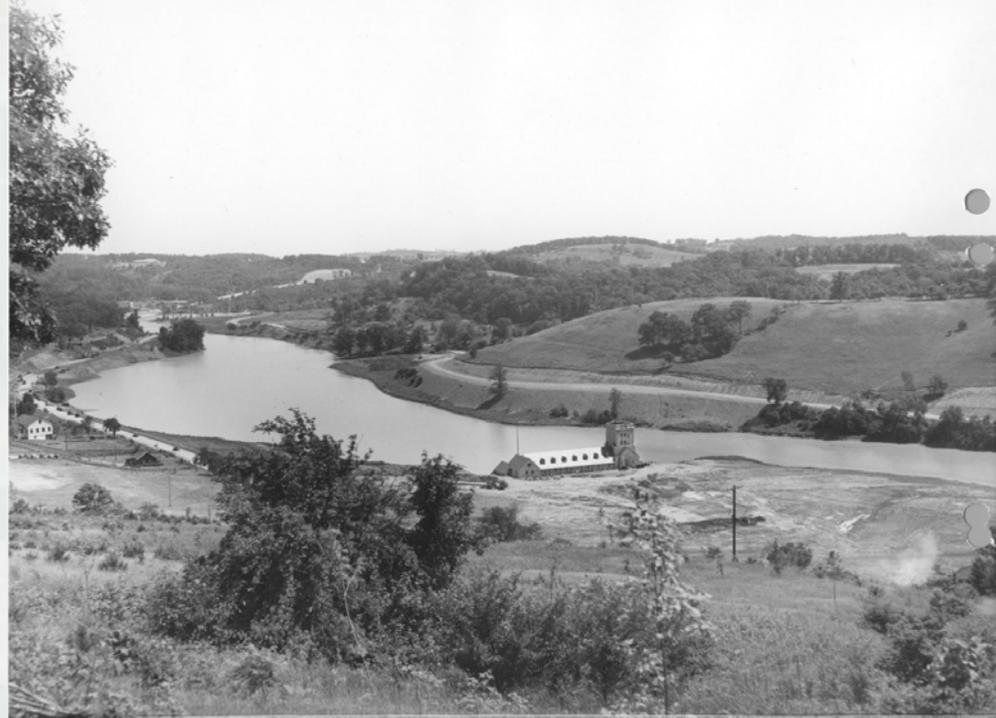
3828-North Park Lake from No. Ridge Drive-6/23/37 Hefelfinger & Austen

**Historic Photo** – View of the North Fork Pine Creek arm of the lake looking downstream. The boathouse is in the center of the photo.

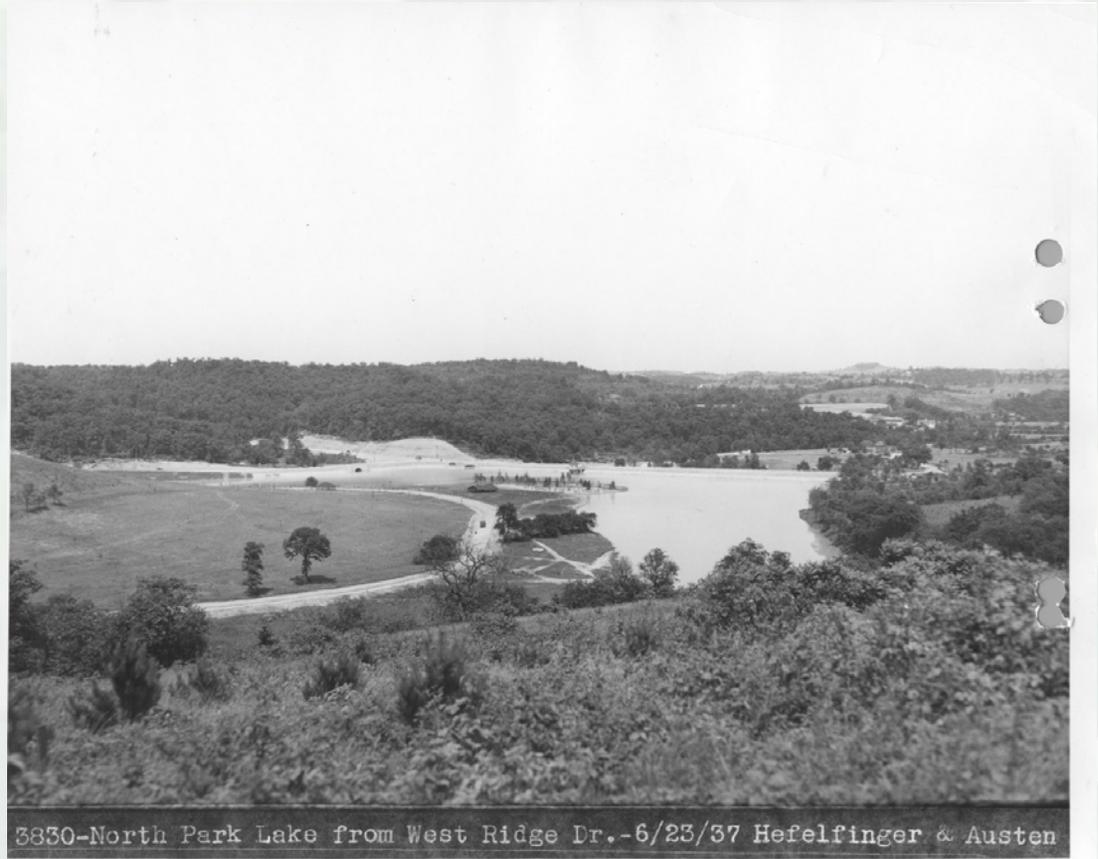
When initially constructed lake was 75 acres in size and approximately 24 feet deep near the face of the dam.

**Historic Photo** – View of the Pine Creek arm of the lake looking downstream toward the dam

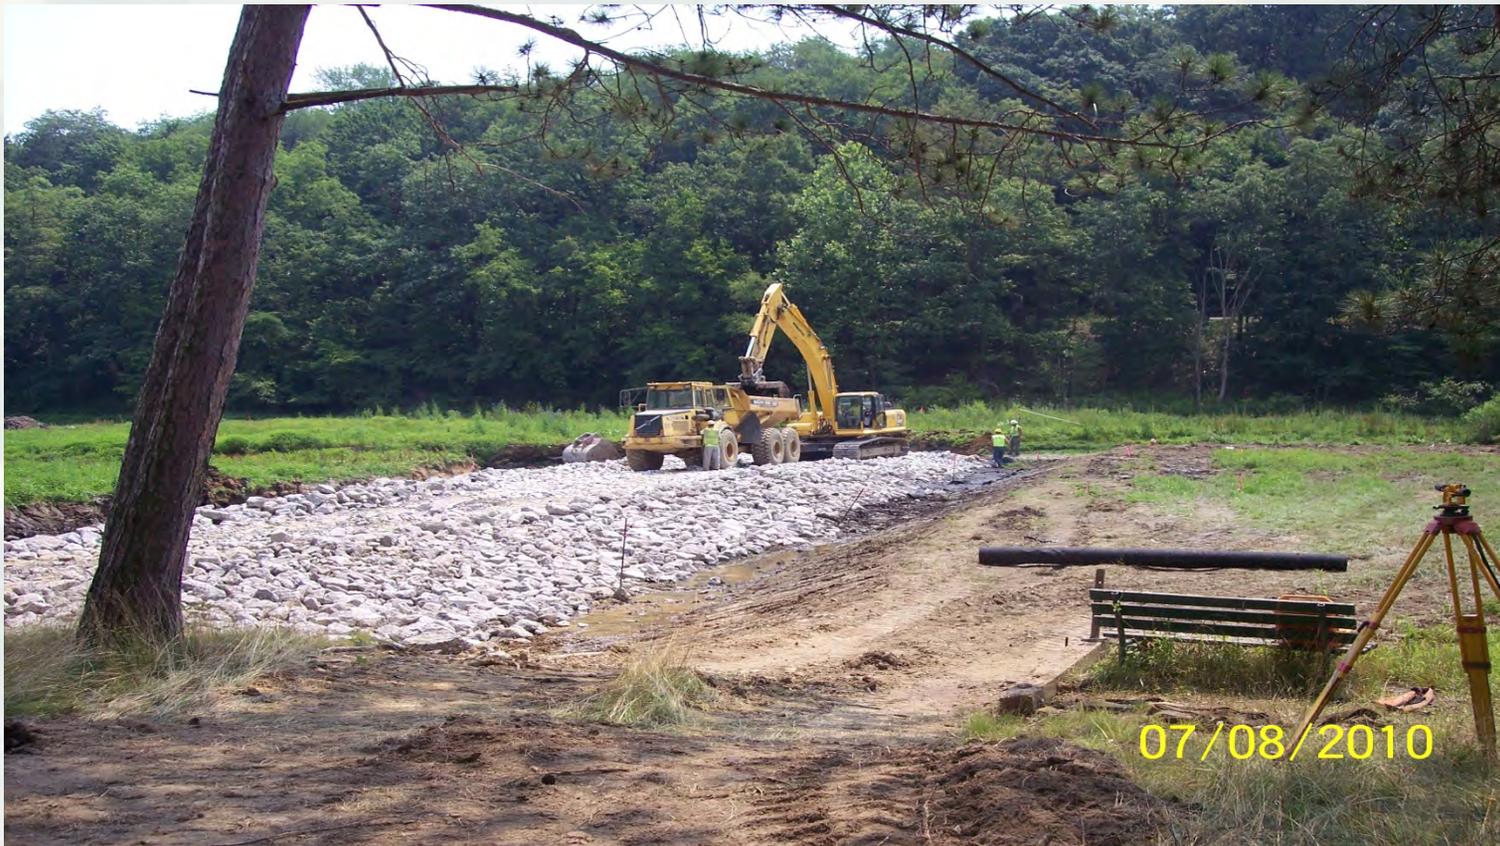
- Porous Rock Dike

- Proposed constructing a porous rock dike across the Pine Creek arm of the lake.
- Section of the lake upstream of the dike would have been sacrificed to act as a sedimentation basin
- Recommended installing new valve to allow the draining of Marshall Lake

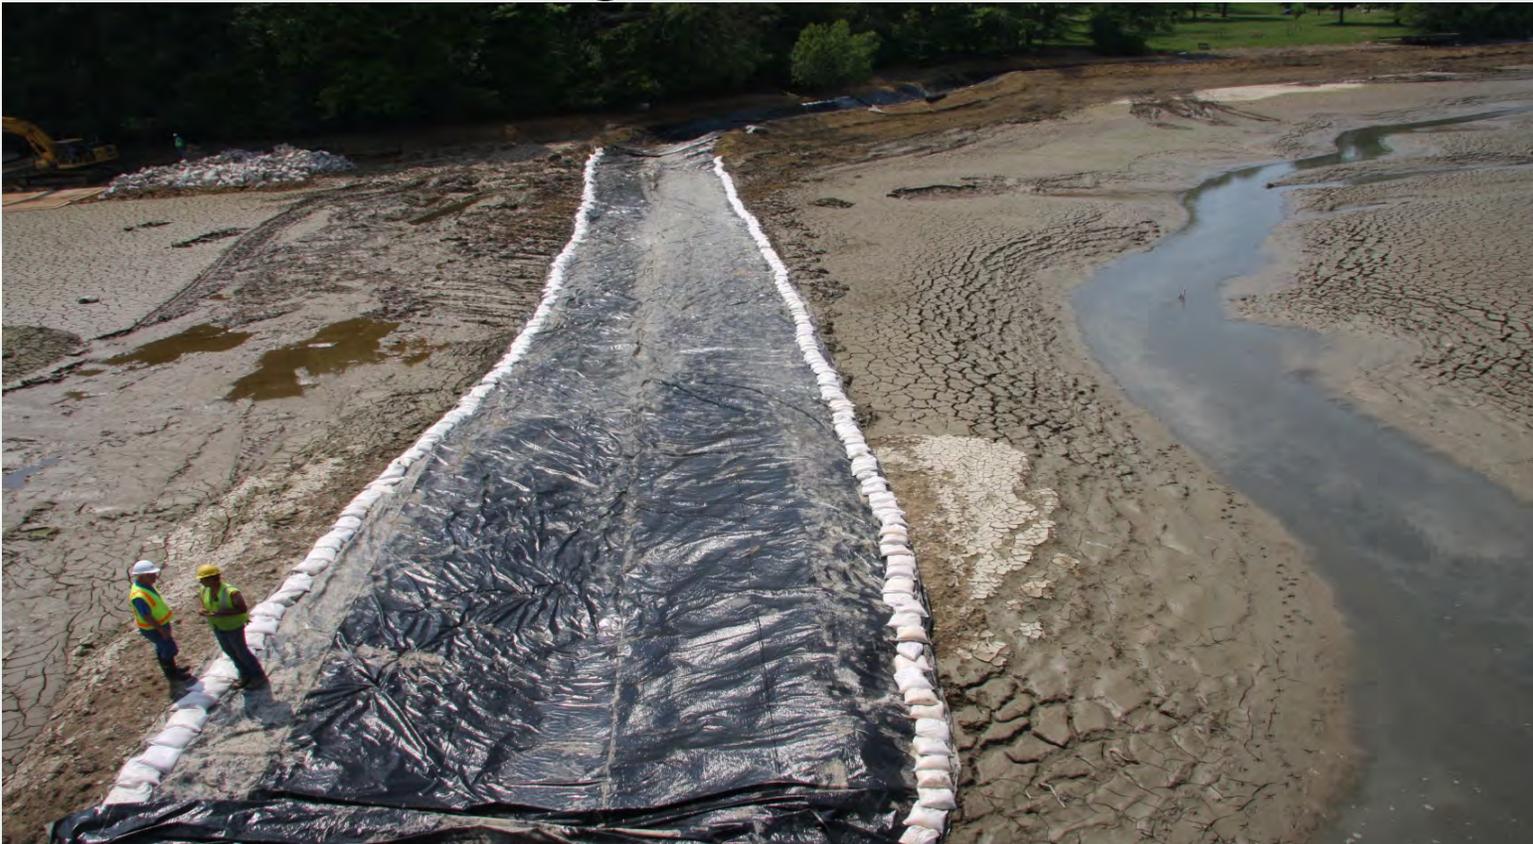
- Lake Draining – Stream Diversions

- Stream Diversion designed to hold 2 year storm event due to constraints of the 5x5 outlet culvert.
- 2 year storm event flow rates  
Pine Creek – 690 (cfs)  
North Fork Pine Creek – 420 (cfs)

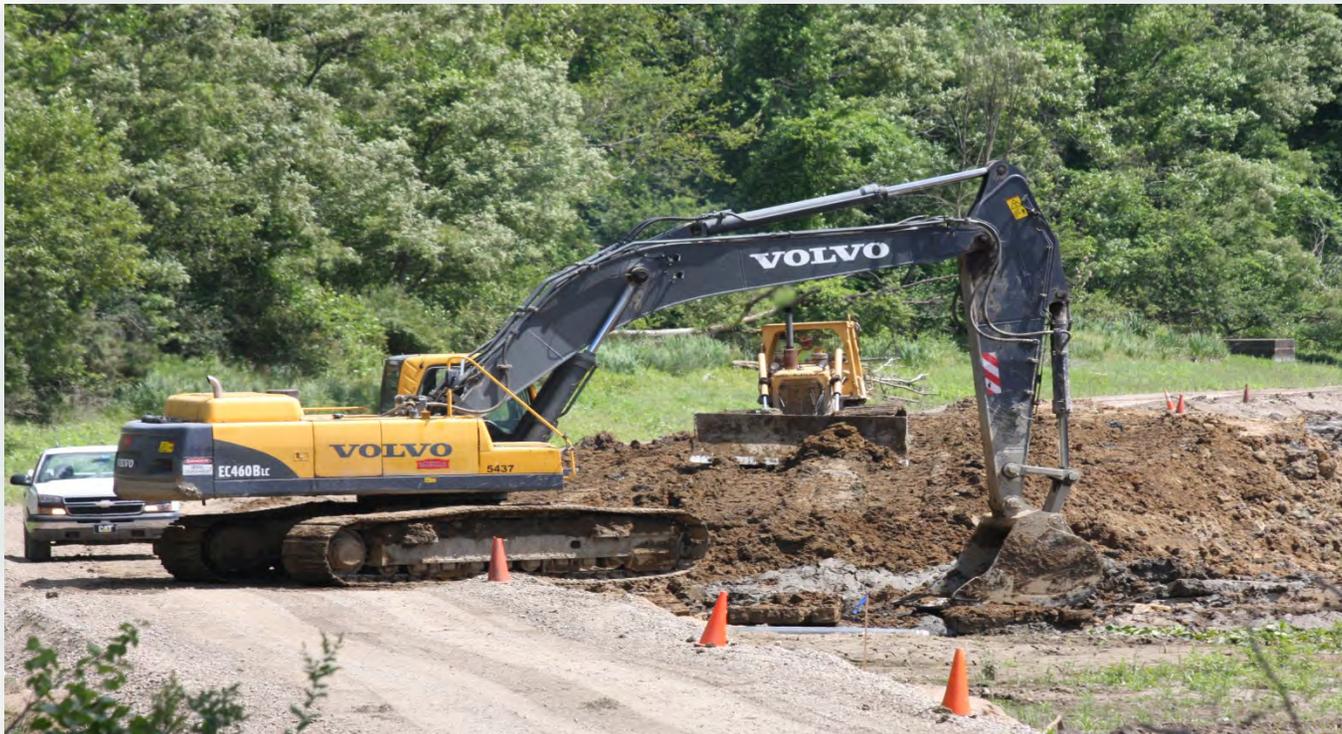
- Lake Draining – Land-based Equipment and Excavation

Completely Drain the lake, allow sediment to dry sufficiently to allow land-based equipment to enter the lakebed and excavate accumulated sediment

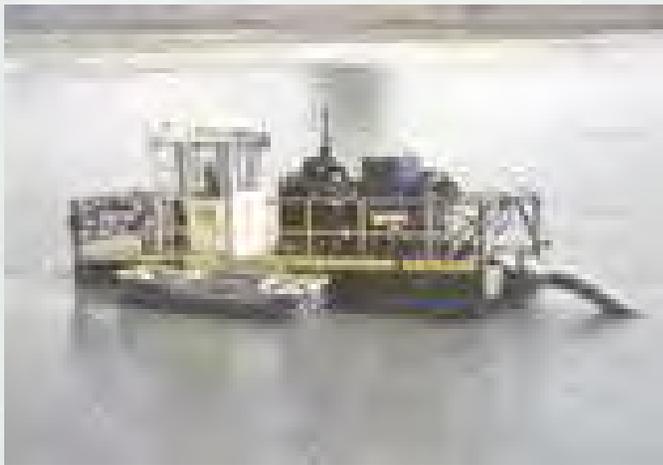
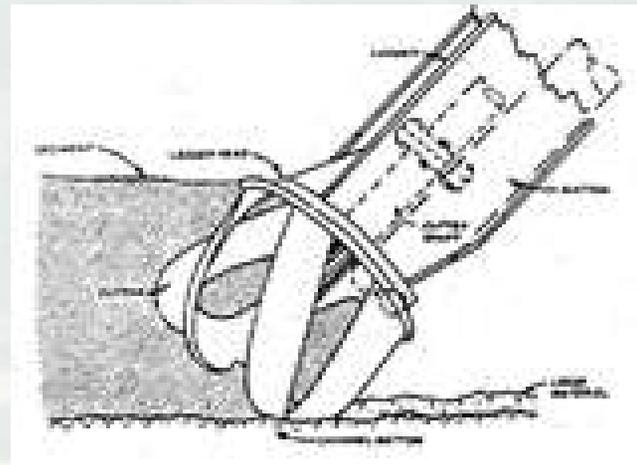
- Hydraulic Dredging – Dredge Equipment

Utilize floating hydraulic dredging equipment to remove the sediment.

Sediment slurry pumped to dewatering areas.

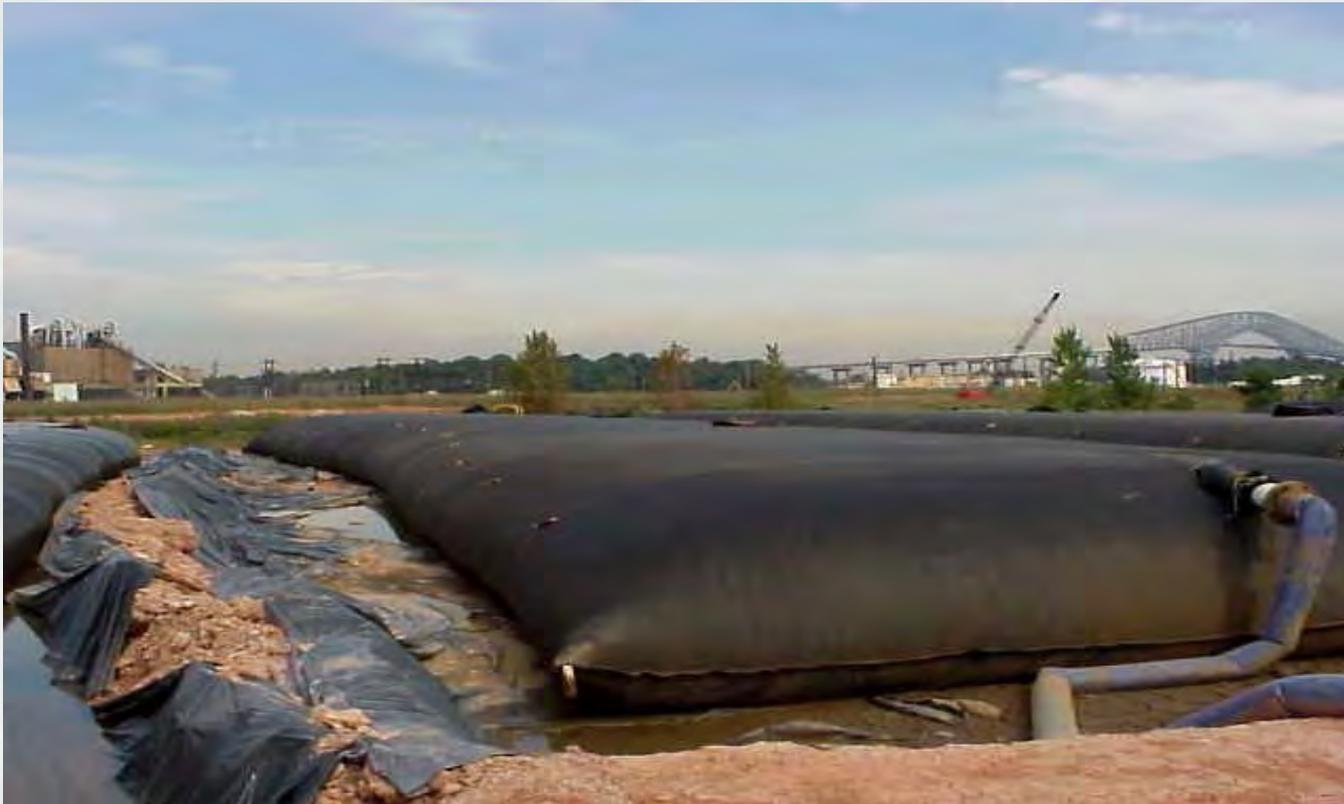
- Hydraulic Dredging – Geotubes

Would have to use Geotubes to dry material due to lack of space for large drying areas.

- Geotubes – Hanging Bag Test
- Combined sediment slurry sample with non-toxic polymer added
- Geotubes with polymer will dry material
- Need low grade laydown areas for geotubes to be effective

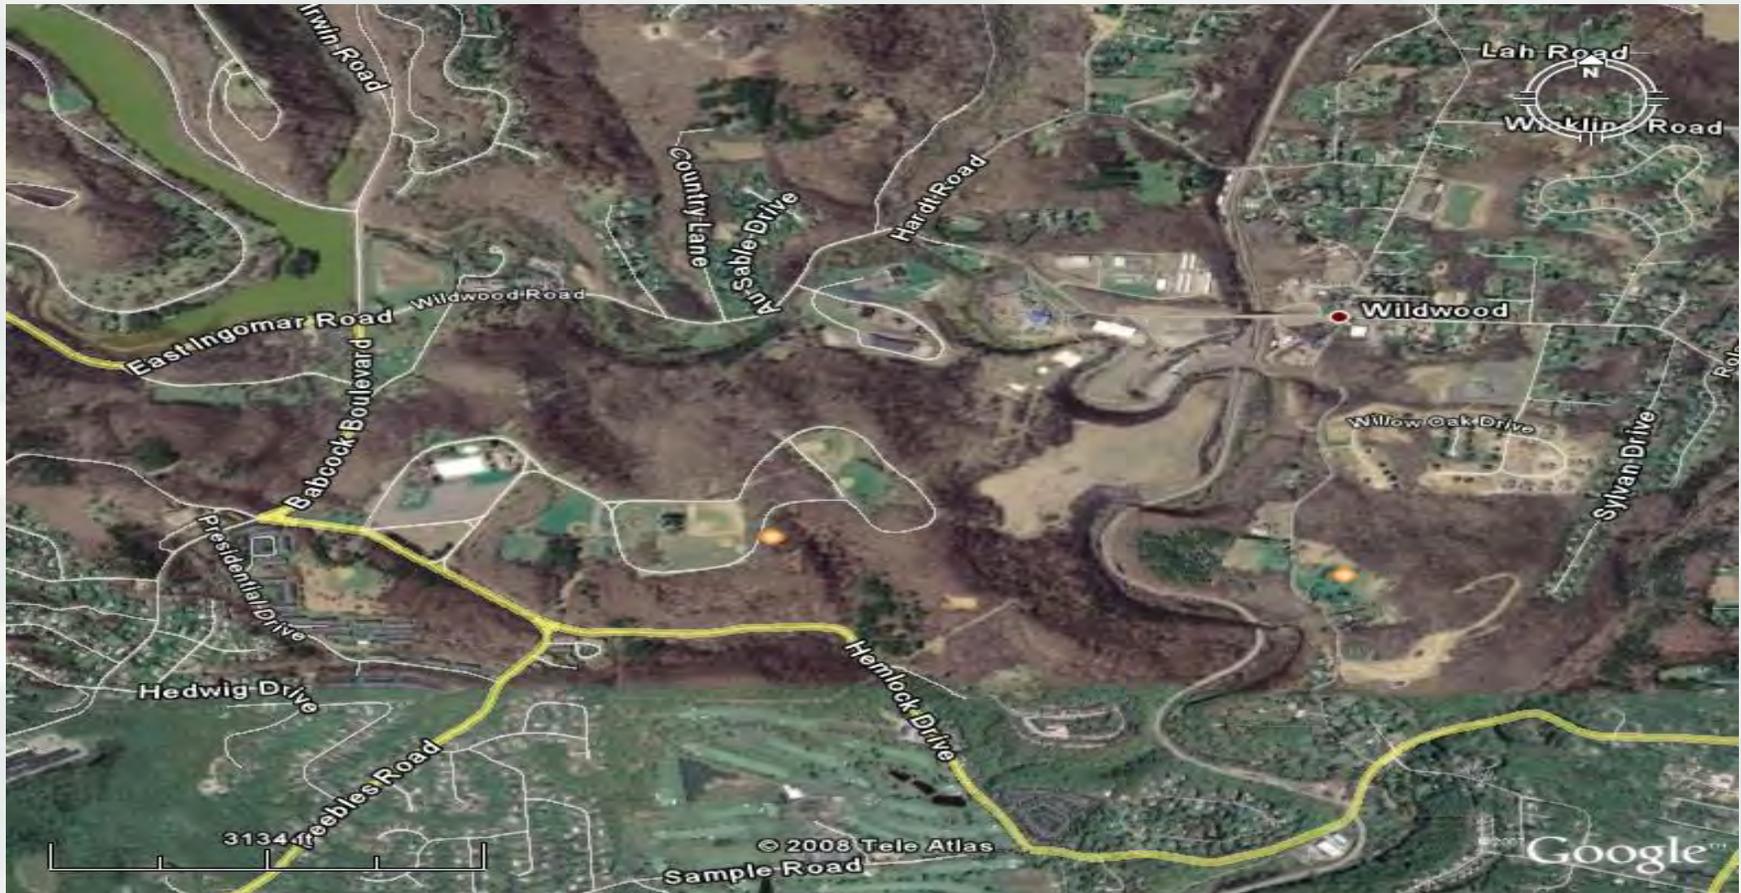
# Planning Process Wildwood Disposal Area

- Wildwood Mine Disposal Site
- 65 Acres
- Site 1.5 miles from Pine Creek Dam
- Reclaimed coal waste pile that was covered with fly ash, heavily fertilized and planted with grass to help prevent erosion
