**Draft
Detailed Project Report
And
Integrated Environmental Assessment**

APPENDIX 3

PHOTOGRAPHS

**North Park Lake
Allegheny County, PA
Section 206 Aquatic Ecosystem
Restoration Project**

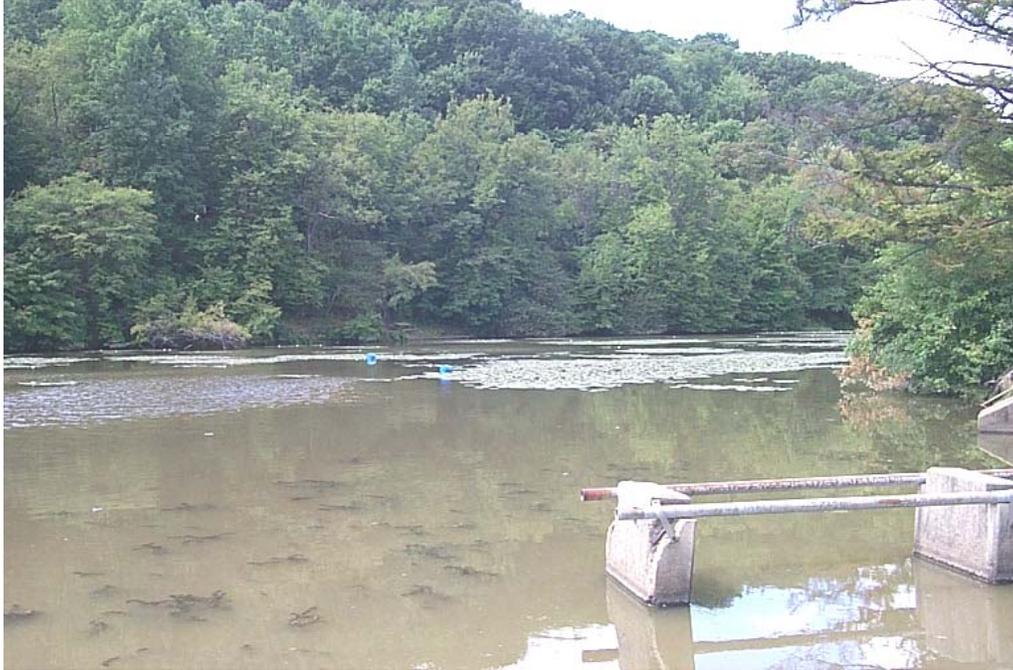
Photo 3 – View of the northern arm of North Park Lake next to the boat house. Note the turbid, shallow conditions with algae bloom

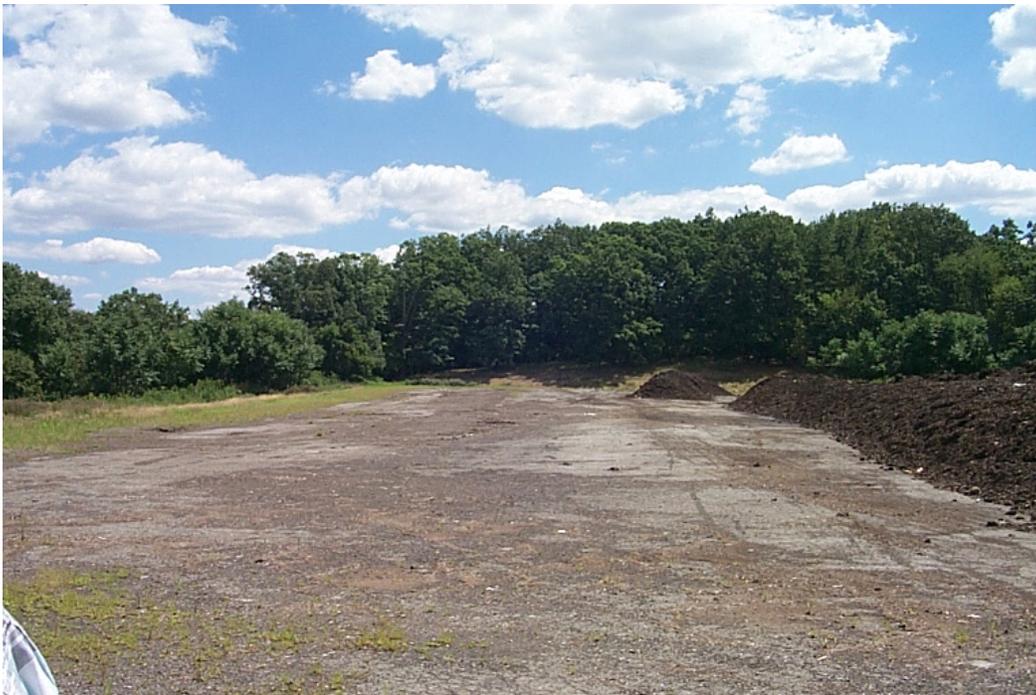
Photo 6 – View of Bull Pen Sediment Placement Site. See PLATE 4a for location. Note piles of disposed leaves on right of photograph. The bulk of this site has been overlain with asphalt.

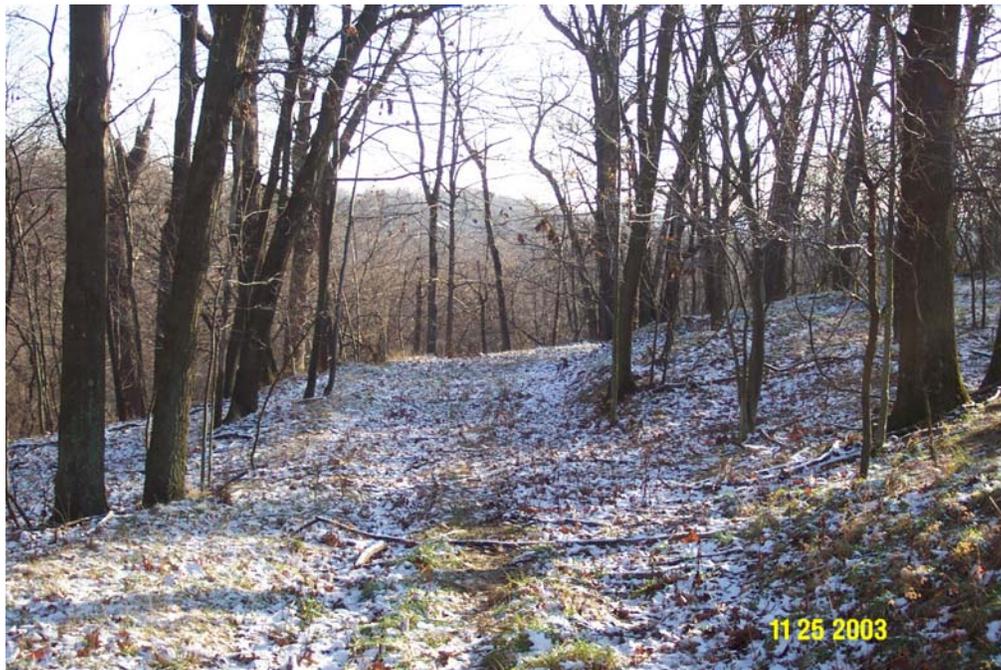
Photo 18 – View of the existing logging road that will be utilized to access the Bull Pen Site from the Point.

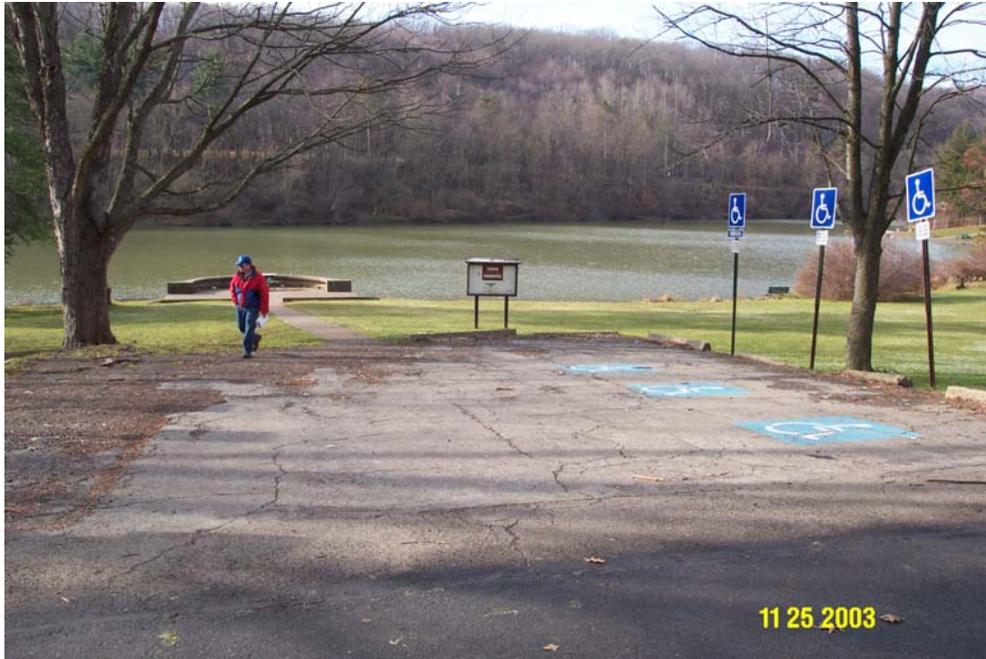
Photo 19 - View of the Rose Barn Access Area viewed looking toward the lake from a parking area just off of Pearce Mill Road. The concrete structure in the foreground is a handicapped fishing platform.

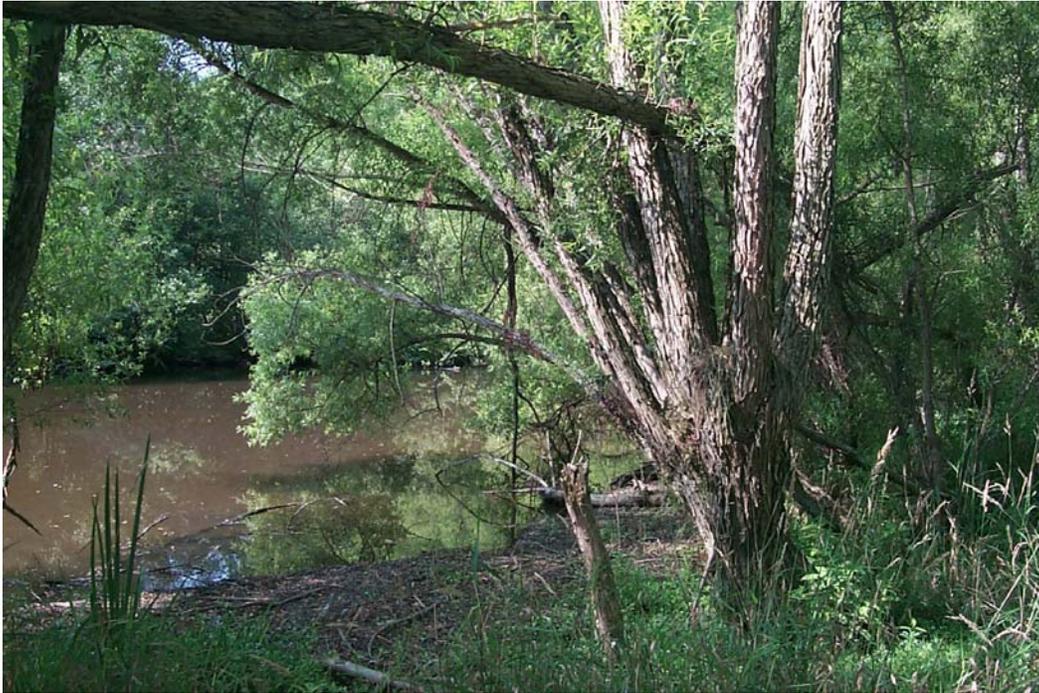
Photo 21 – View from an “island” within the braided portion of Pine Creek showing a portion of the creek and wetland vegetation including trees that now grow in what was once open water of North Park Lake.

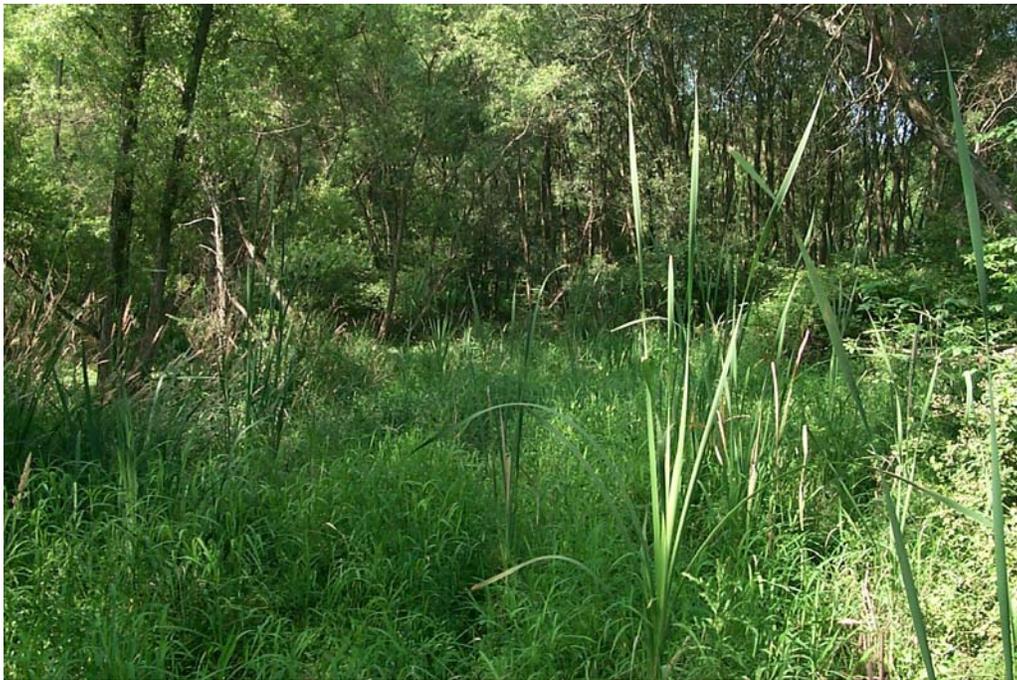
Photo 22 – View of wetlands between Lakeshore Drive and braided portion of Pine Creek within North Park that used to be open lake. Photo was taken landward of Photo 21.

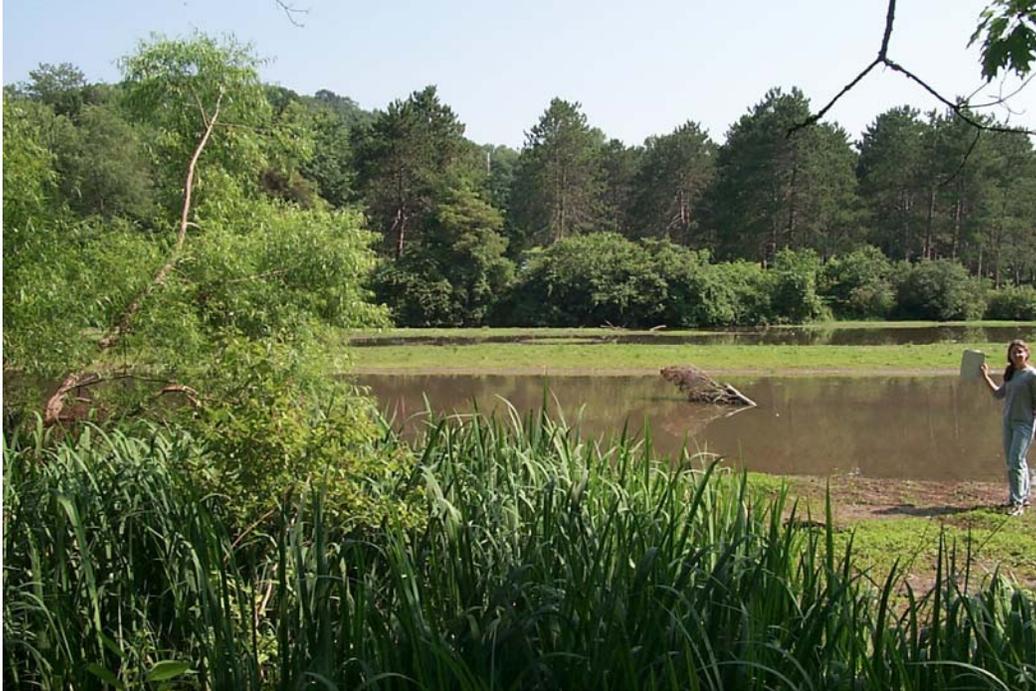
Photo 23 – Looking from the right bank to the left bank of the upper section of North Park Lake. This view shows the wetland encroaching into the open water.

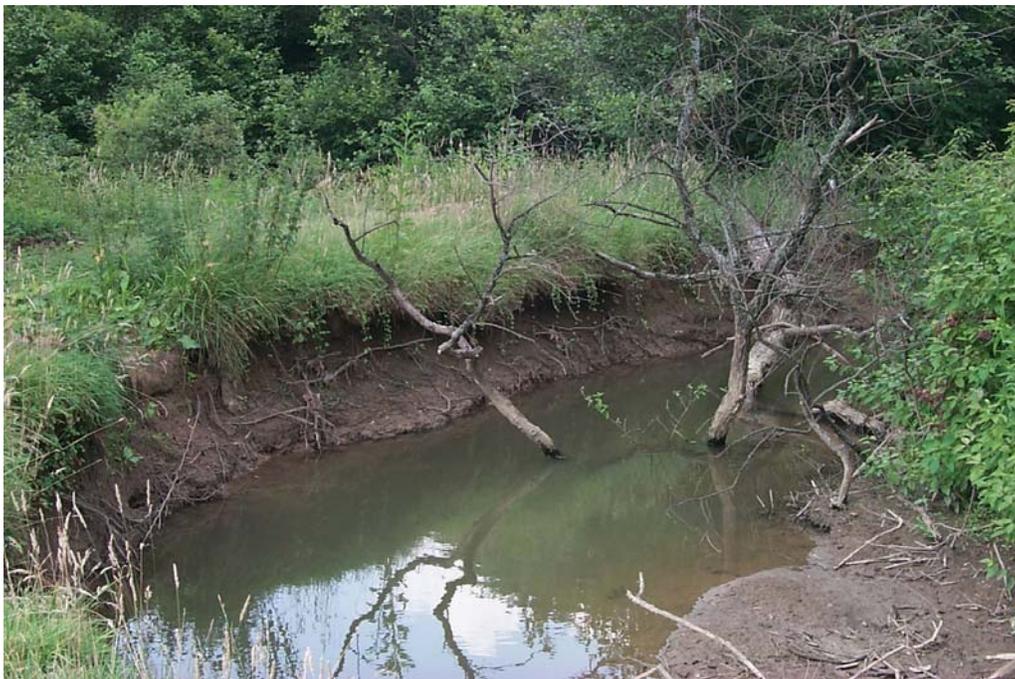
Photo 24 - View of North Fork of Pine Creek looking downstream. This photo shows the wetlands along the bank tops and the erosion bank erosion along the stream caused by the lack of a riparian buffer strip along the stream.

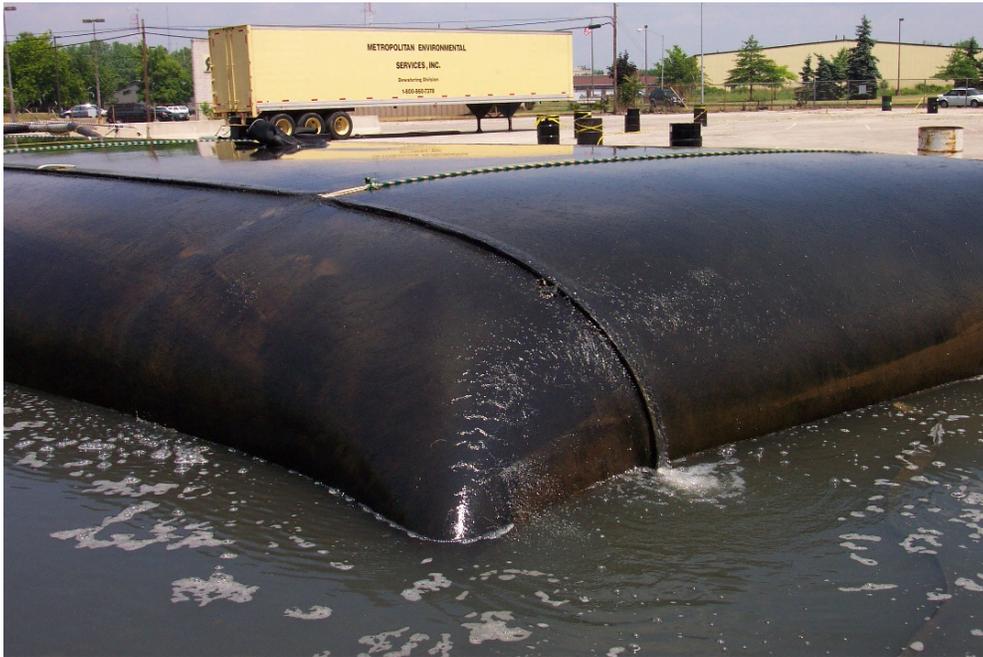
Photo 26 – Geotube being filled with sediment from the Mahoning River, Ohio, environmental dredging project. The water seen in the photos is draining from within the tube itself. The drainage water is then directed back into the Mahoning River.

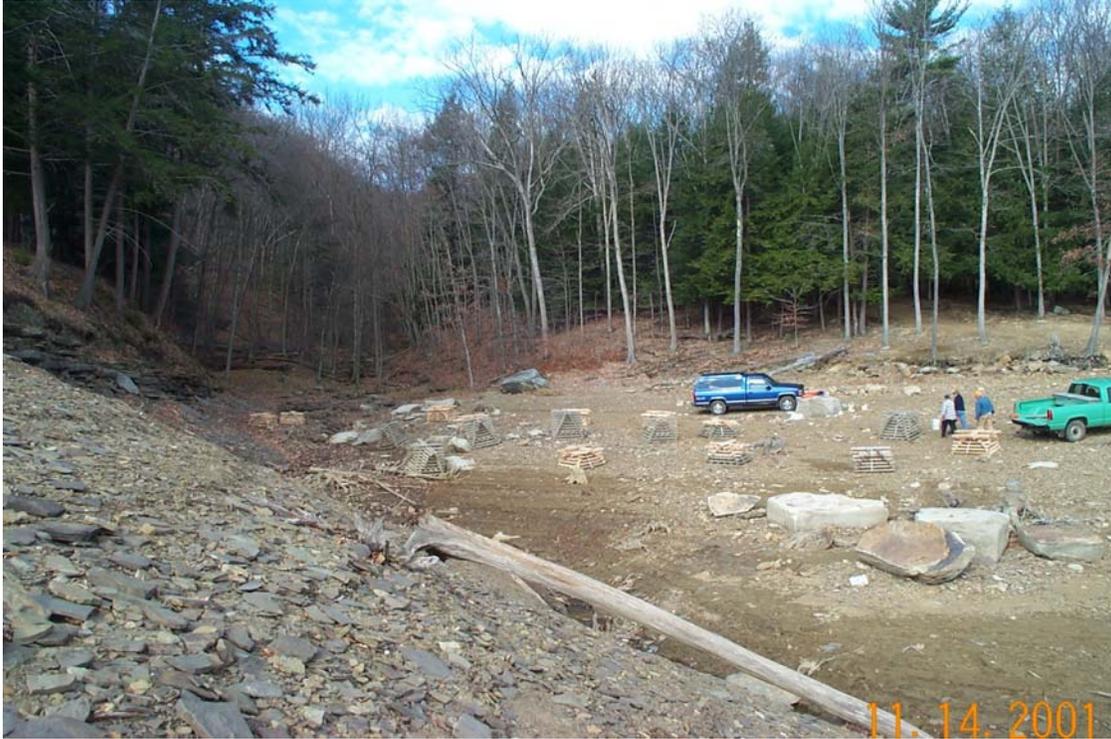
Photo 27 – Porcupine cribs being placed in the dry on the bed of a lake.

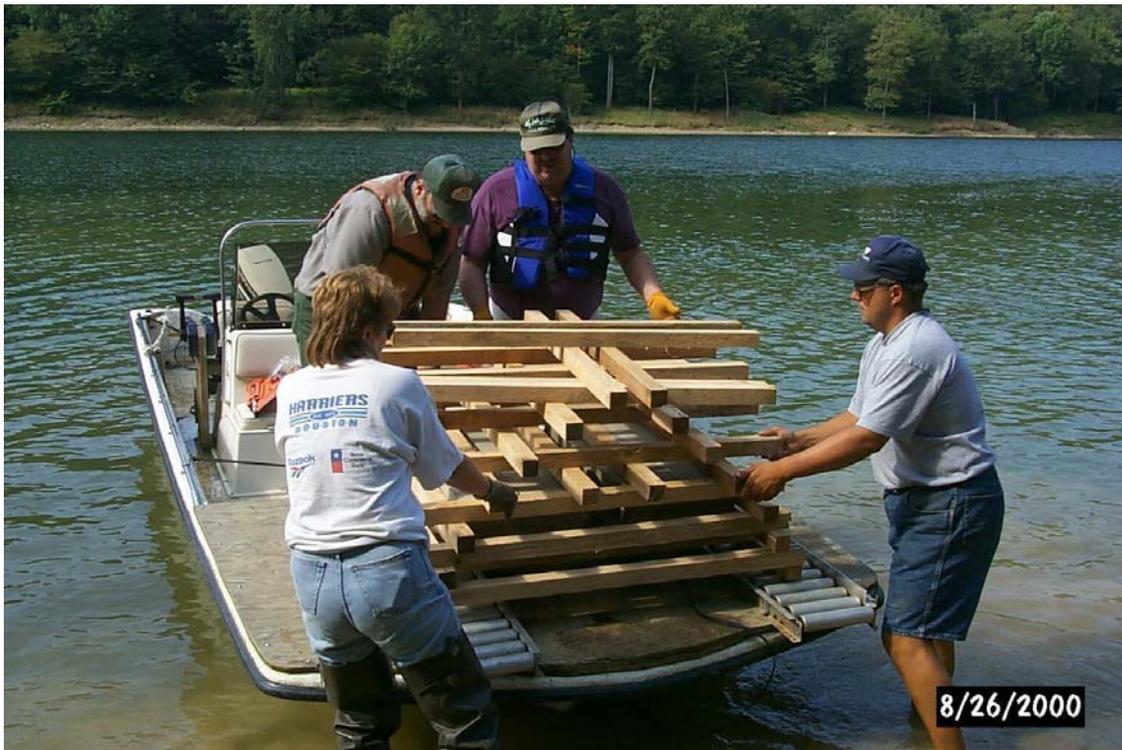
Photo 28 – Porcupine Crib Jr. being loaded on a small boat to be floated out to its final location.

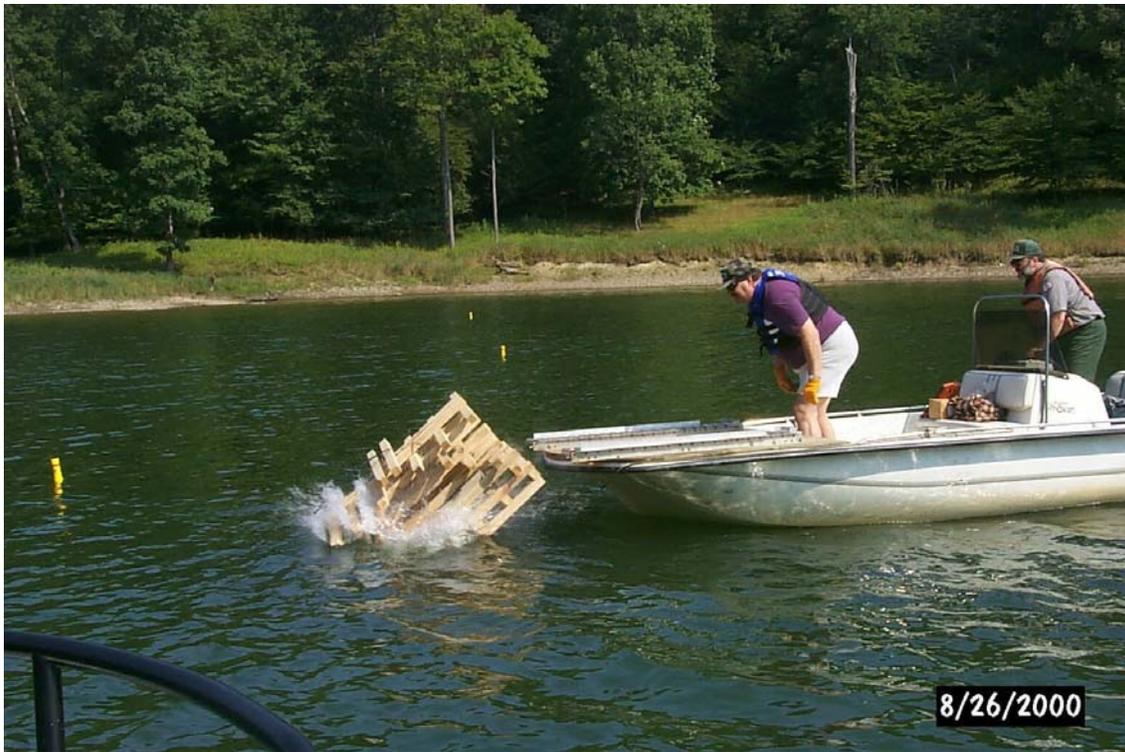
Photo 29 – Porcupine crib Junior being offloaded from a small boat.
