**US Army Corps
of Engineers®**

**Draft
Detailed Project Report
And
Integrated Environmental Assessment**

**HYDRAULICS AND
HYDROLOGY**

**North Park Lake
Allegheny County, PA
Section 206 Aquatic Ecosystem
Restoration Project**

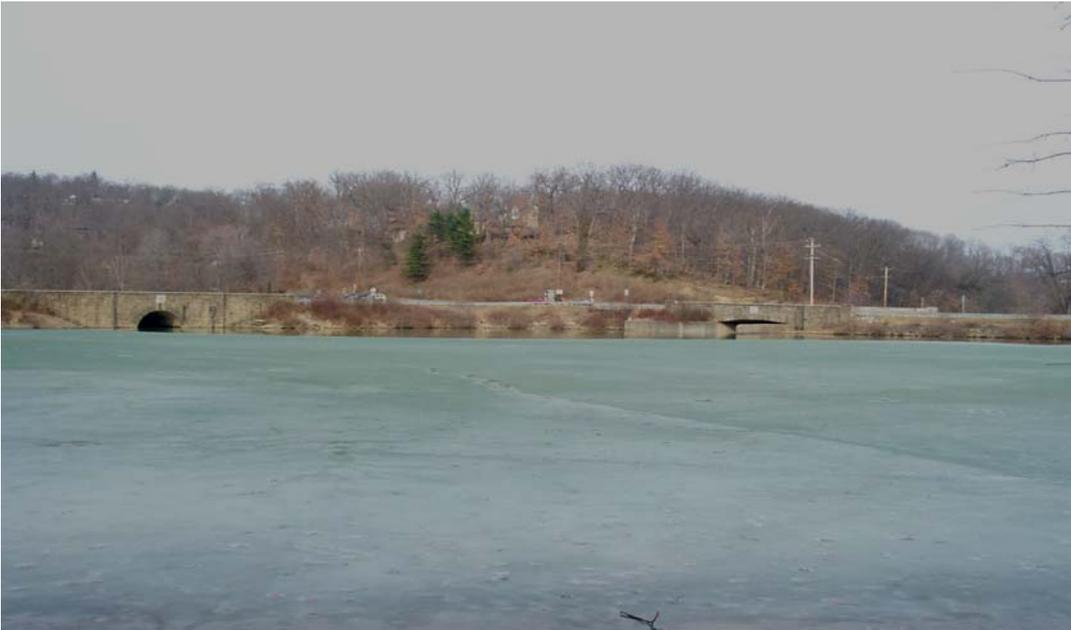
Photograph 2. Pine Creek Dam

Pine Creek Dam is 33 feet high, approximately 1,130 feet long, has a 60-foot wide crest and is located on Pine Creek. It has an uncontrolled spillway set at 10 feet below the top of the dam. The outlet works consist of an intake tower with a manually controlled 5 foot by 5 foot sluice gate which has not been operated recently. Table 1 shows pertinent
