**U.S. ARMY CORPS OF ENGINEERS
REGULATORY PROGRAM
APPROVED JURISDICTIONAL DETERMINATION FORM (INTERIM)
NAVIGABLE WATERS PROTECTION RULE**

ORM Number: LRP-2021-00067

Review Area Location¹: State/Territory: West Virginia City: Martinsburg County/Parish/Borough: Berkeley County

MARTINSBURG PROPERTY
5139 WILLIAMSPORT PIKE
BERKELEY COUNTY, WEST VIRGINIA

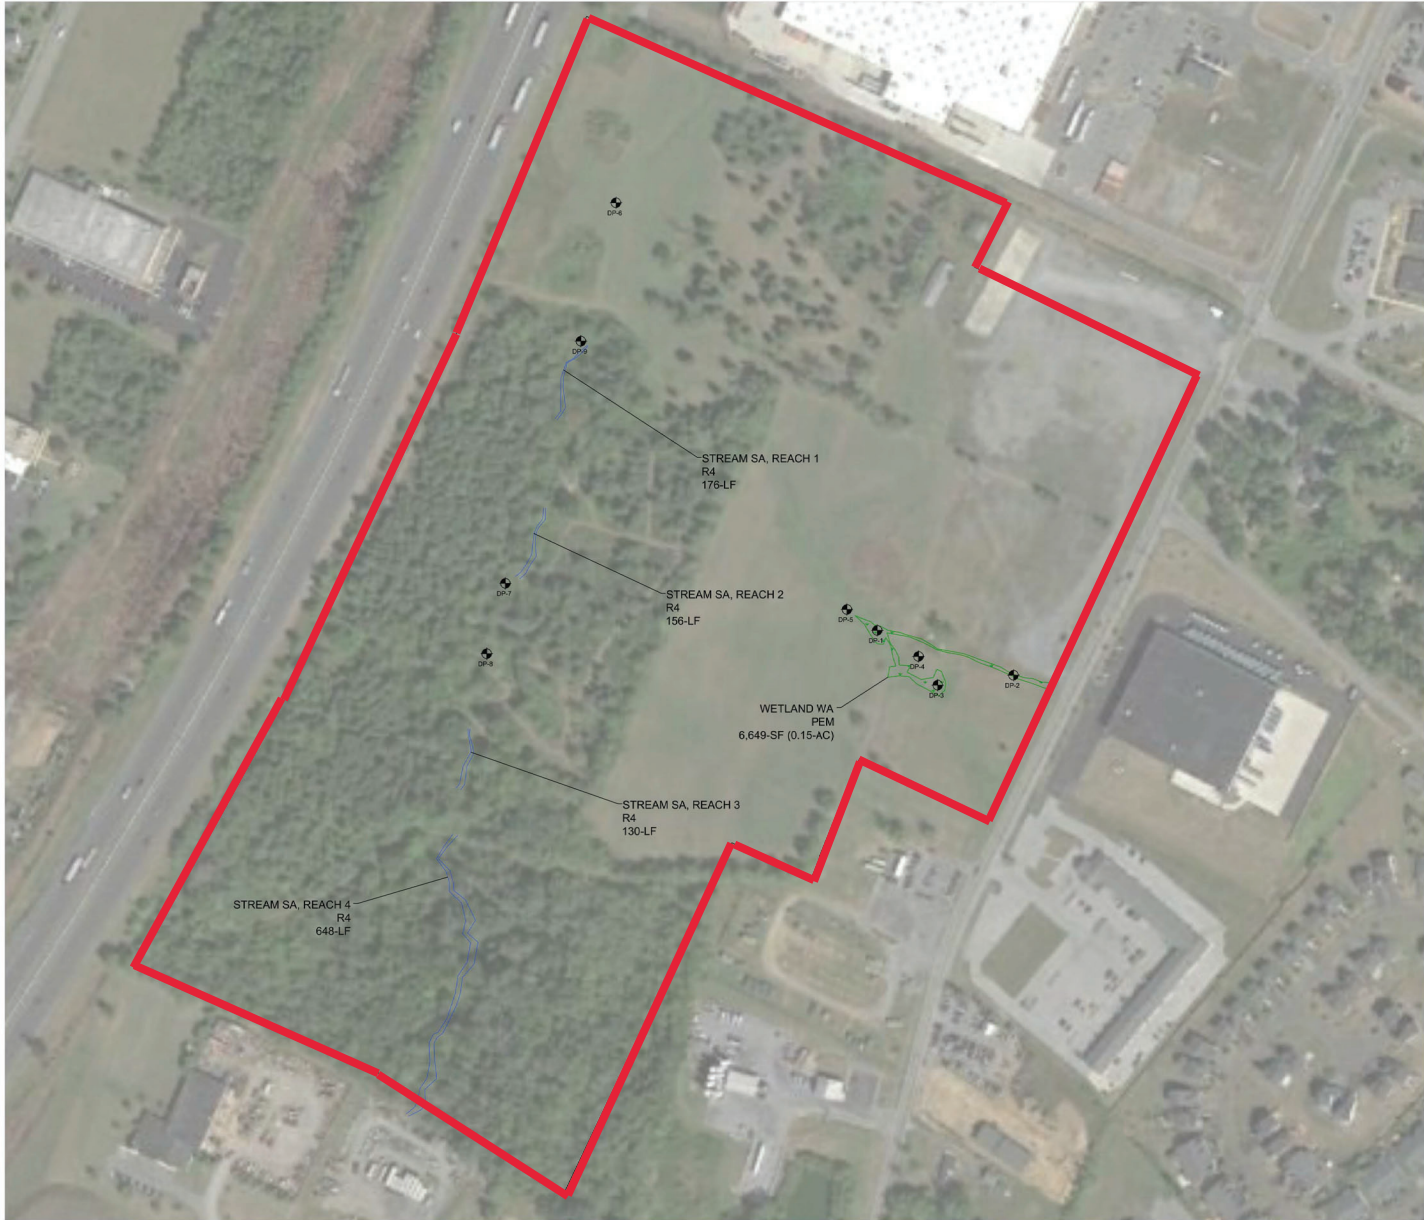
WATERS OF THE U.S.
DELINEATION MAP
NOVA VENTURES

*WATER FEATURES WERE DELINEATED BY ECS ON JANUARY 11, 2021 AND LOCATED USING A SUB-METER ACCURACY GPS UNIT

Resource and jurisdiction evaluation found in AJD Form
