DRY LAND APPROVED JURISDICTIONAL DETERMINATION FORM¹
U.S. Army Corps of Engineers

B. DISTRICT OFFICE, FILE NAME, AND NUMBER: CELRP-RG-S 2021-00285

State: West Virginia County/parish/borough: Berkeley City: Martinsburg
Center coordinates of site (lat/long in degree decimal format): Lat. 39.469823 °, Long. -77.919283 °
Universal Transverse Mercator: 18T, 248873/4372984

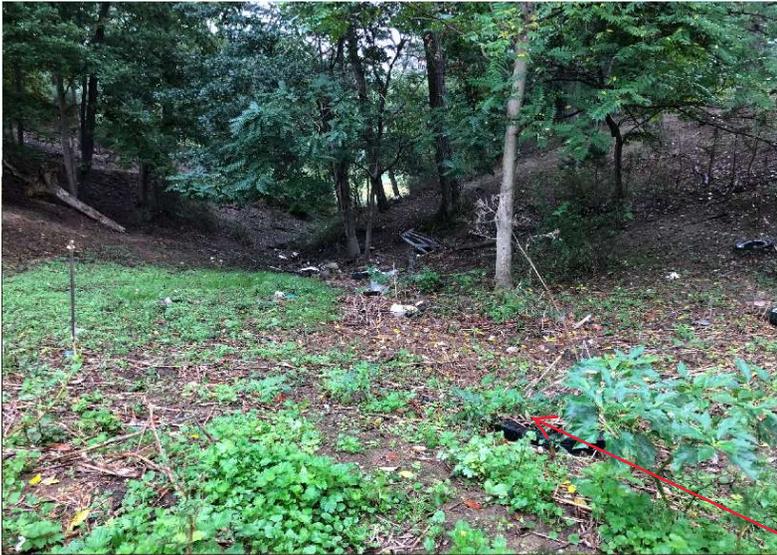
Facing Southeast looking down valley bottom. Some wracking of materials found as evidence of surface flows, though no identifiable bed & bank of a stream feature.
