# PHASE I ENVIRONMENTAL SITE ASSESSMENT REPORT

**PHASE I ENVIRONMENTAL SITE ASSESSMENT  
RIO GRANDE DE MANATI FLOOD RISK MANAGEMENT STUDY  
CIALES, PUERTO RICO**

**U.S. Army Corps of Engineers  
Pittsburgh District**

**SEPTEMBER 2019**

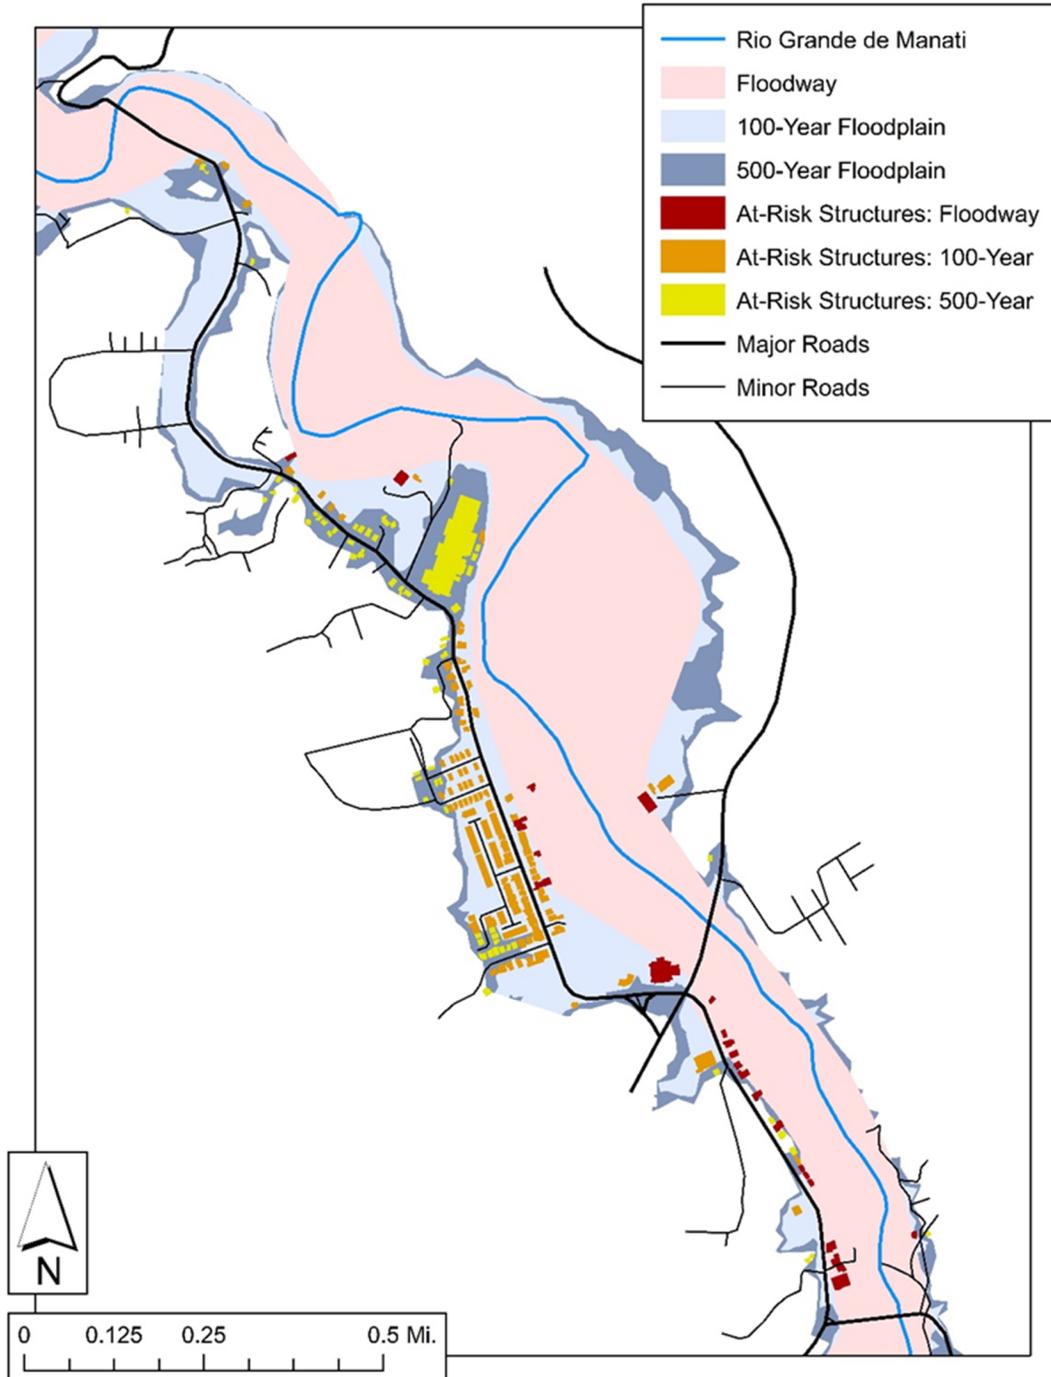
Figure 5. Floodway and 100- and 500-year Floodplains

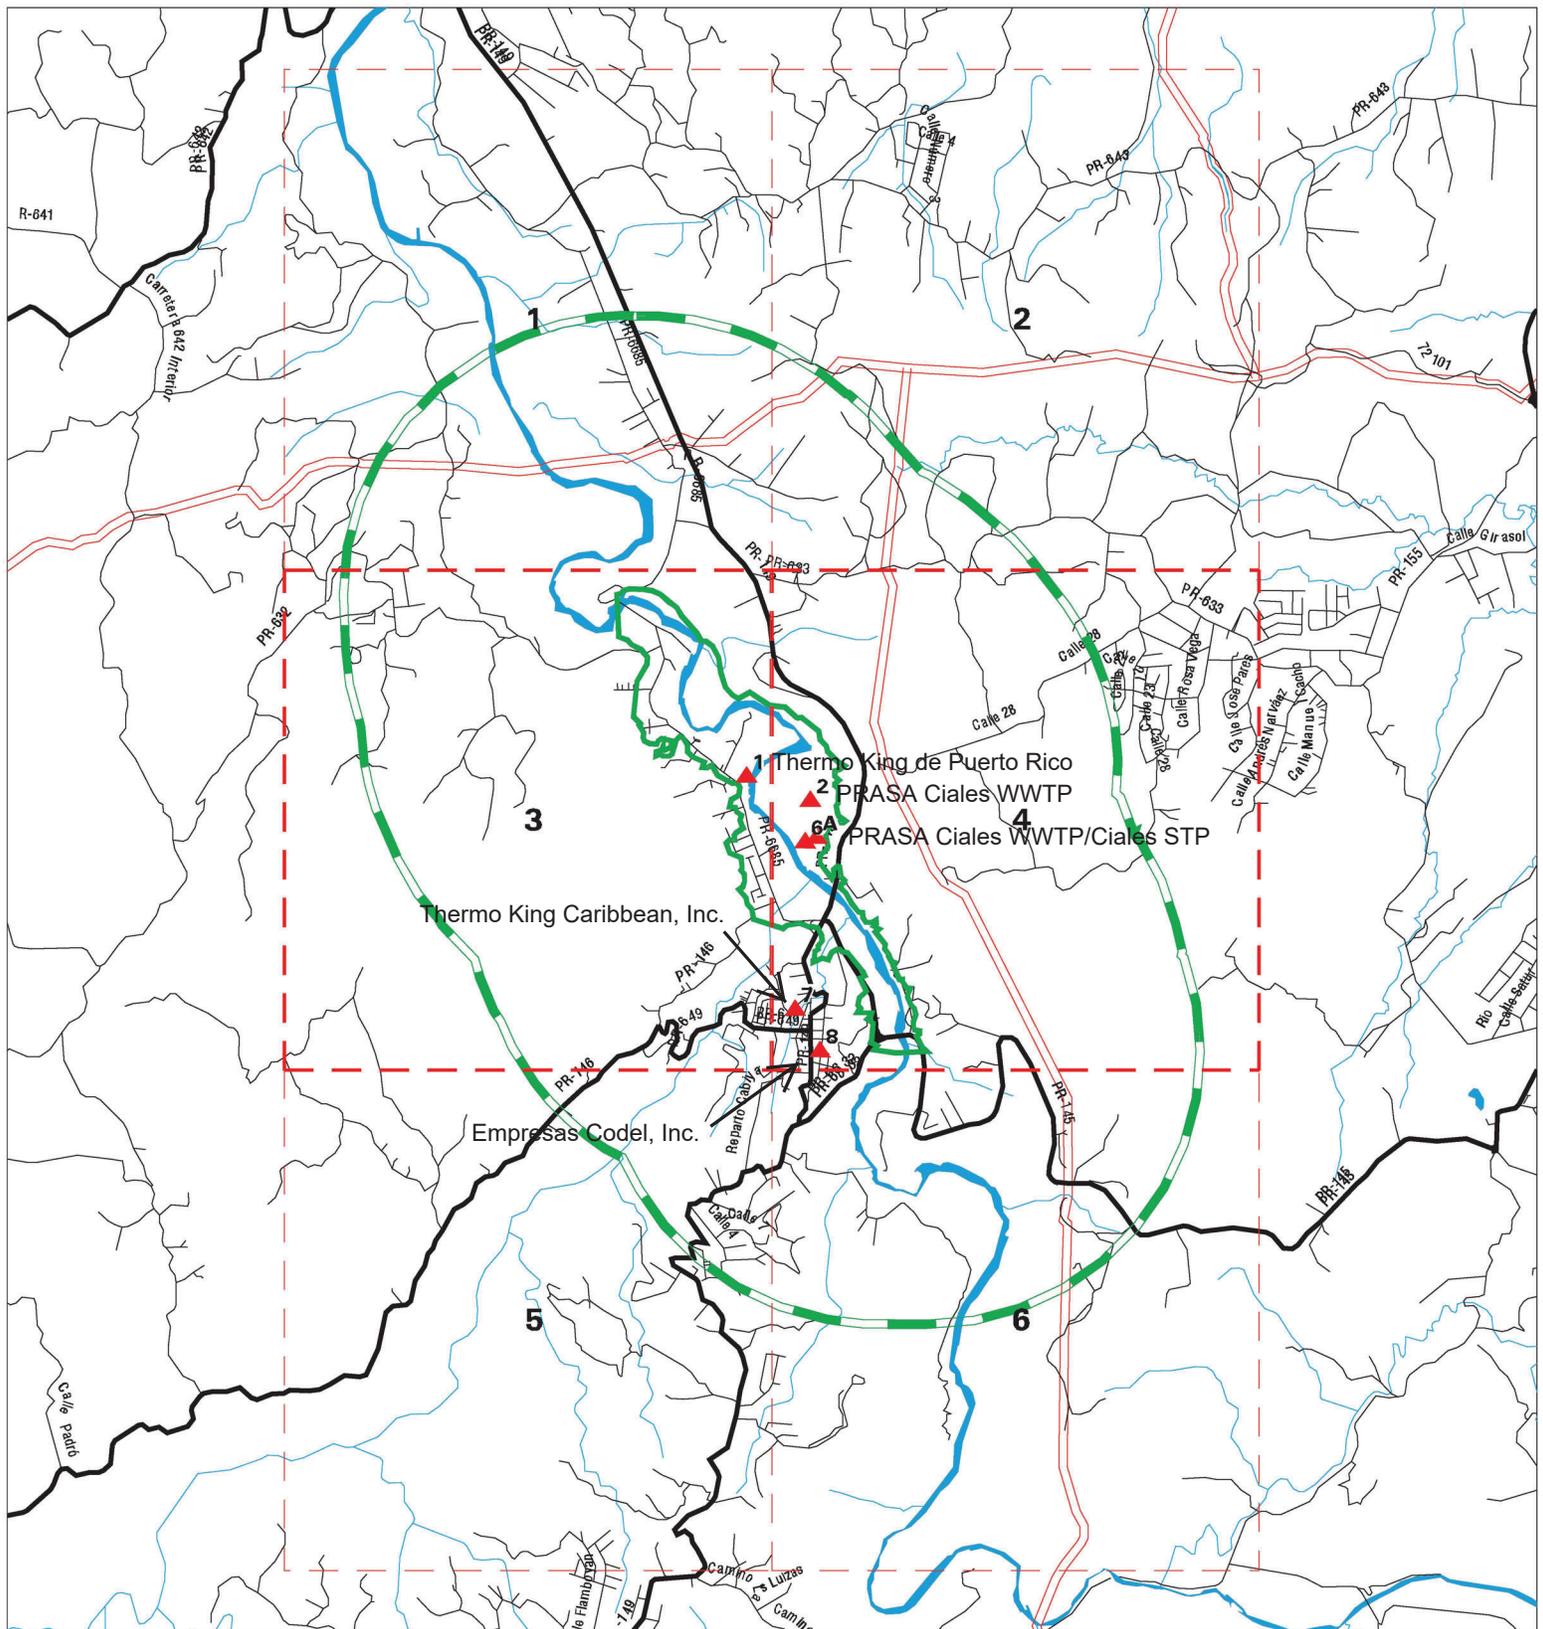
**Figure 7. USEPA List of Toxic Releases, Hazardous Waste Sources & Water Discharges**

A review was conducted of USEPA EnviroMapper website for petroleum and hazardous material releases in the vicinity of the Study Area (Figure 7). Results of the search indicate the sites listed in Table 2 below and shown in Figure 7 are located within the Study Area and within approximately one mile of the Study Area.

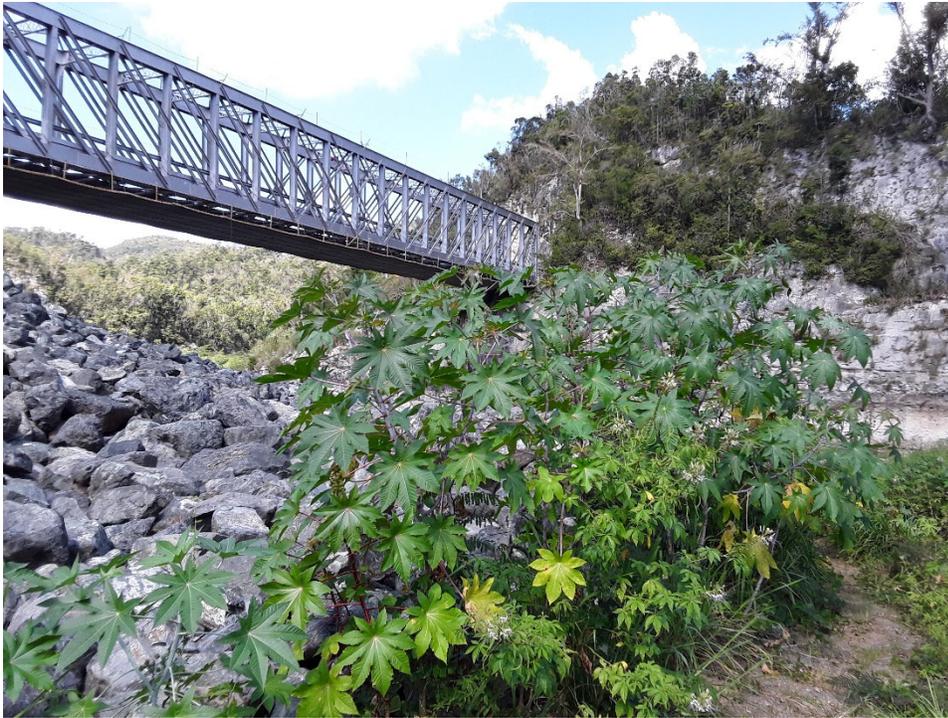
Photo 1. General view of terrain at the northern end of the Study Area, including the Mata de Platanos Bridge along PR-6685, which spans the Rio Grande de Manati River. Photo view northwest.

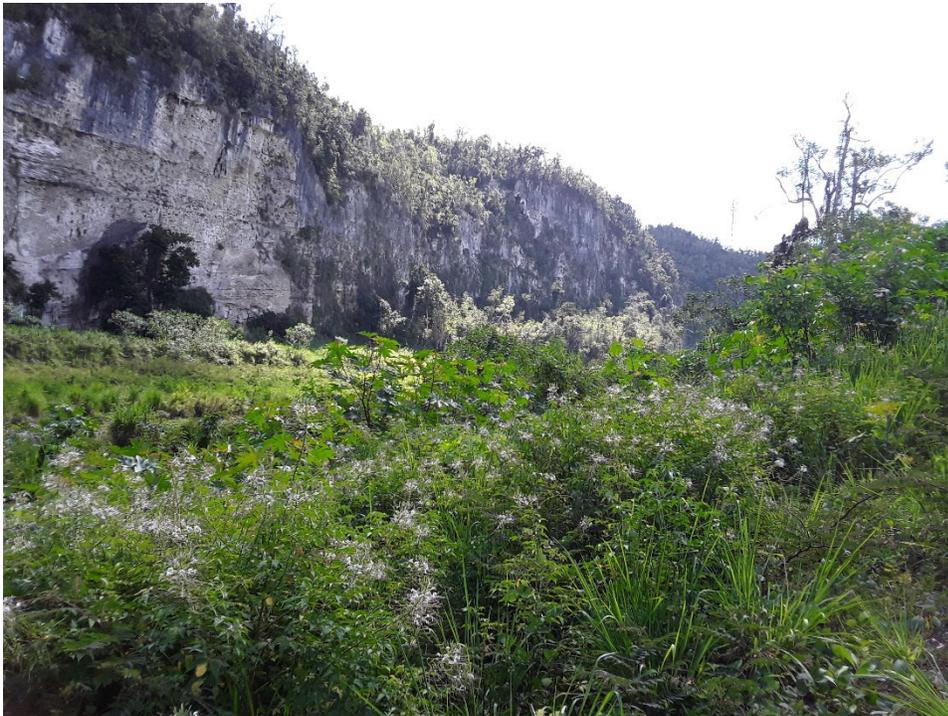
Photo 2. General view along the Rio Grande de Manati River. Exposed cliff face is on the right descending side of the river. Photo view east.

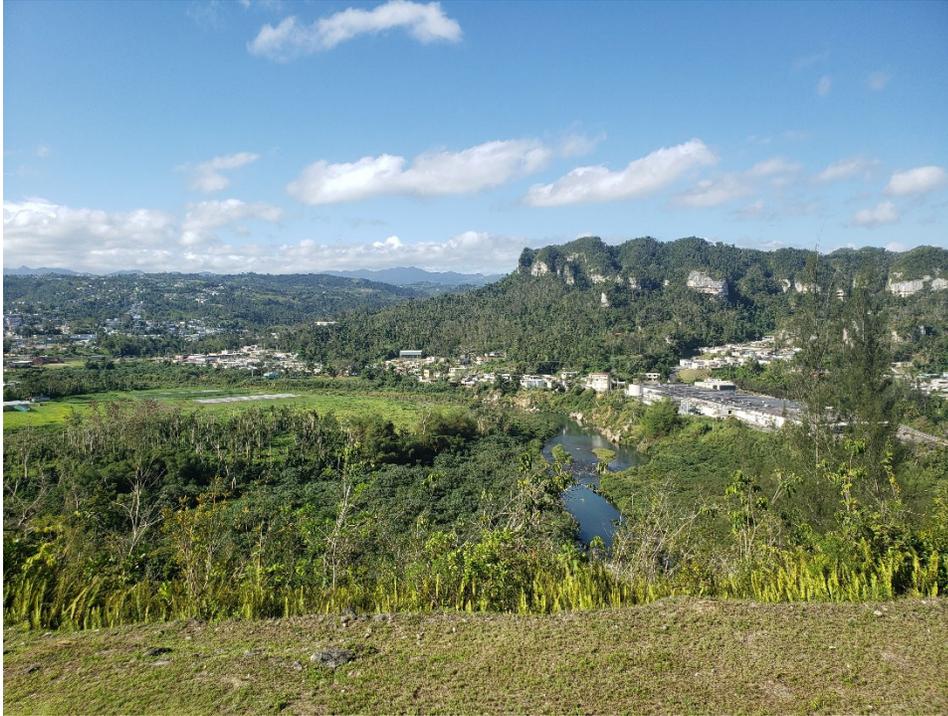
Photo 3. General view of the project area from the scenic overlook located along PR-149. The former Thermo King de Puerto Rico industrial building is located adjacent to the Rio Grande de Manati River at right of center. Photo view southwest.

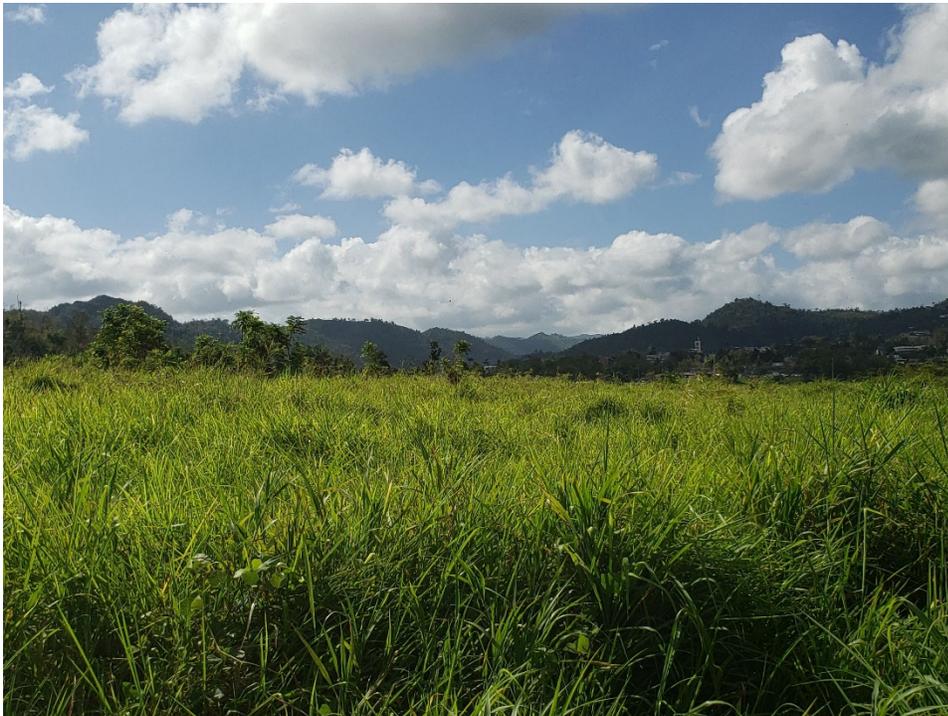
Photo 4. General view of a grassland agricultural field along the right descending bank of the Rio Grande de Manati River. Photo view east.

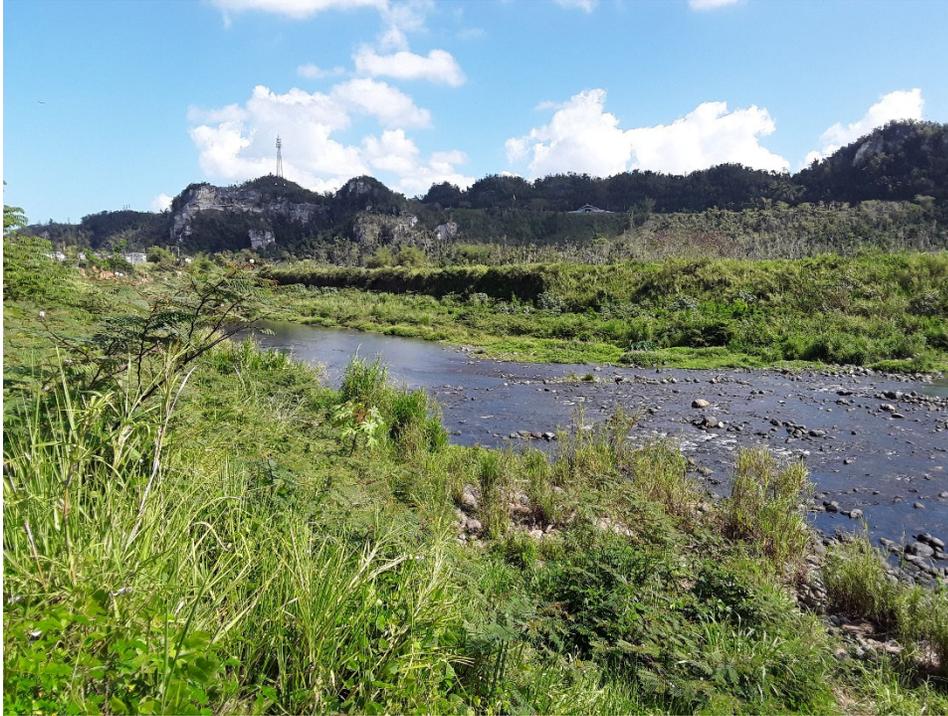
Photo 5. General view along the left descending bank of the Rio Grande de Manati River. Photo view north.

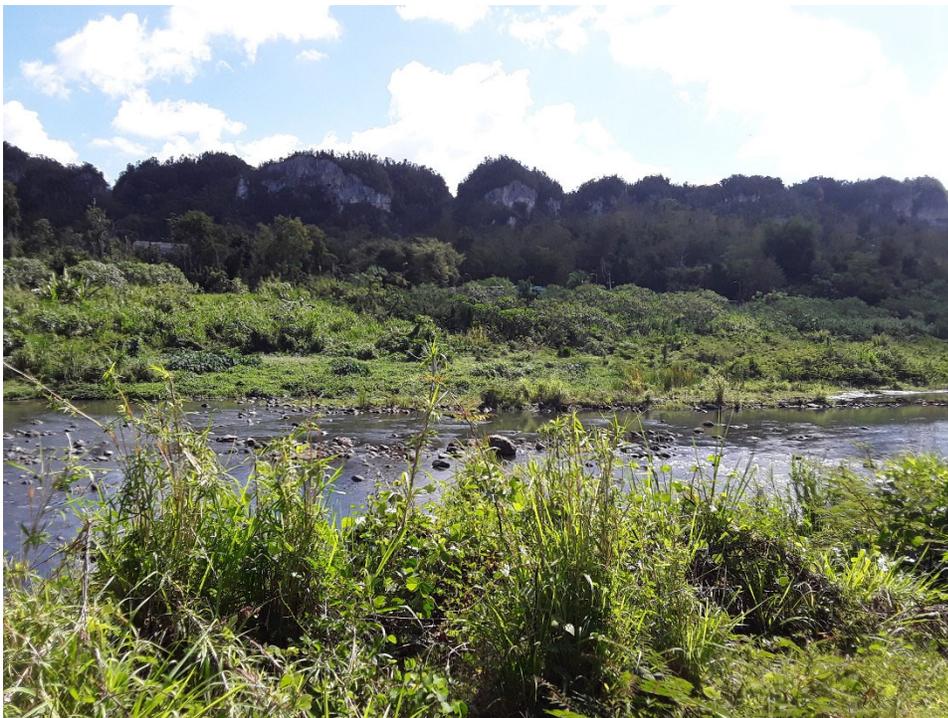
Photo 6. General view along the left descending bank of the Rio Grande de Manati River. Photo view east.

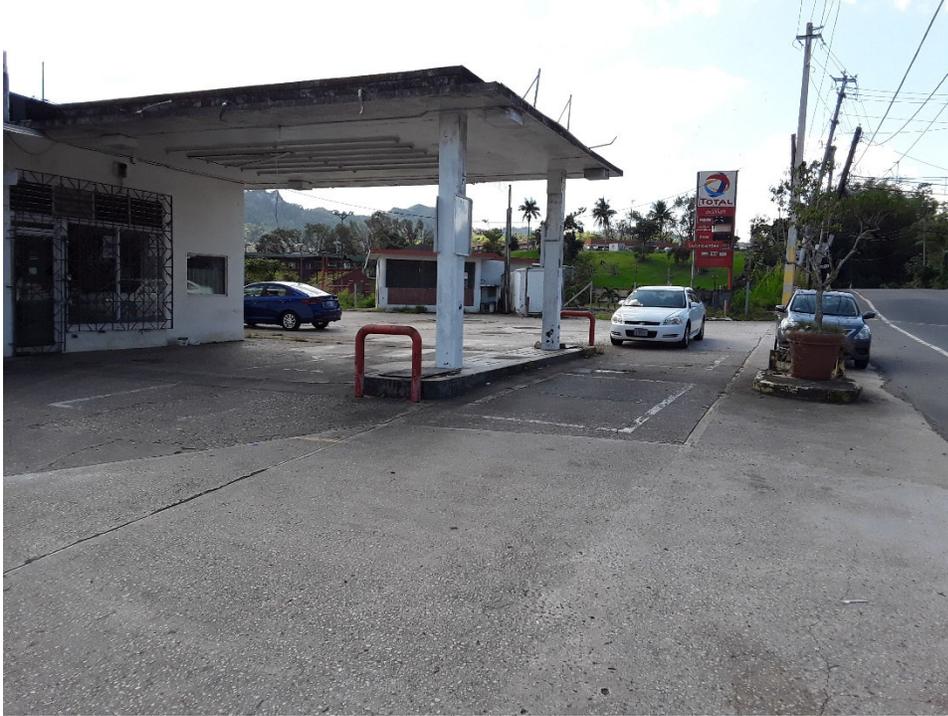
Photo 7. View of a vacant gasoline station at the intersection of PR-146 and PR-6685. Photo view southeast.

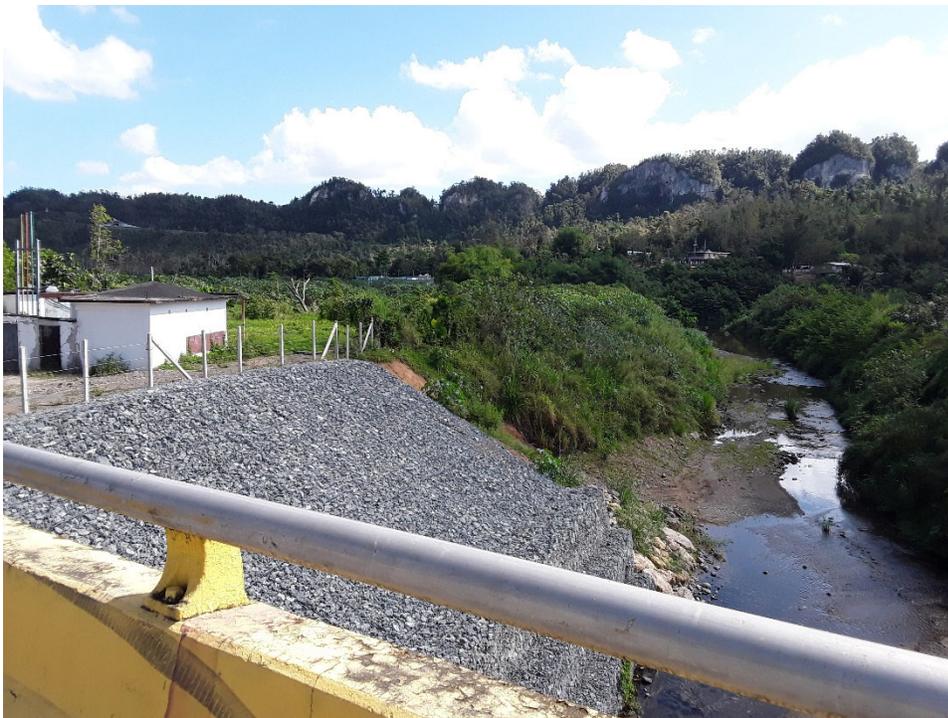
Photo 8. General view of Rio Cialitos Creek. The gasoline station property in Photo 7 above is visible at left of center. Photo view northeast from PR-146 Bridge.

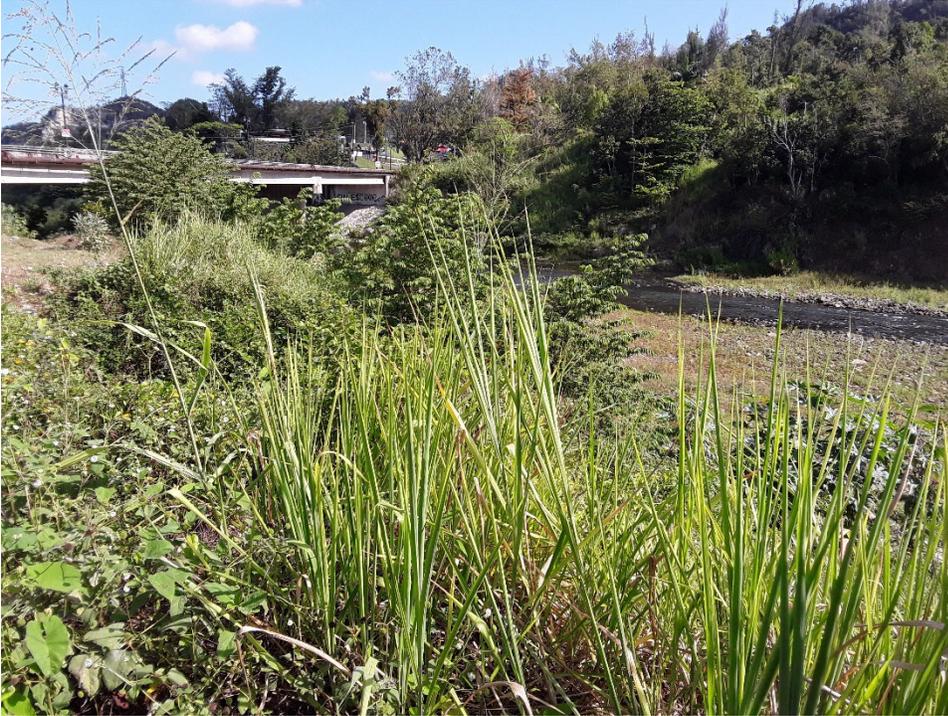
Photo 9. General view of the PR-149 Bridge spanning the Rio Grande de Manati River. Photo view northwest.

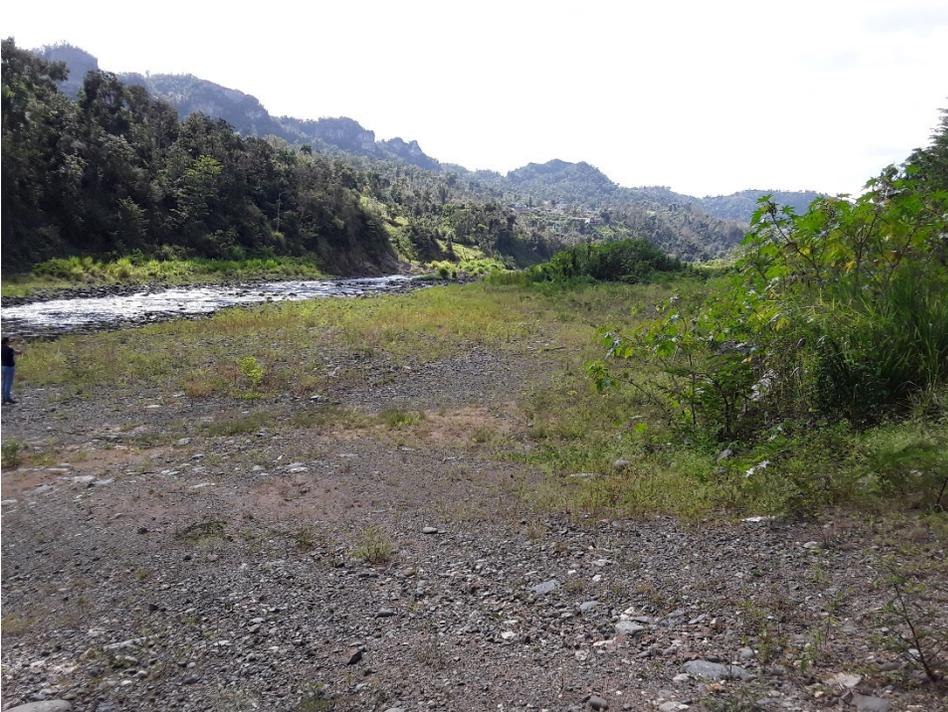
Photo 10. General view along the left descending bank of the Rio Grande de Manati River. Photo view southeast.

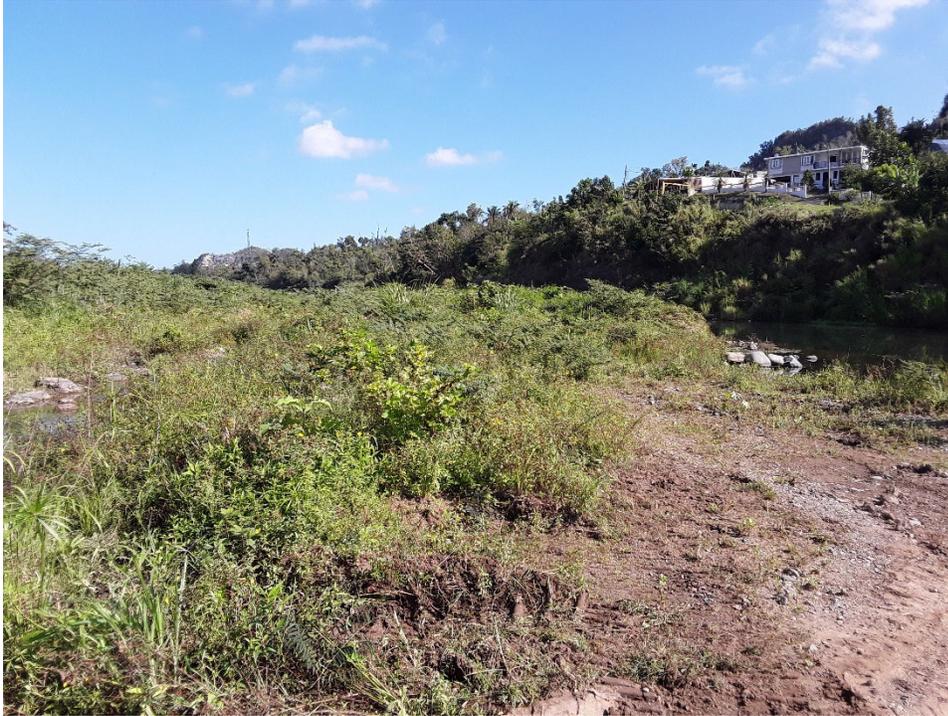
Photo 11. General view along the left descending bank of the Rio Grande de Manati River. Photo view northwest.

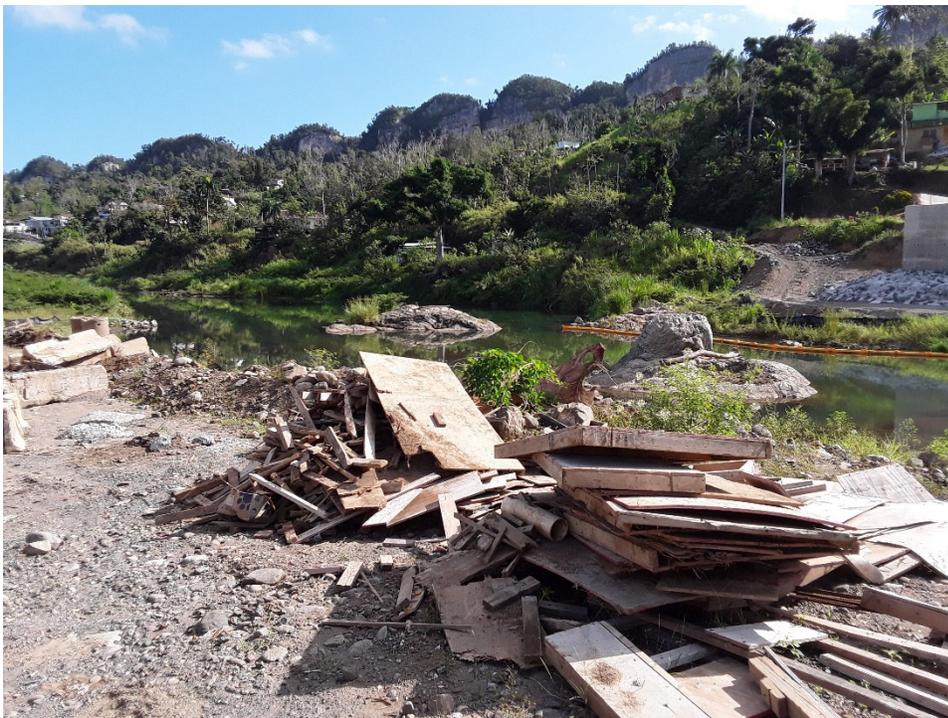
Photo 12. General view of the PR-145 Bridge construction site at the southern end of the Study Area. Construction debris is visible in the foreground. The newly-constructed bridge abutment is visible along right side of photograph. Photo view northeast.

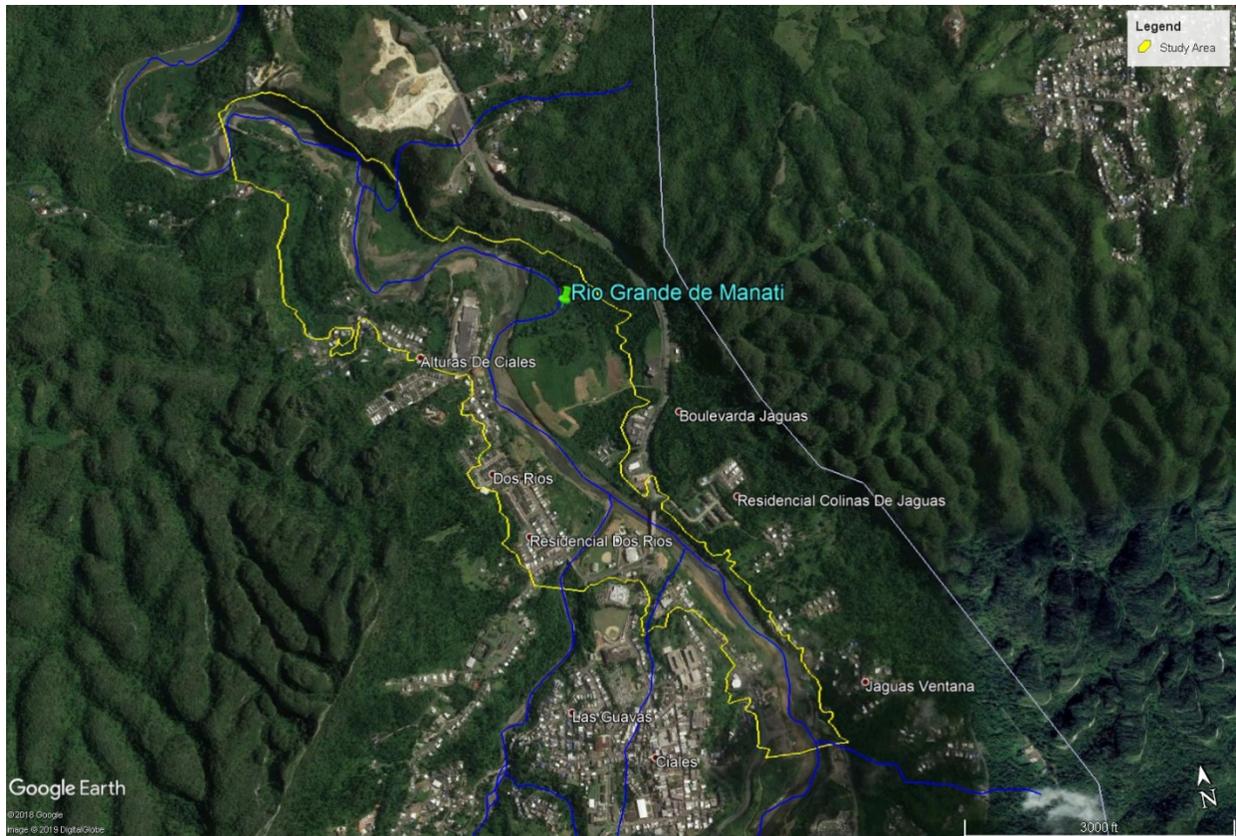
Figure 2. Rio Grande de Manati location within the study area.

The Municipality of Ciales is located on the northern slopes of the Central Mountain Range, approximately 25 miles southwest of San Juan (Figure 1). Approximate coordinates in the center of the study area are 18.345784°N and -66.469817°W. The Rio Grande de Manati flows through the study area (Figure 2).

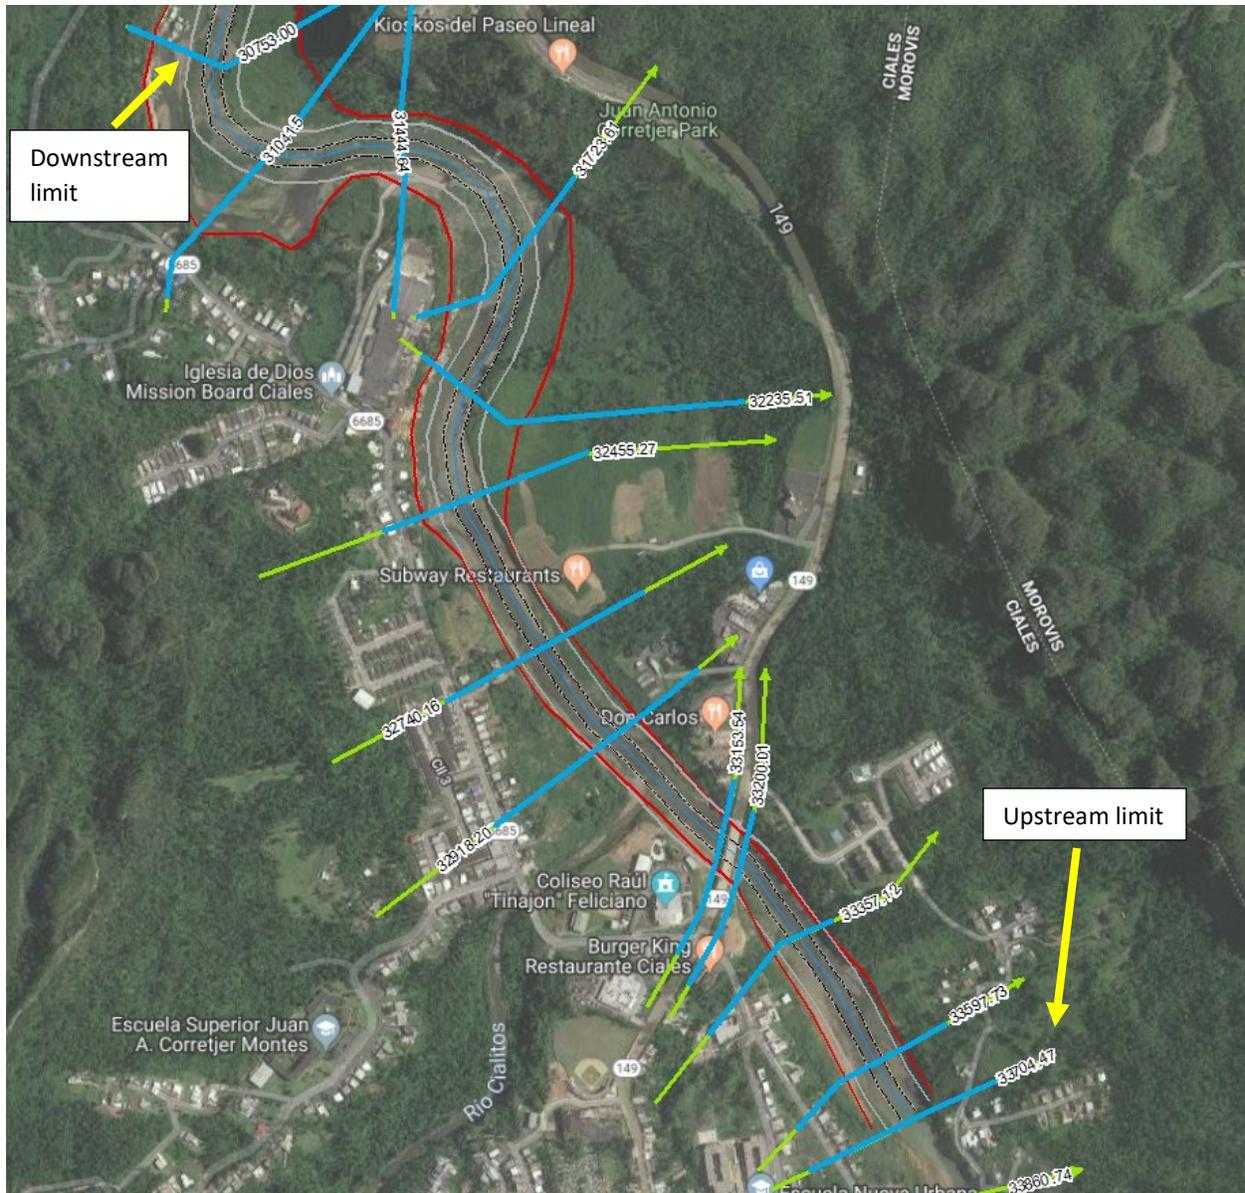
Alternative 2. Channelization: Channelization involves constructing approximately 9,000 linear feet of concrete-lined channel within existing riverbank limits (Figure 3). The trapezoidal channel would be approximately 280 feet wide and 15 feet deep, requiring excavation (i.e., widening and deepening) within the existing riverbed. Channelization would reduce flood risk by increasing capacity and expediting water movement through the study area, as well as prevent additional stream bank erosion.

Figure 3. Extent of channelization associated with Alternative 2 (gray and black lines). Blue and green lines represent cross sections. Channelization would occur between cross sections 33704.47 and 30753.00.

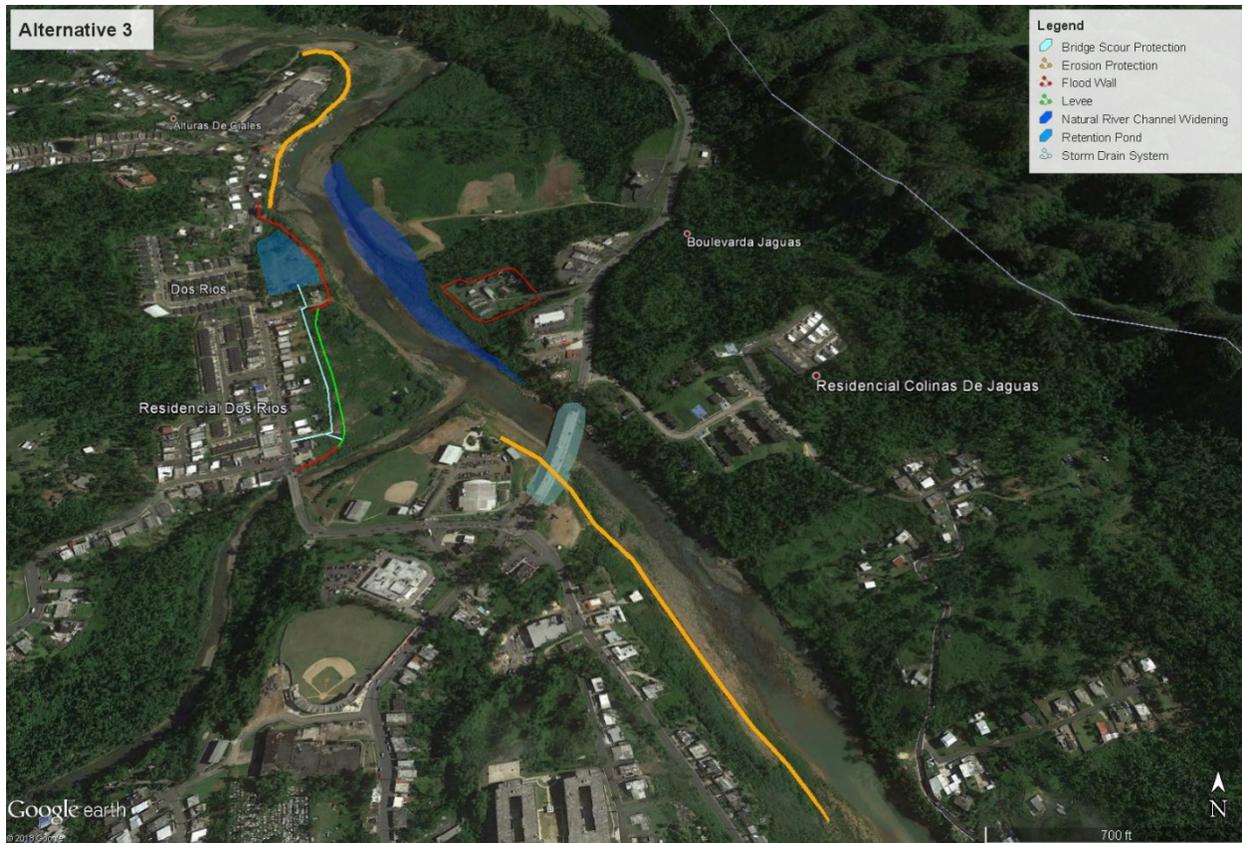
**Alternative 3. Levee/Floodwall & Stream Bank Protection:** This alternative incorporates the original, locally developed 2008 Flood Protection Works project design, which included a combined levee/floodwall system, a drainage system and retention pond, as well as channel improvements to reduce flood risk within the community of Dos Rios. Alternative 3 also incorporates a 1,200-foot floodwall around the wastewater treatment plant and approximately 4,000 linear feet of riprap stream bank protection that would require excavation to key the riprap into the channel (Figure 4).

Figure 4. Management measures associated with Alternative 3, including bridge scour protection, bank erosion protection, floodwall/levee system, and channel improvement (widening).

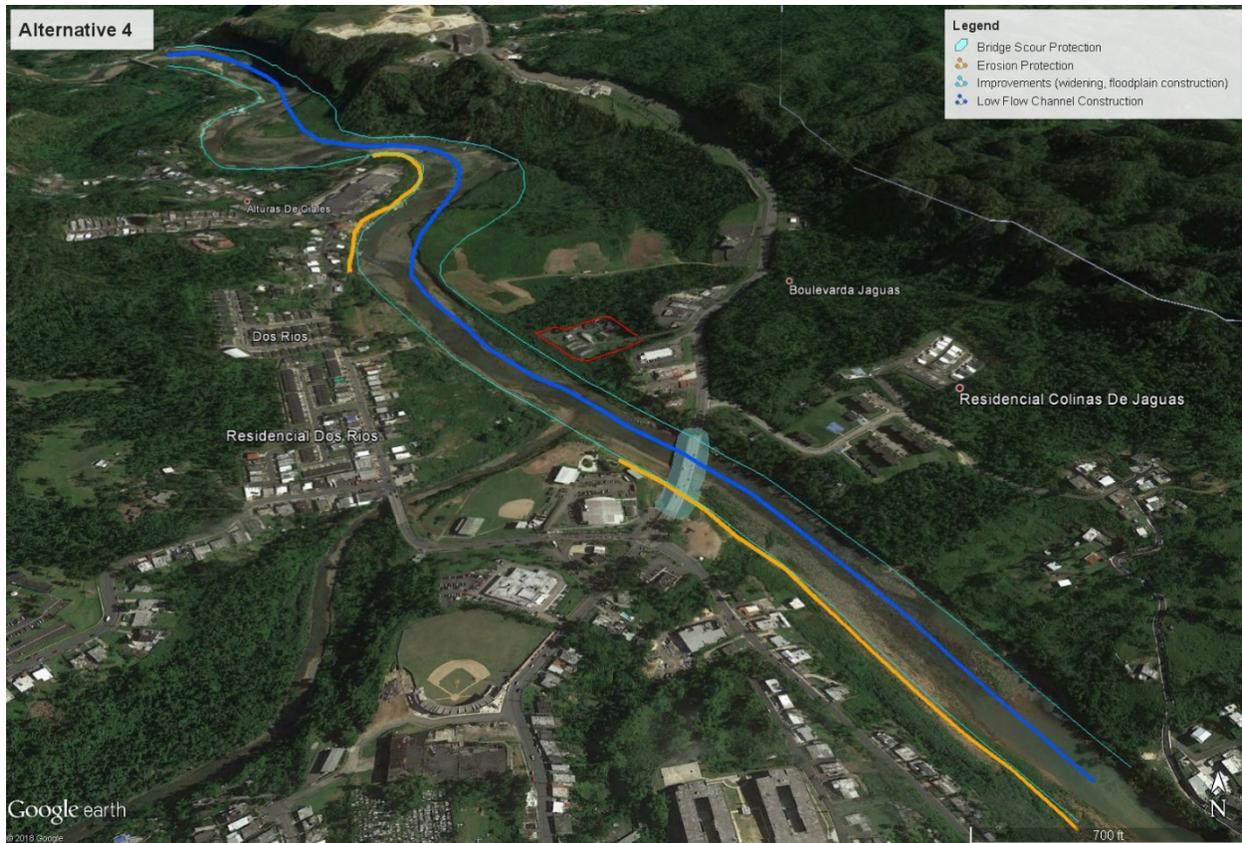
**Alternative 4. Channel Improvement & Realignment:** This alternative includes construction of approximately 10,000 feet of new, meandering low flow channel and widening of the channel within the existing floodplain to improve hydraulic conductivity and increase capacity. Channel improvements (i.e., widening and deepening) at the PR-149 Bridge would be designed to reduce water backup upstream of the bridge. Alternative 4 also incorporates a 1,200-foot floodwall around the wastewater treatment plant and approximately 4,000 linear feet of riprap stream bank protection that would require excavation to key the riprap into the channel (Figure 5).

Figure 5. Management measures associated with Alternative 4, including low flow channel construction, stream improvements (i.e., widening, floodplain construction), a flood wall around the water treatment plant, stream bank protection, and bridge scour protection.

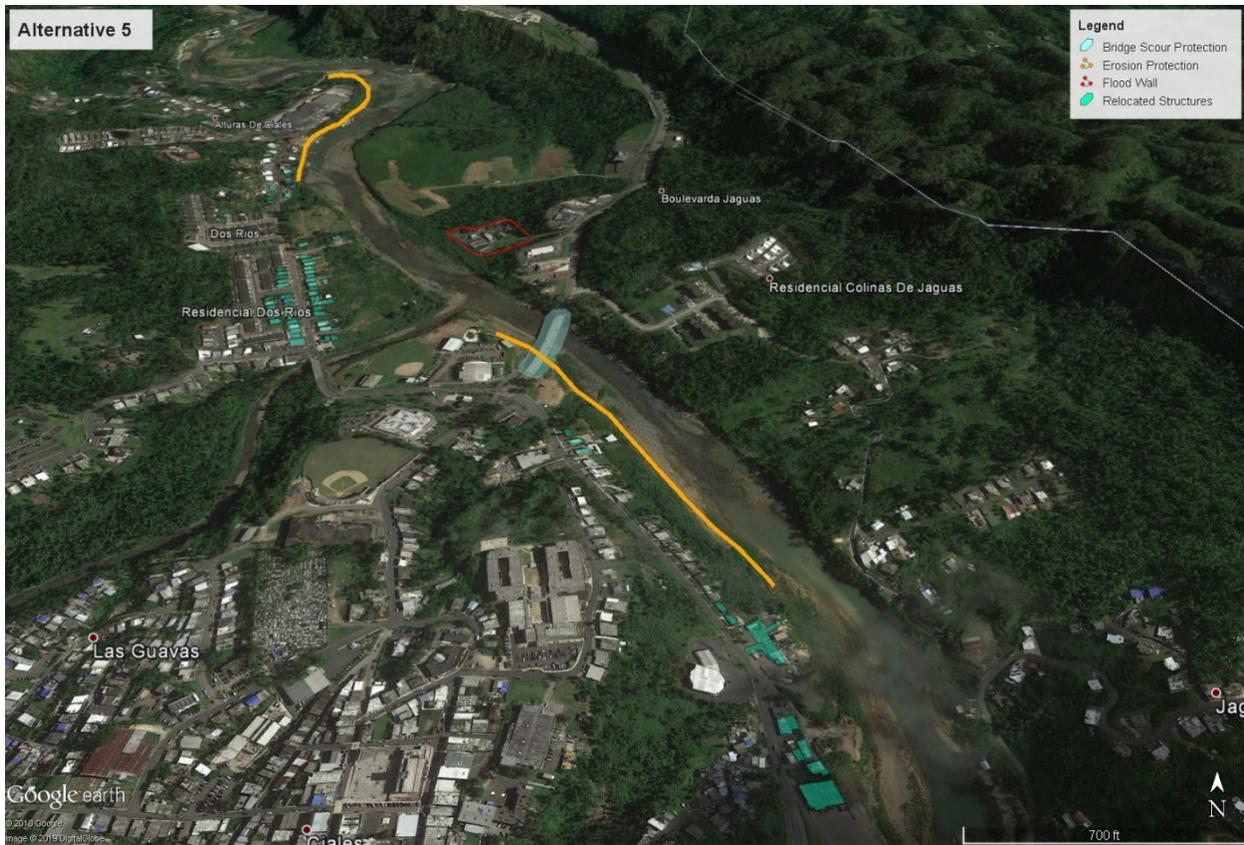
Alternative 5. Non-structural Relocations & Stream Bank Protection: Private structures within the 25-year floodplain would be acquired and demolished. Residents would be relocated outside of the floodplain. A 1200-foot floodwall would be constructed around the wastewater treatment plant. Alternative 5 also includes approximately 4,000 linear feet of riprap stream bank protection that would require excavation to key the riprap into the channel (Figure 6).

Figure 6. Management measures associated with Alternative 5, including structure relocation, bridge scour protection, bank erosion protection, and a floodwall/levee system.

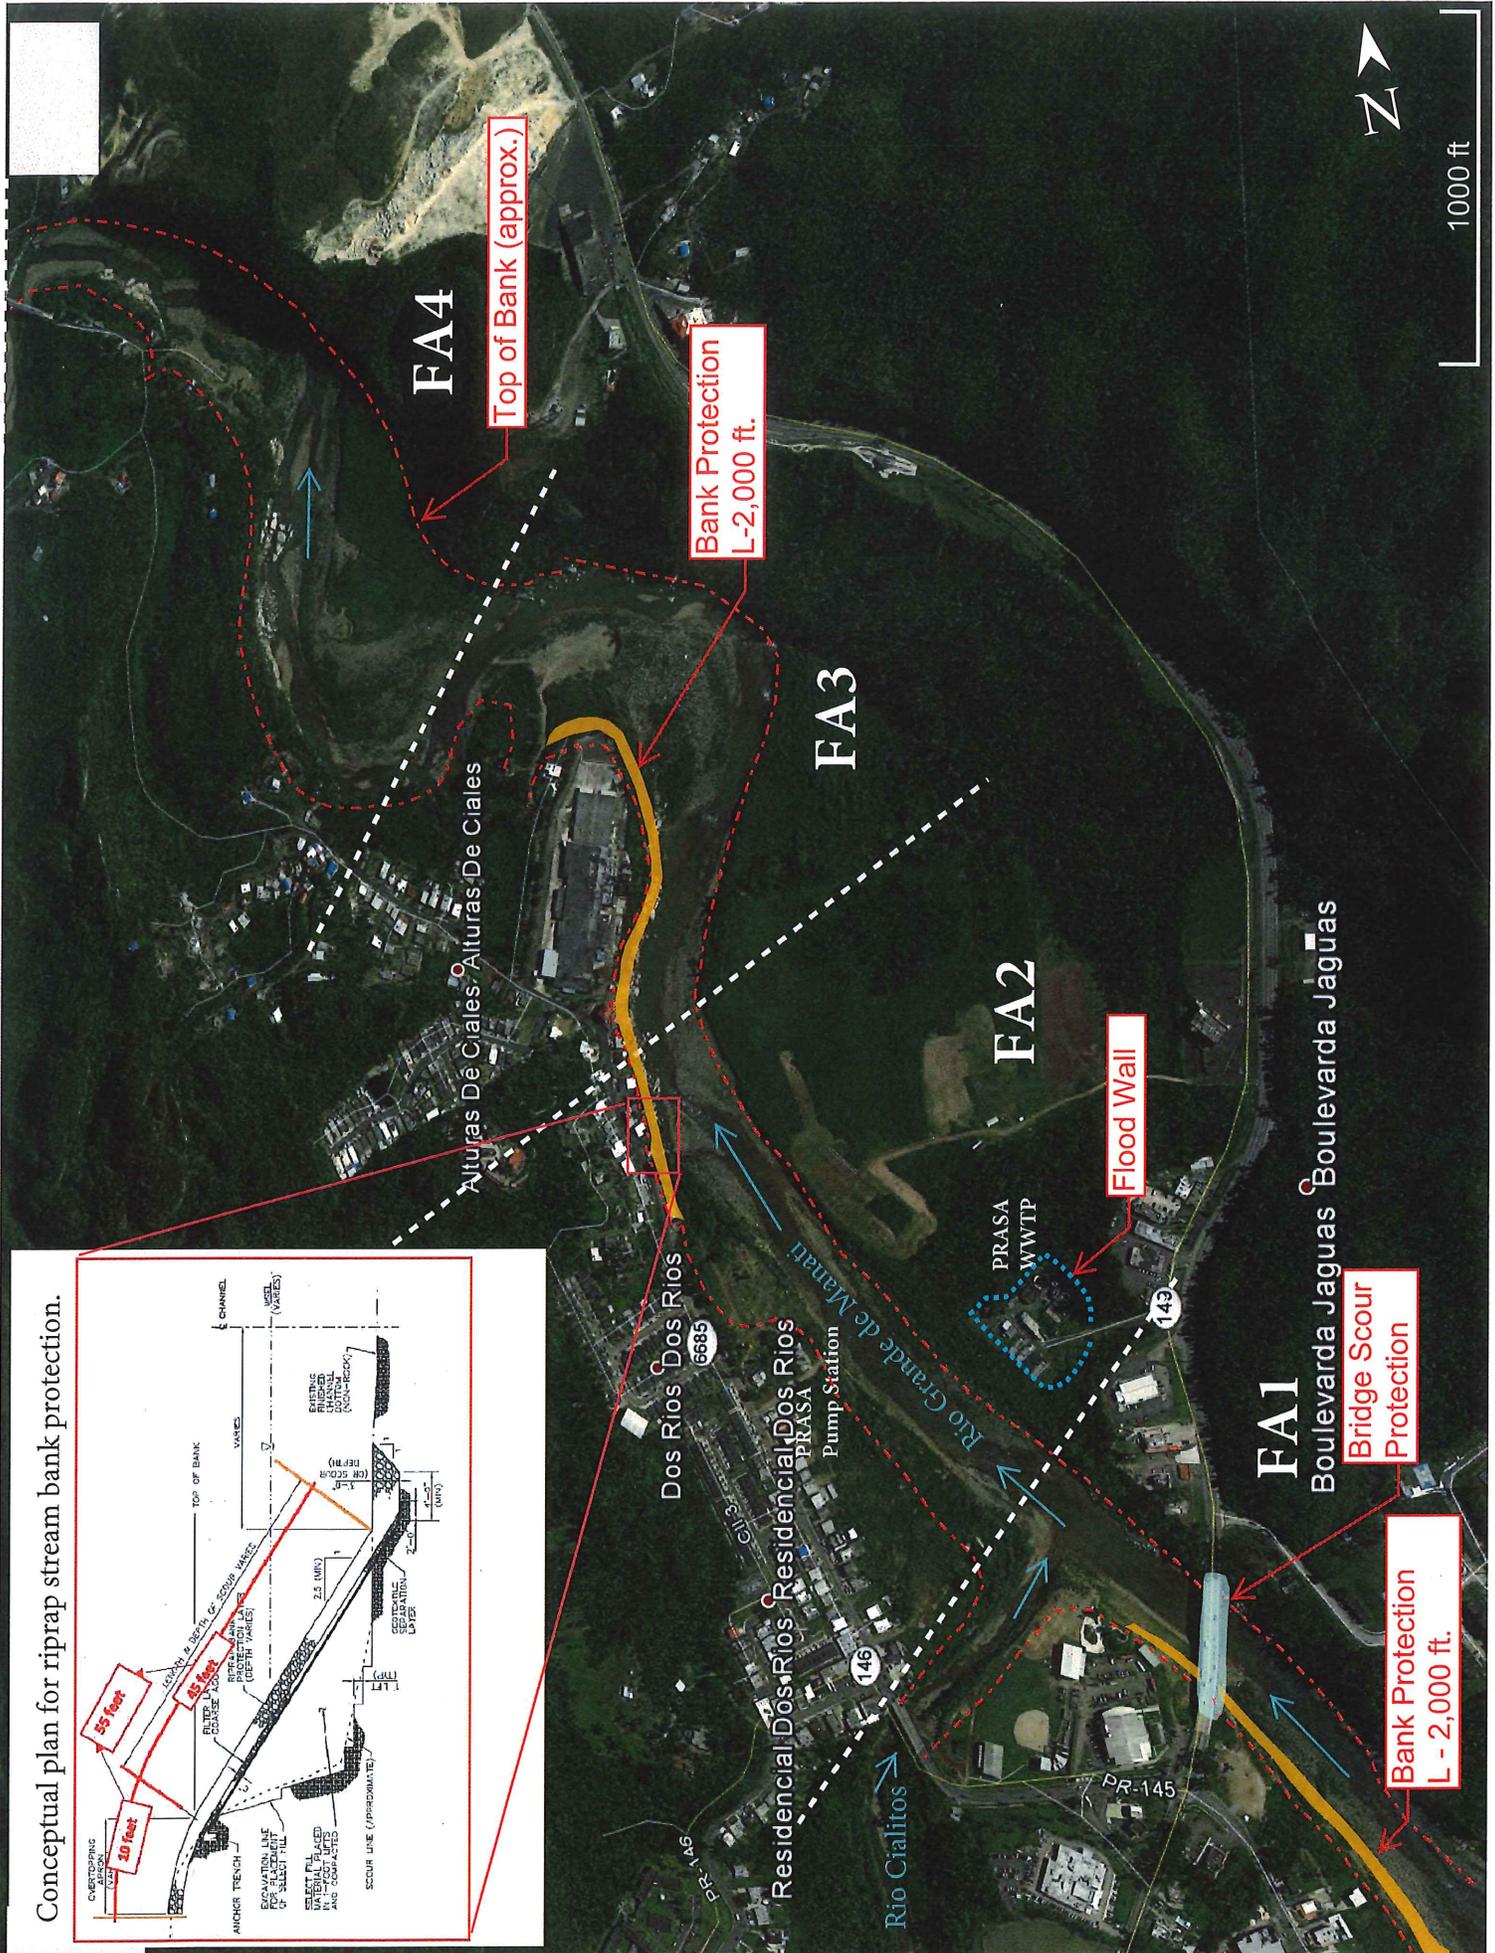
Conceptual plan for riprap stream bank protection.
