# PHASE I ENVIRONMENTAL SITE ASSESSMENT REPORT

**PHASE I ENVIRONMENTAL SITE ASSESSMENT  
RIO GRANDE DE MANATI FLOOD RISK MANAGEMENT STUDY  
CIALES, PUERTO RICO**

**U.S. Army Corps of Engineers  
Pittsburgh District**

**SEPTEMBER 2019**

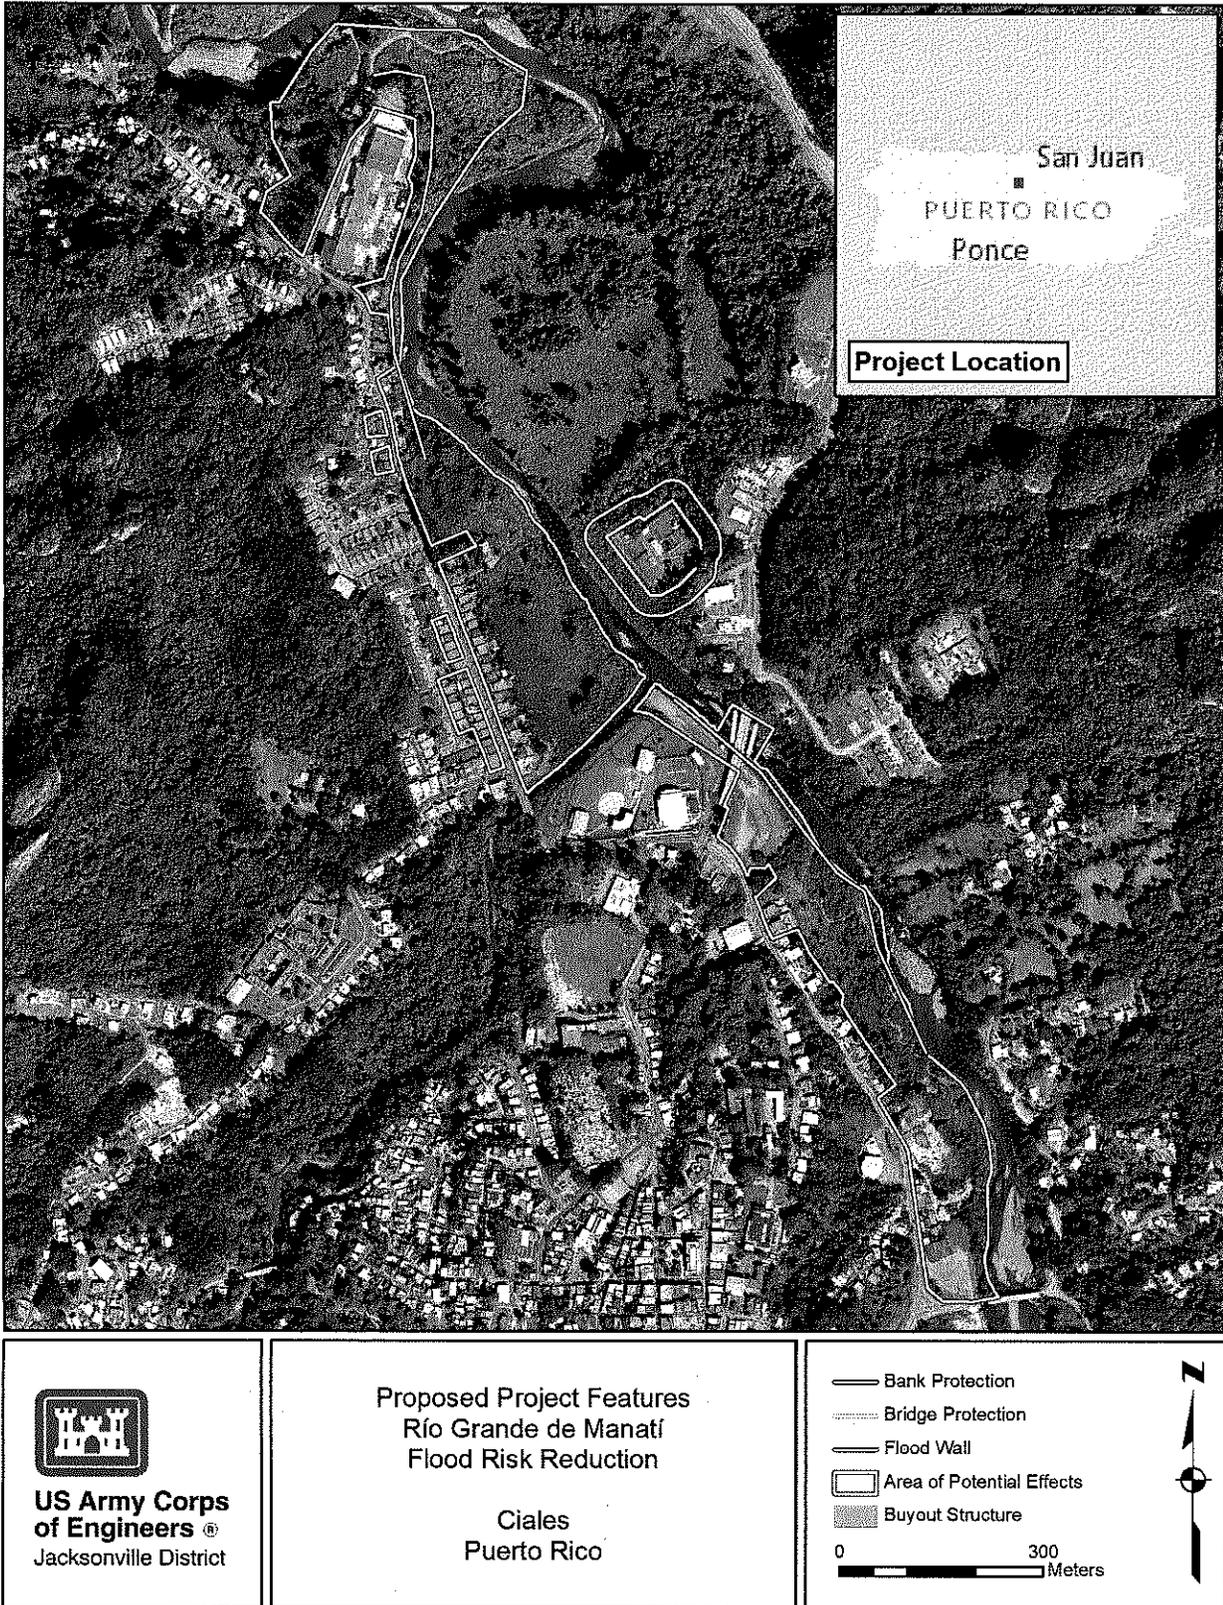
Figure 1. Features from the Tentatively Selected Plan and the proposed APE for the Río Grande de Manatí Flood Risk Management Project.

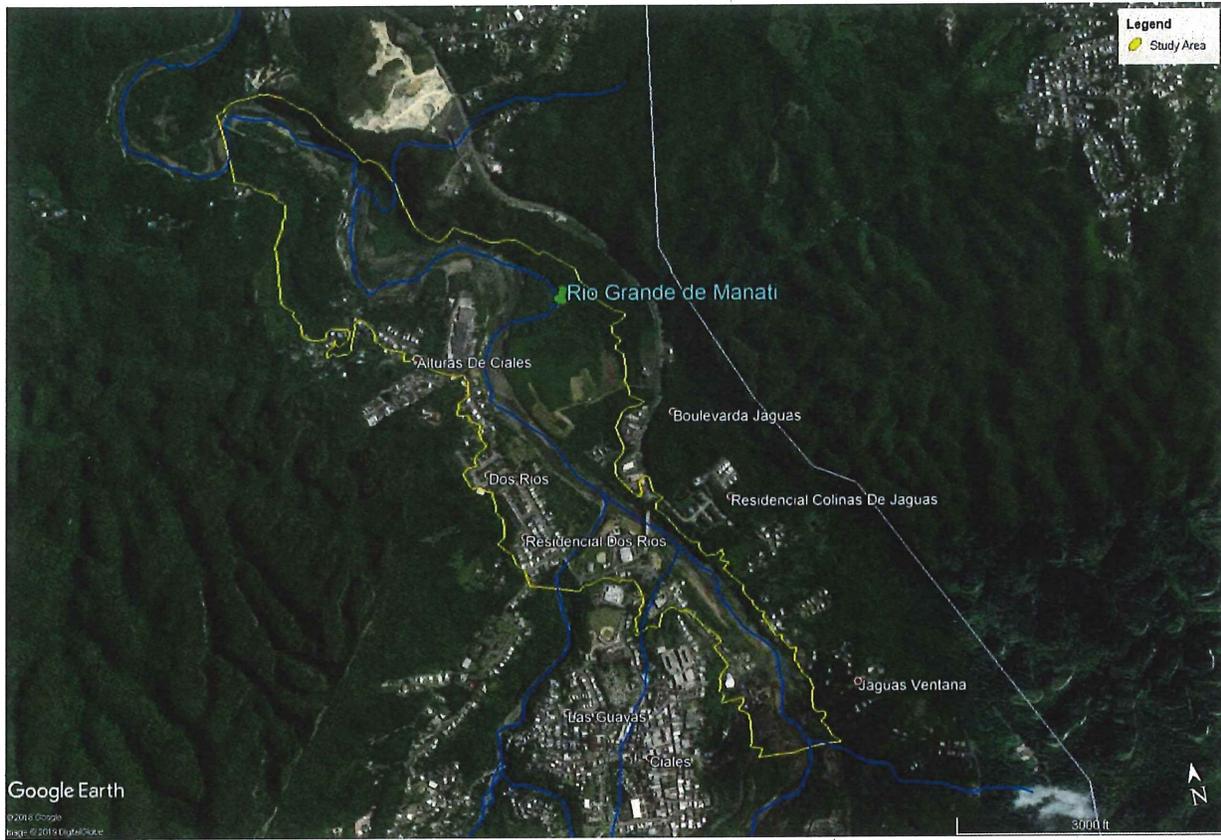
Figure 2. Rio Grande de Manati location within the study area.

The Municipality of Ciales is located on the northern slopes of the Central Mountain Range, approximately 25 miles southwest of San Juan (Figure 1). Approximate coordinates in the center of the study area are 18.345784°N and -66.469817°W. The Rio Grande de Manati flows through the study area (Figure 2).

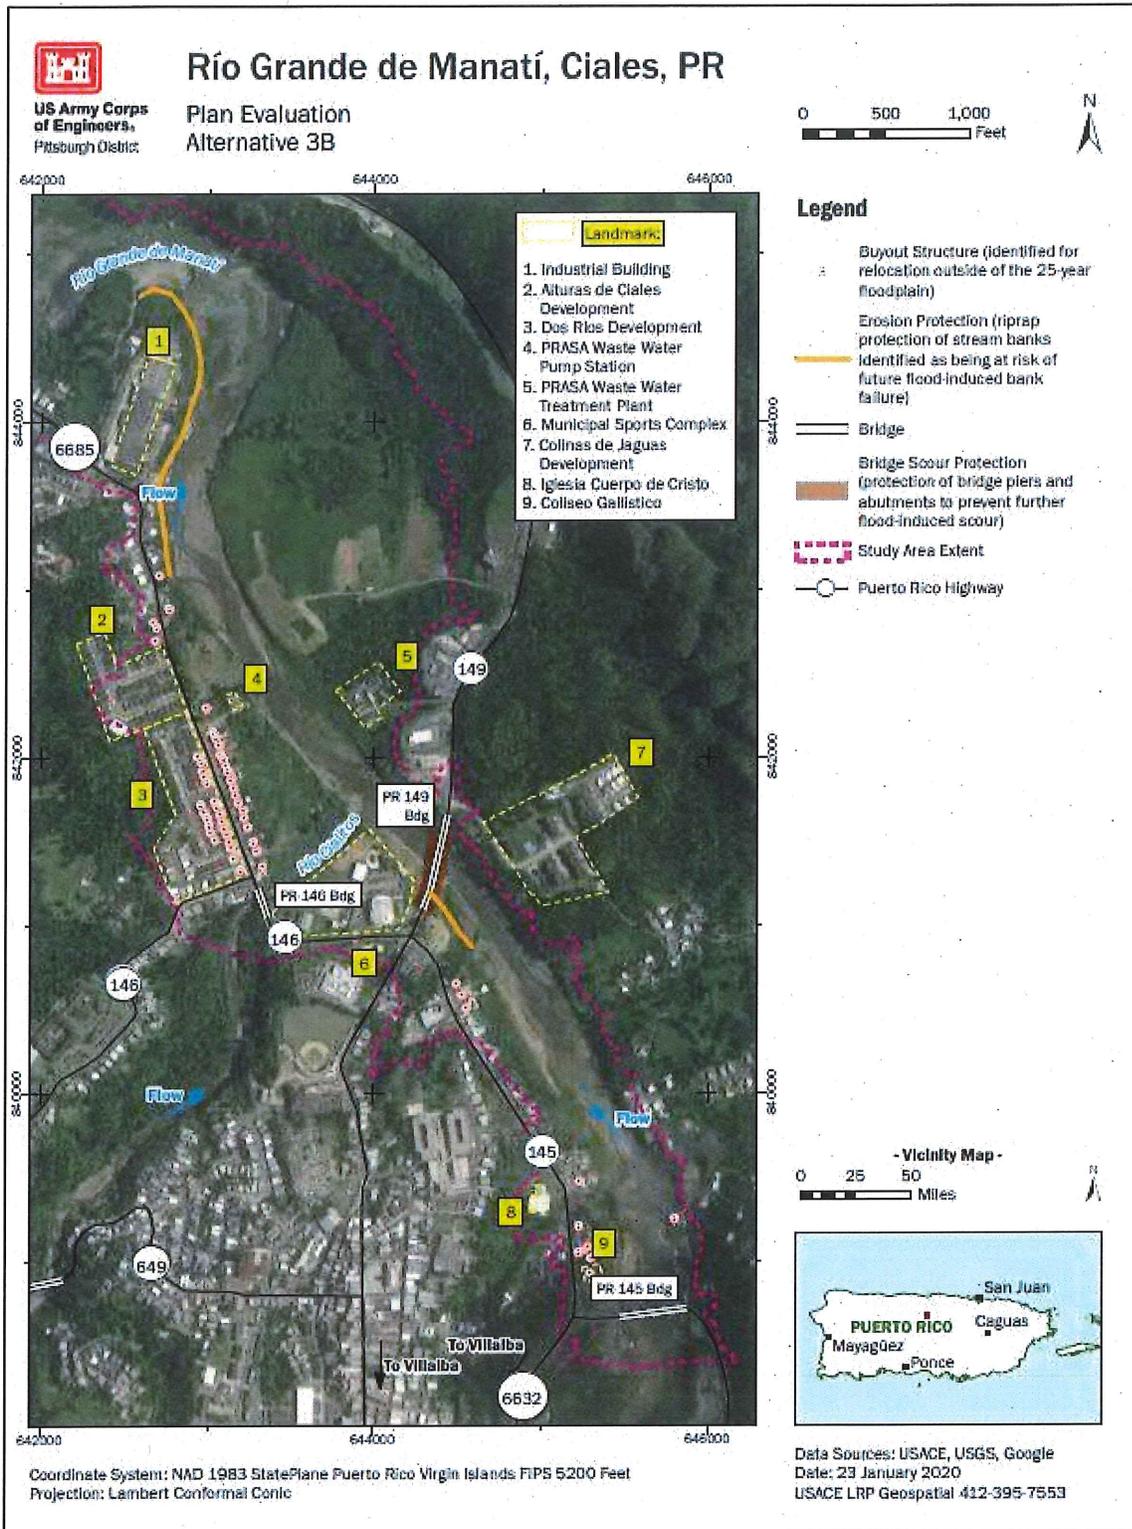
The Recommended Plan consists of the following construction: approximately 2,400 feet of riprap bank protection built to the 25-year flood elevation or top of bank located in two separate locations, approximately 400 feet of bank protection upstream of the PR-149 bridge and approximately 2,000 feet of bank protection downstream of the bridge; and the placement of riprap around the bridge piers and abutments of the PR-149 bridge as scour protection. Bridge scour protection will extend one pier-width (5 feet) upstream, seven pier-widths (35 feet) downstream, and 2 pier-widths (11 feet) on the sides of each pier with a depth of 6-feet. The Recommended Plan also includes the acquisition, demolition, and relocation of 58 private homes and businesses located within the 25-year floodplain (Figure 3).

Figure 3. Plan showing proposed bank stabilization, bridge scour protection, and structures proposed for buyouts.
