Shallow Land Disposal Area Geophysical Investigation

Geophysical Survey Report Revision 0

U.S. Army Corps of Engineers - Pittsburgh District

Science Applications International Corporation

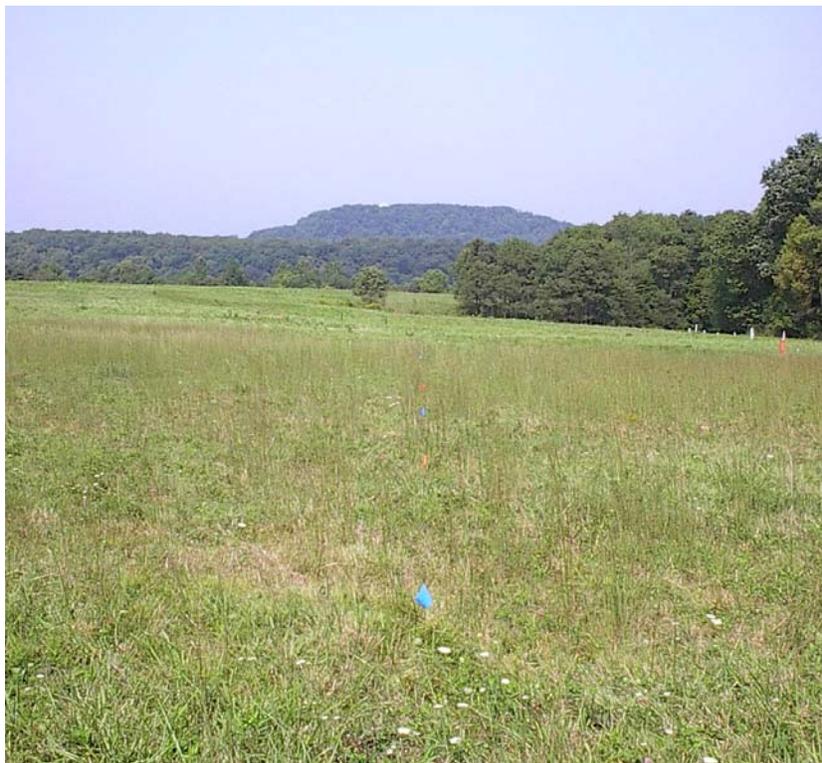
Photograph 2. Reference Grid Pin Flags With Trench 1 on the Right

Upon observation of the site, field personnel established a 15-ft reference grid across the cleared areas of the site. The Work Plan proposed establishing a 15-ft survey grid by placing survey flagging along the perimeter fence as a visual reference grid at the end of the traverses. However, site topography and wooded areas prevented effective view across the site. Therefore, a submeter PRO-XRS DGPS manufactured by Trimble Limited® of Sunnyvale, California was used to establish a 300-ft survey grid across the site with intermediate wooden stakes or pin flags placed as necessary. Once the basic grid was established with DGPS, SAIC established a 15-ft grid across the area of interest using a 300-ft measuring tape. These traverses were generally oriented perpendicular to the orientation of the previously identified trenches. Survey traverses were marked with pin flags and surveyor's tape for visual reference. During the investigation, range poles and/or safety cones were used as visual discriminators to maintain correct survey lanes throughout data collection.

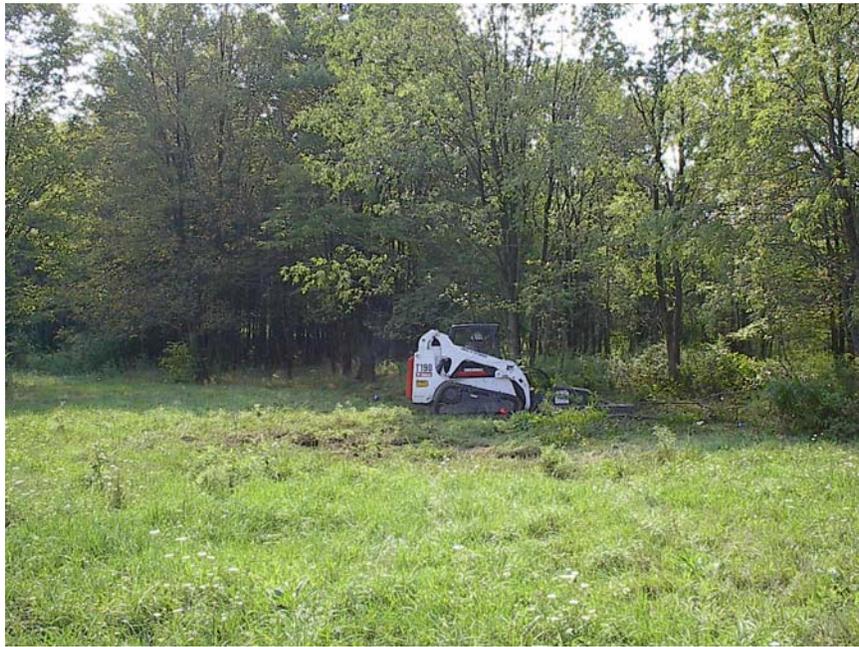
Photograph 3. Site Clearing Along Tree Line with Bobcat

Because significant portions of the site are wooded, a Bobcat fitted with a brush-hog attachment and hand tools were used to clear small trees (generally less than 2 inches in diameter) and brush to allow access for the geophysical survey personnel and equipment. All areas where mechanical clearing was prevented by large trees, steep topography, or extremely soft ground were cleared by hand to the extent possible. However, in most wooded areas the 15-ft traverses were not attainable due to these obstacles. Therefore, a meandering path survey method was used. Meanders were performed through the wooded areas to obtain as much coverage and geophysical data as reasonably possible, but without the rigors of neatly spaced traverses.

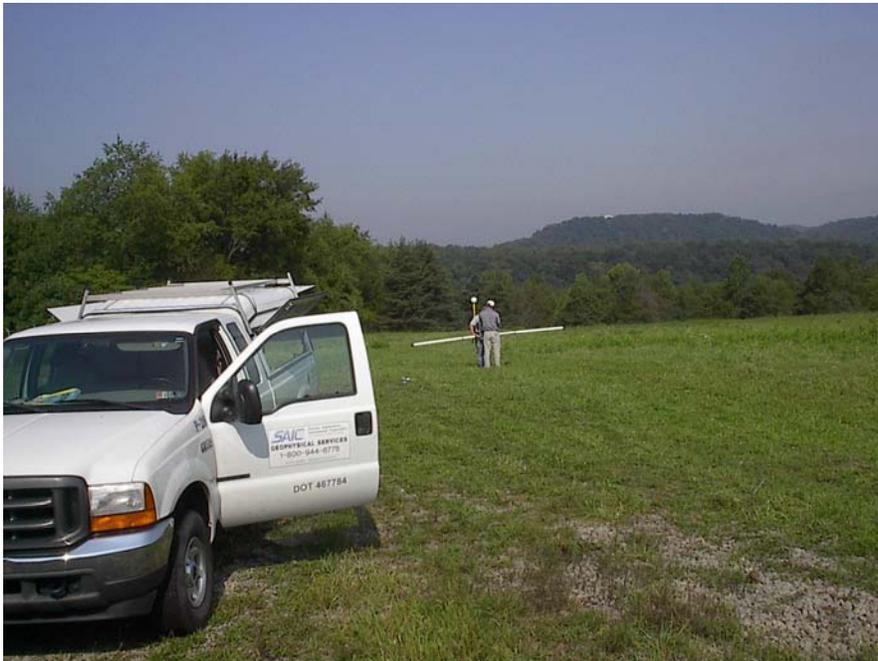
Photograph 4. Calibration of EM31 at Reference Station

As part of the infield data quality control assessment, SAIC reviewed daily static test data to verify calibration results, data repeatability, and reliability. SAIC utilized Geonics DAT31W software package to integrate EM and DGPS data. During data pre-processing, SAIC performed lag adjustment as appropriate and normalized data results to a consistent background response. SAIC generated color-enhanced contour maps of inphase (magnetic susceptibility) and quadrature (terrain conductivity) datasets using the Surfer[®] contour and mapping software package. Potential EM31 anomalies were investigated to ensure surface debris or other potential interferences did not adversely influence subsequent characterization activities. As appropriate, a site features map was superimposed on the contour map to aid in data interpretation.

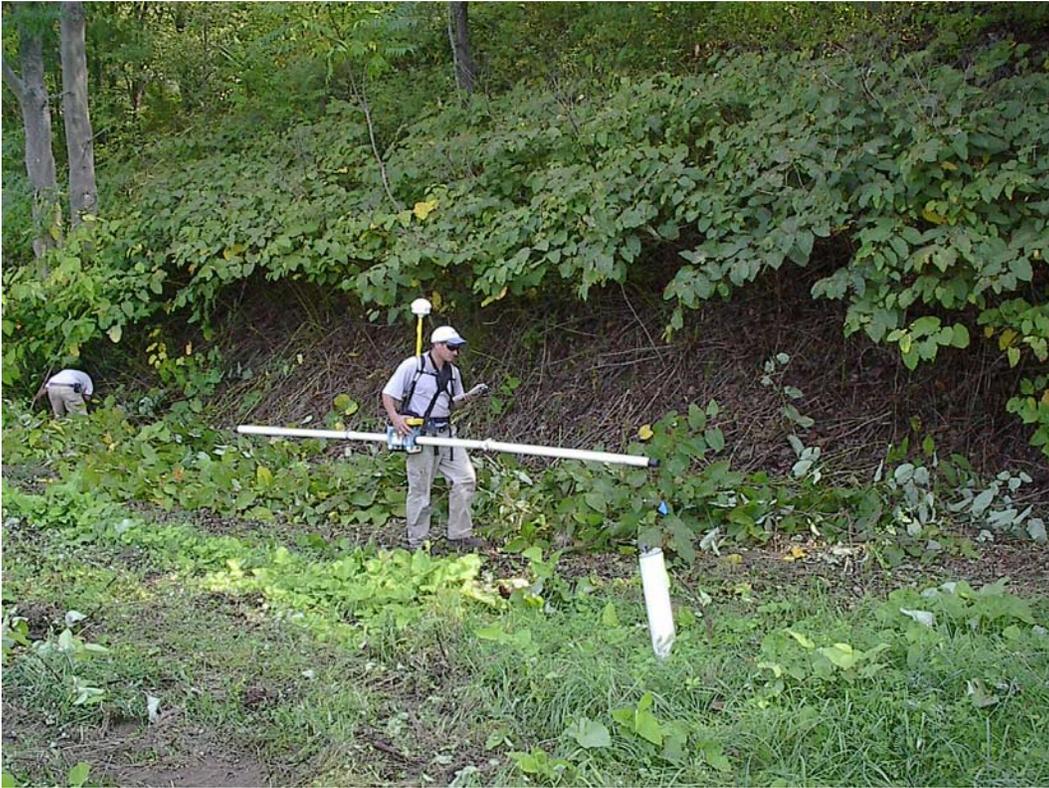
Photograph 5. EM31 Survey Along Toe of High Wall

The EM31 survey was conducted using a terrain conductivity meter manufactured by Geonics Limited of Mississauga, Canada. Data was acquired by carrying the EM31 along the pre-marked survey lines at a normal walking speed following SAIC Geophysical Procedure GP-002 *Surface Electromagnetic Surveys* (included in Appendix B of the Work Plan). During the investigation, inphase and quadrature phase, vertical dipole data was recorded along traverses nominally spaced every 15 ft (4.6 m). In areas that were known to contain buried material (i.e., near the trenches), intermediate traverses spaced every 7.5 ft (2.3 m) were investigated in order to better delineate these areas. EM31 data was recorded at a rate of 2 Hertz (2 times per second) and integrated with DGPS data collected at a rate of 1 Hz. In wooded areas, SAIC performed a series of fixed width traverses and/or meandering path transects to accommodate the required data density. A total 94,730 EM31 measurements were recorded representing approximately 203,018 linear ft (38.5 miles or 61.9 km) of data. The EM31 data track map is presented as Figure 4.

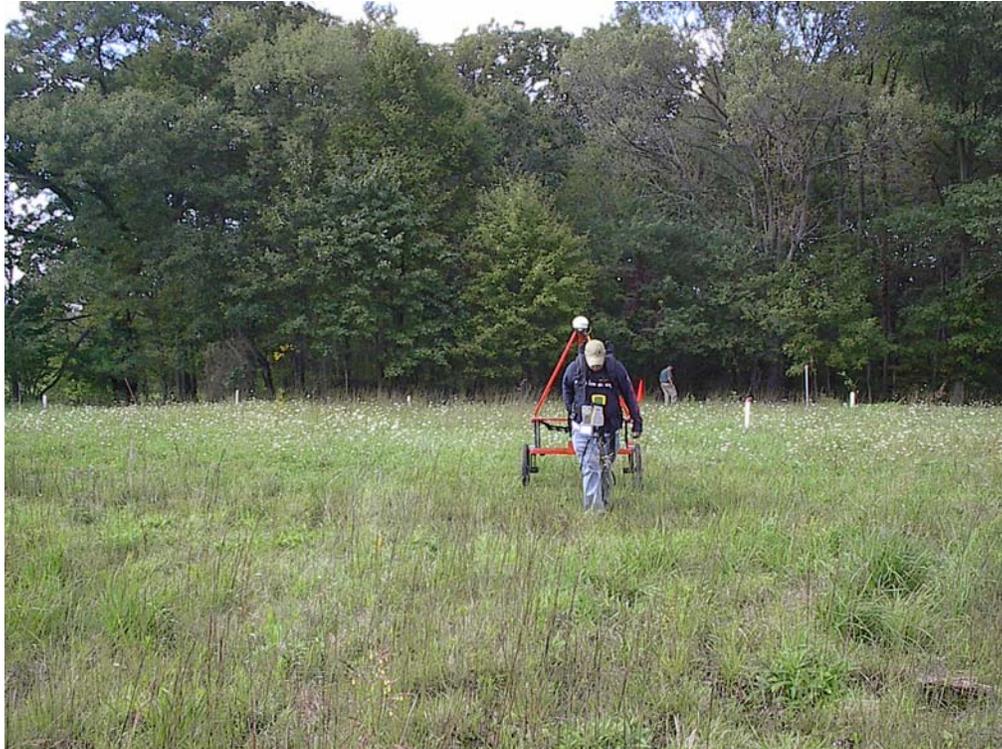
Photograph 6. EM61 Survey

The EM61 data were acquired by towing the EM61-MK2 along pre-marked survey lines at a normal walking speed. During the investigation, data was recorded along traverses nominally spaced every 5 ft (1.5 m), at a rate of 4 Hertz (4 times per second). These data were integrated with DGPS data collected at a rate of 1 Hz. A total 90,278 EM61-MK2 measurements were recorded representing approximately 83,442 linear feet (15.8 miles, 25.4 km) of data. The EM61-MK2 data track map is presented as Figure 13.

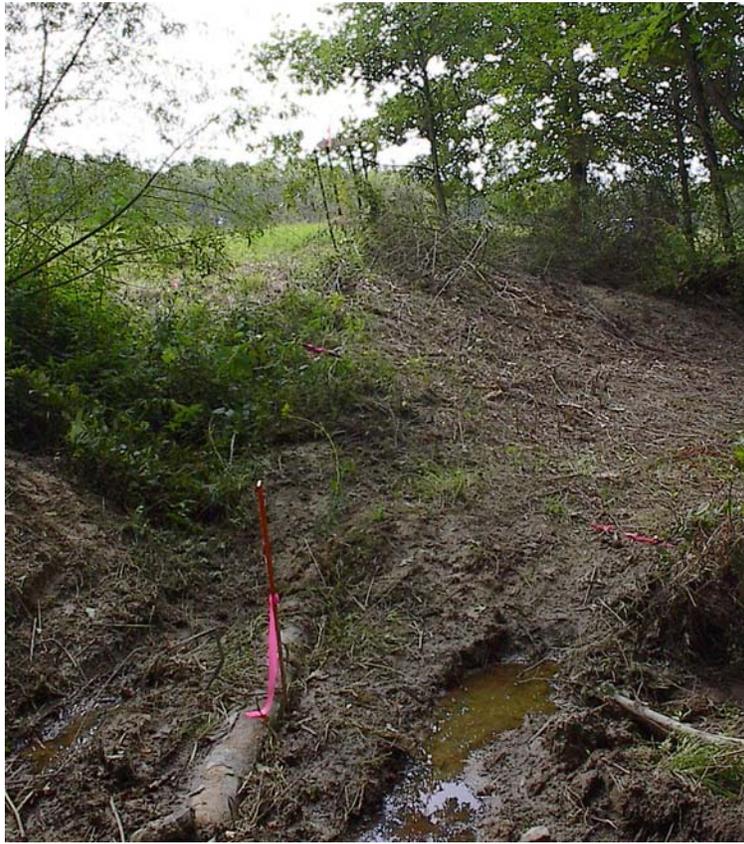
Photograph 7. Exposed Utility Line in Dry Run and Metal Debris East of Trench 3

Metal debris (such as pipes and stands) was observed on the ground surface in many areas, usually in the wooded portions of the site. When identified, these objects were marked with flagging tape for visibility and moved from the area before conducting the geophysical surveys, if possible. Metal items unable to be easily moved may appear as small isolated areas of elevated response on the results figures.
