Understanding Streambank Erosion and Failure

STREAMBANK EROSION

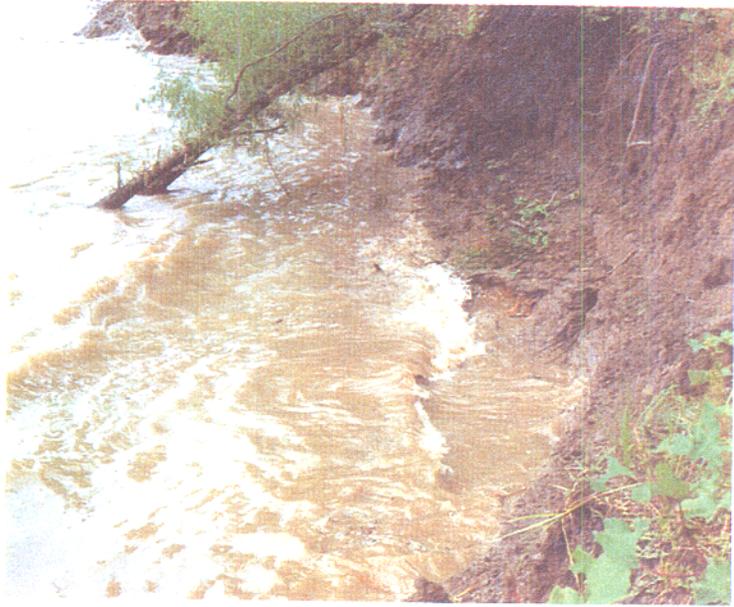
Wave attack on a streambank.

WAVE ATTACK. Passing boats or wind can set up waves on a stream. As the waves come into contact with a streambank the repeated agitation tends to dislodge soil particles. Wave attack can be an erosion force on streams with heavy commercial traffic and recreational activity or on streams with large areas of open water where the wind can build up waves. Wave attack is generally not a serious problem on small streams.

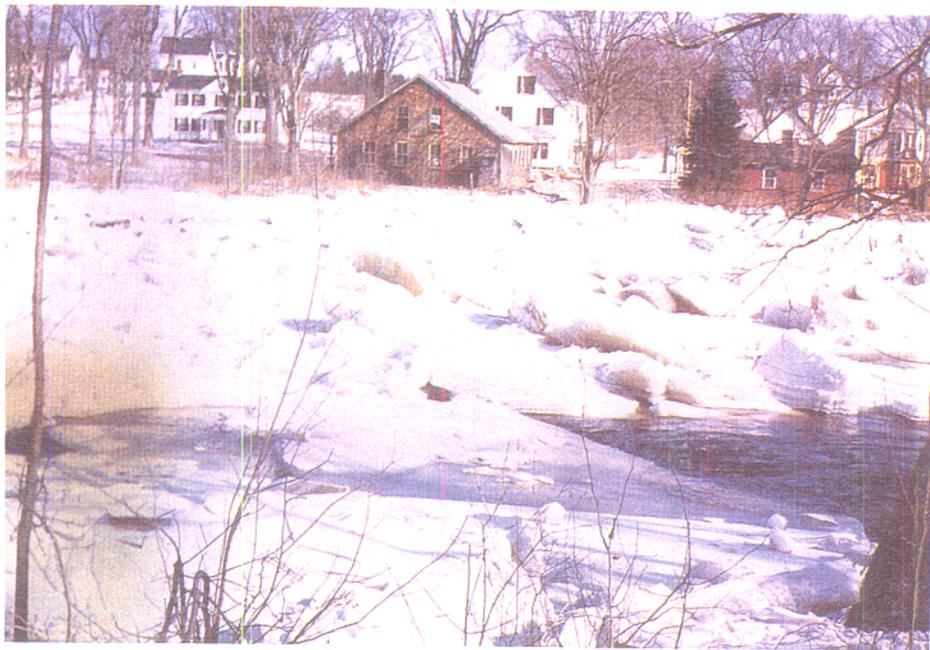
Ice generally remains in place during the winter months and causes very little streambank erosion.

ICE AND DEBRIS. After formation of an ice pack, the ice remains essentially *in place* during the winter months and causes very little streambank erosion. As the pack thaws in the spring, the ice breaks up into chunks and begins floating downstream. During this period, the amount of damage

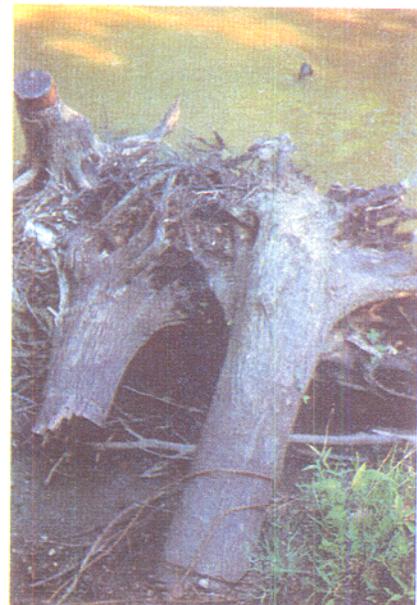
Debris can cause streambank erosion due to abrasion or impact.

to the streambanks is largely determined by whether the banks are still frozen or have begun to thaw. Frozen banks generally sustain little soil loss; however, structures such as boat docks, as well as trees and other vegetation, may be stripped away from the frozen banks by the impact of the ice chunks or pressure buildup from an ice jam. If the chunks of pack ice pass through a channel where the banks have already thawed, severe bank erosion can occur, mainly due to grinding of the ice against the streambank (abrasion). Debris, like ice, can cause streambank erosion by either abrasion or impact. The most common debris found in streams are the remains of fallen trees.

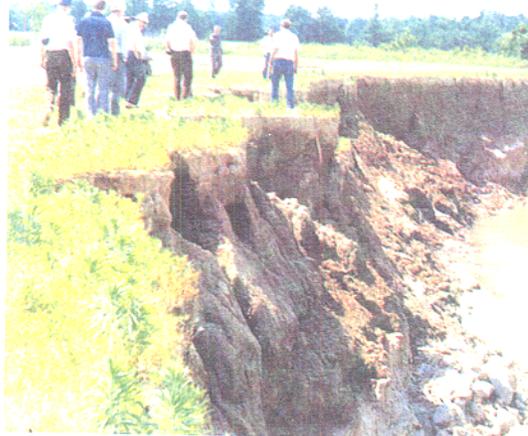
Streambank sloughing.

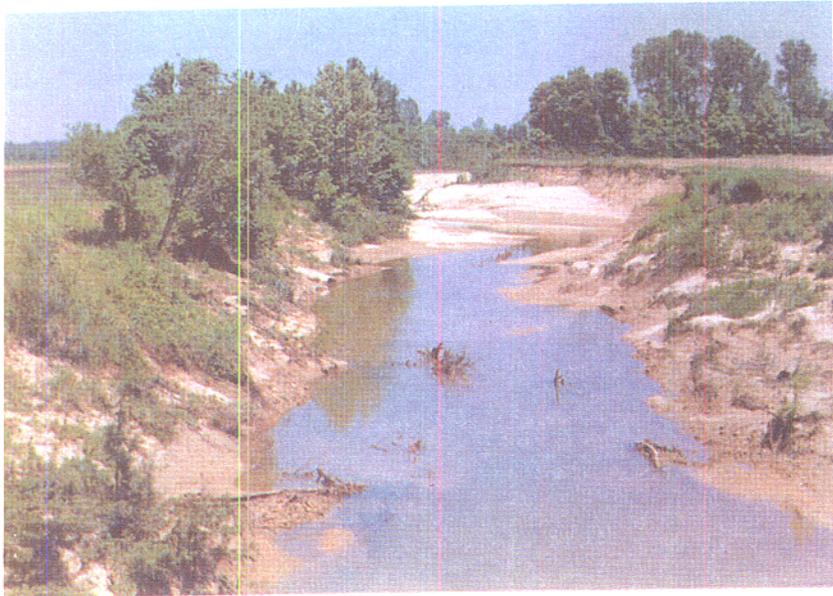
Bed scour in effect raises the height of top bank which in turn may lead to bank failure.

As the bed of a channel is scoured out by passing streamflow, the height of top bank above the bed increases. The bank may fail if its height continues to increase (see photo next page). Erosion of a bank face can increase shear stress in two ways: by undercutting the toe that buttresses the bank or by steepening the bank slope.
