Figure 3- 2. Lower Mahoning River Ohio and PA, Stream Channel Sediment Quality Metal Analyses, 1998 and 2000

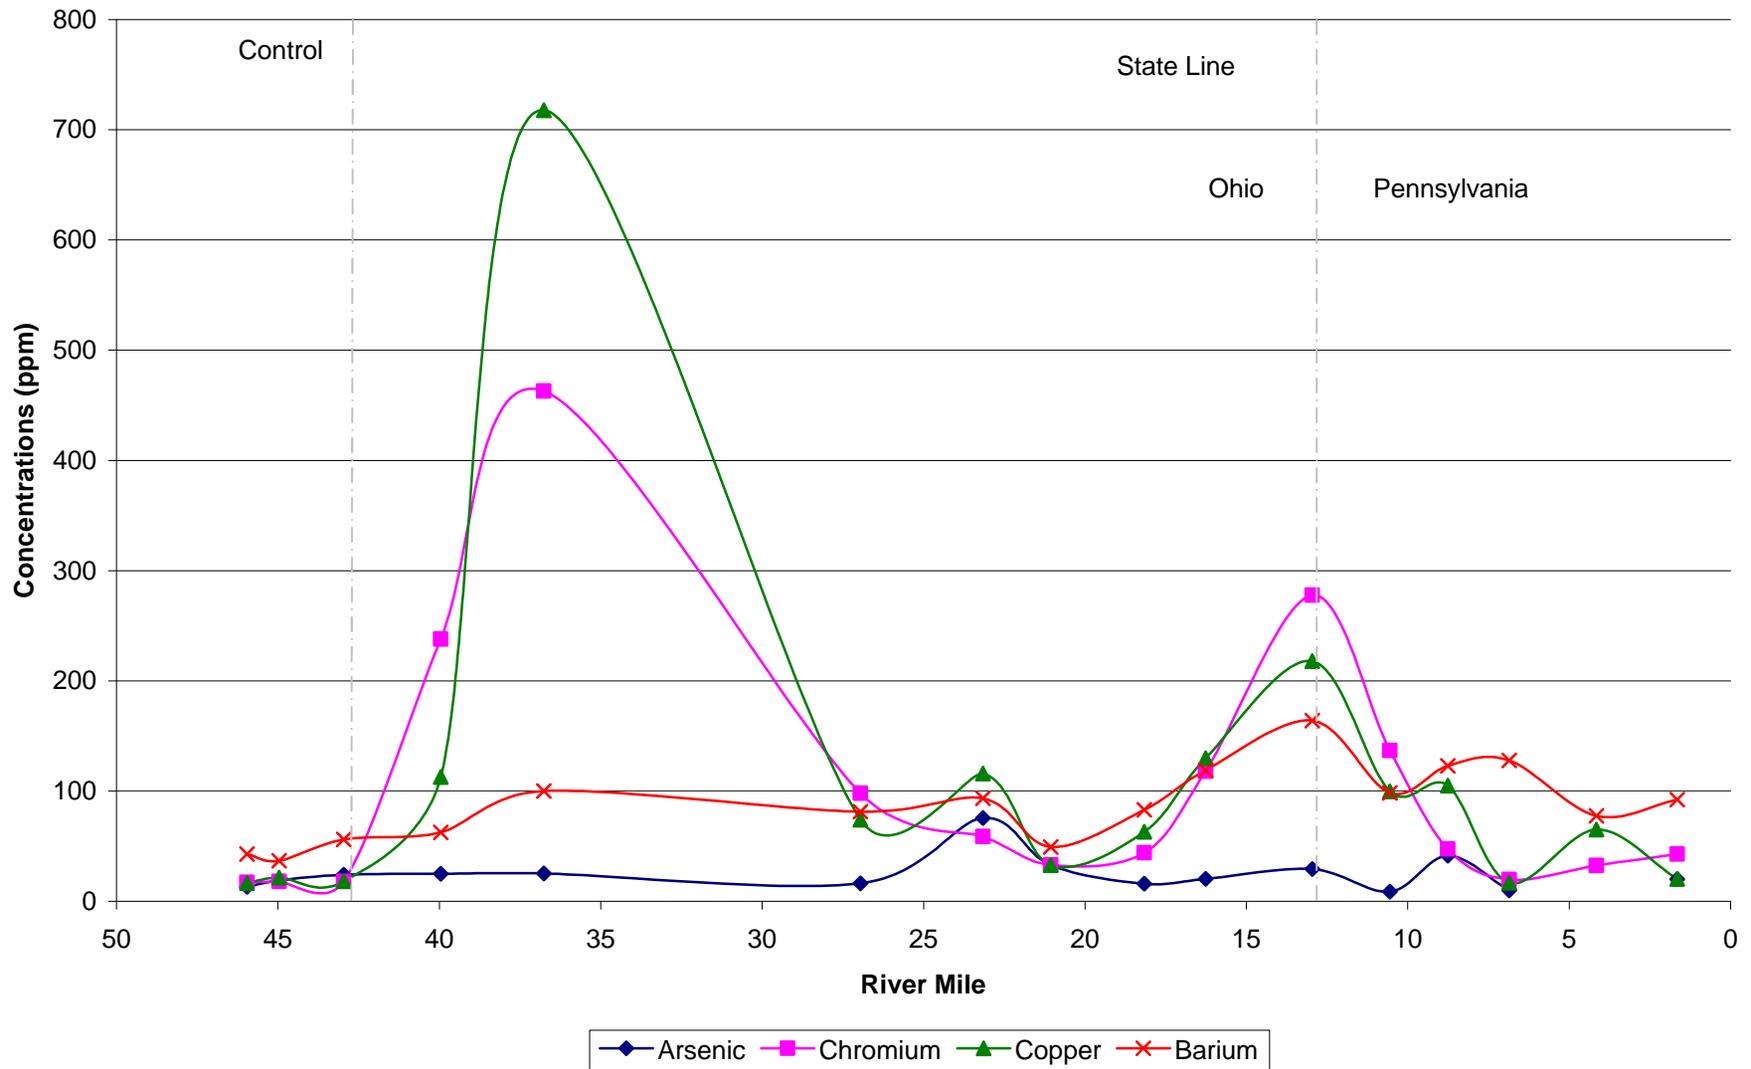
Ohio samples were composited 0 to 4 feet deep;
 Pennsylvania samples were 0 to 6 inches or surface
